**FINAL REPORT
MATANUSKA RIVER DEBRIS SITE ASSESSMENT
PALMER, ALASKA**

**Alaska Department of Environmental Conservation
555 Cordova Street
Anchorage, Alaska, 99501**

**OASIS Environmental, Inc.
807 G Street, Suite 250
Anchorage, Alaska 99501**

25 August 2004

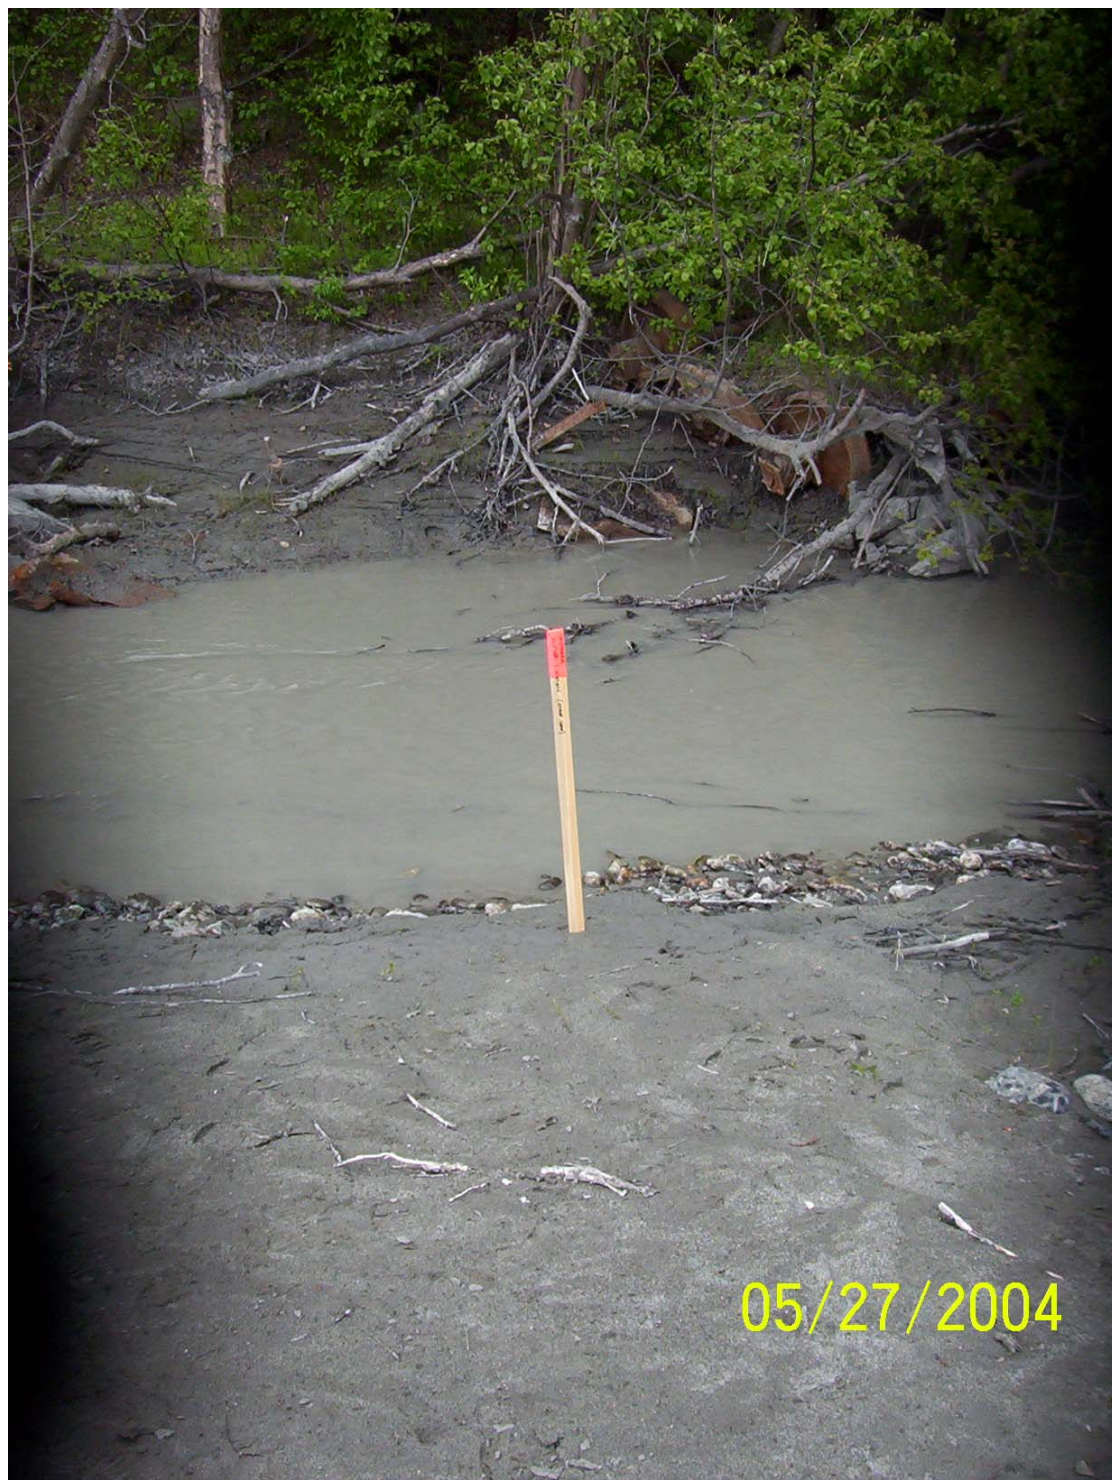
Photo #21 – View of upstream surface water and sediment sample location MD-03. (5/27/2004)
