# Lake Lucile Stormwater Outfall Source Area Estimates

Final Report for the Alaska Department of Environmental Conservation: July 2019

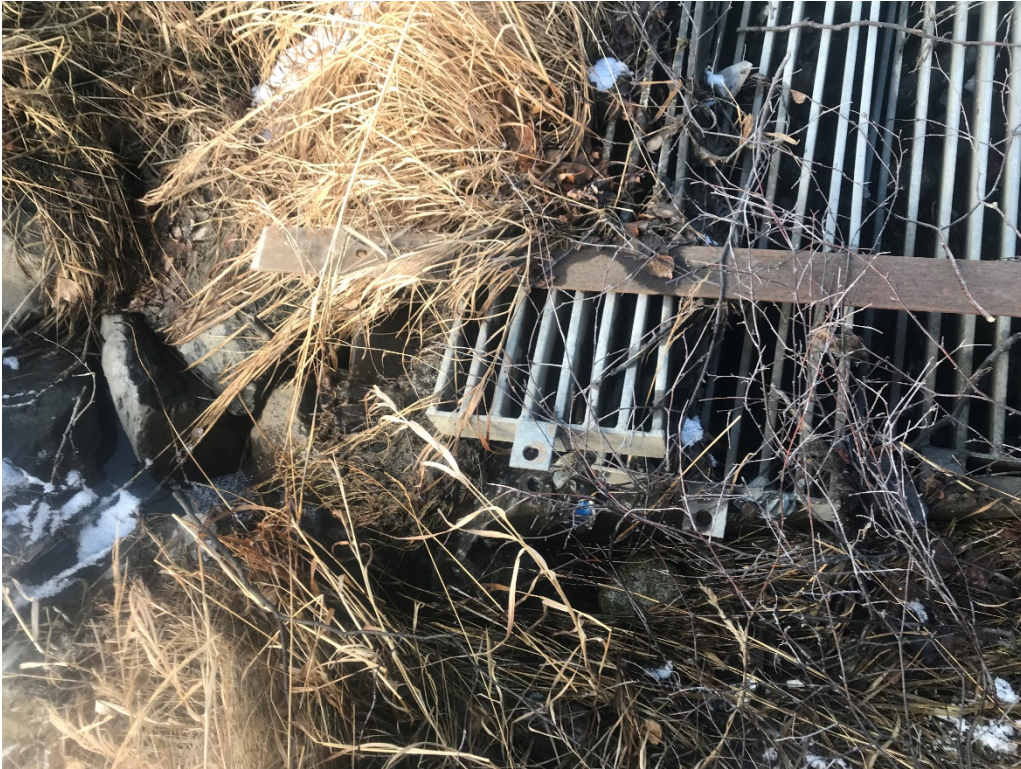
Photograph A1. West outfall. (3/19/19)

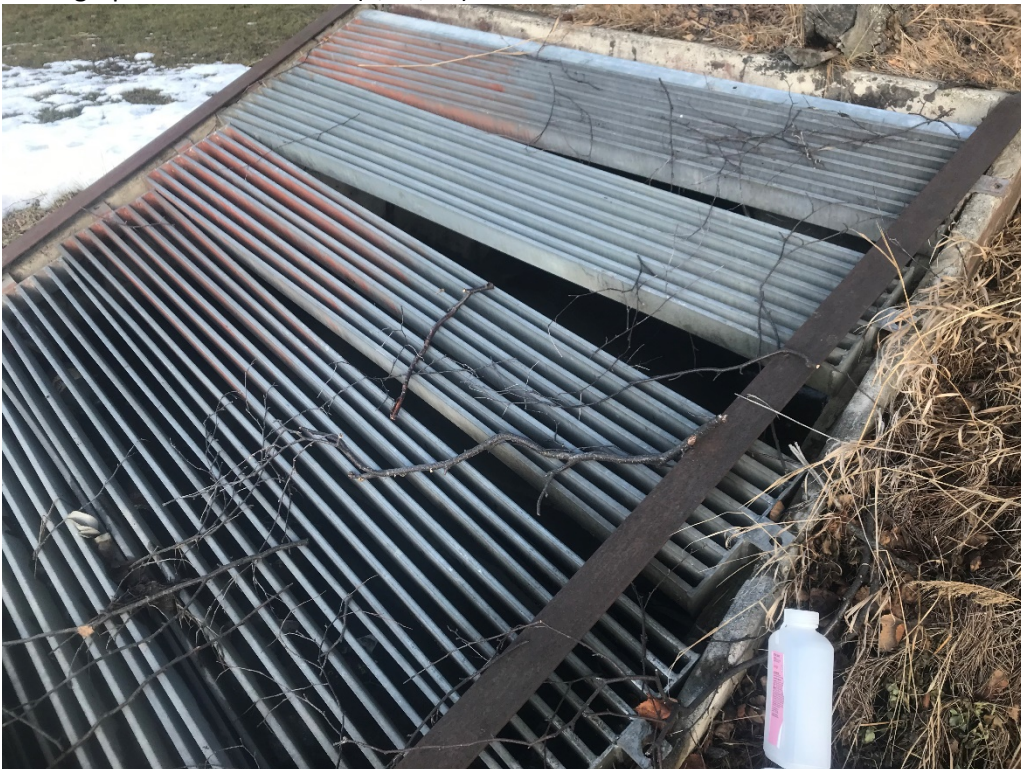
Photograph A2. West outfall. (3/19/19)

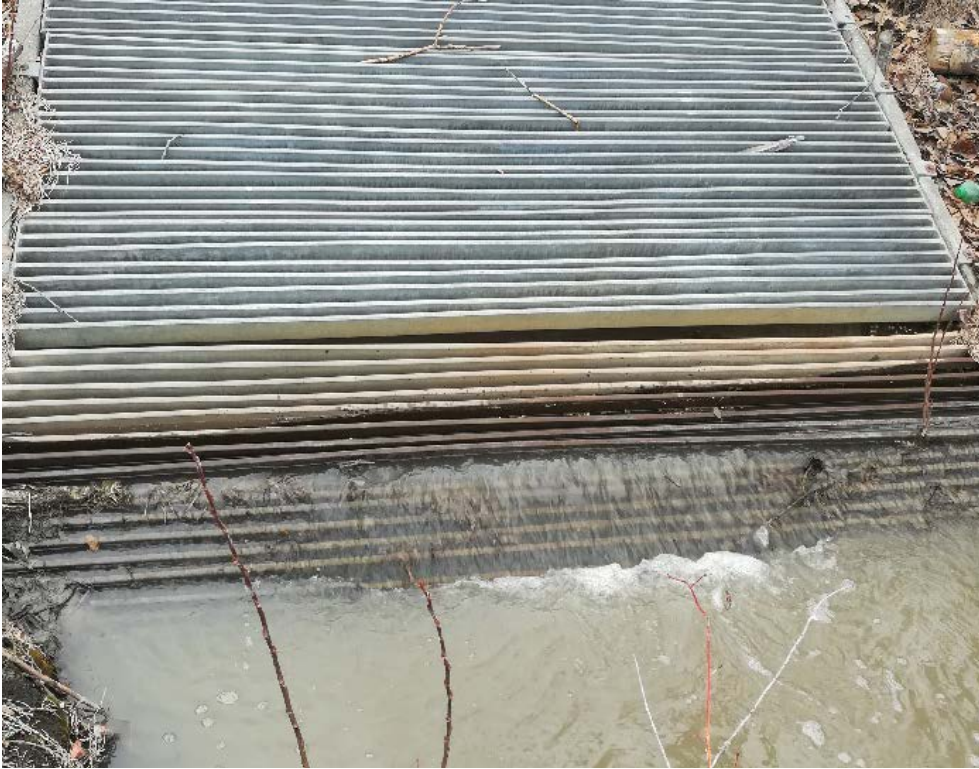
Photograph A3. East outfall. (3/18/19)

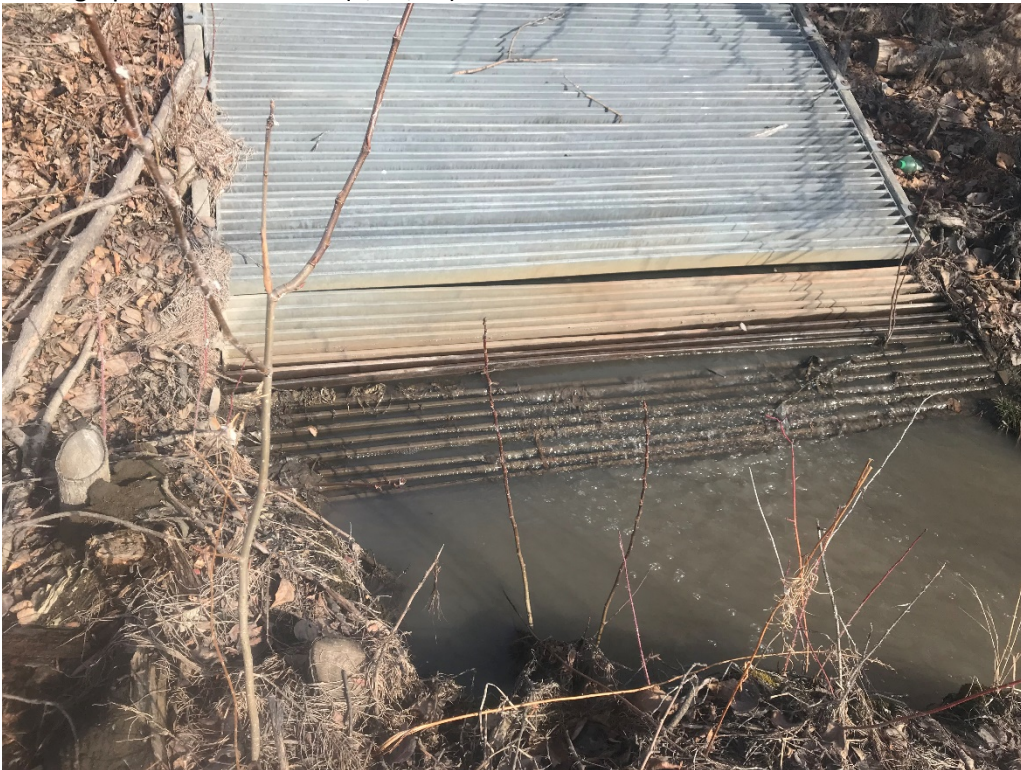
Photograph A3. Turbid discharge from east outfall. (3/19/19)

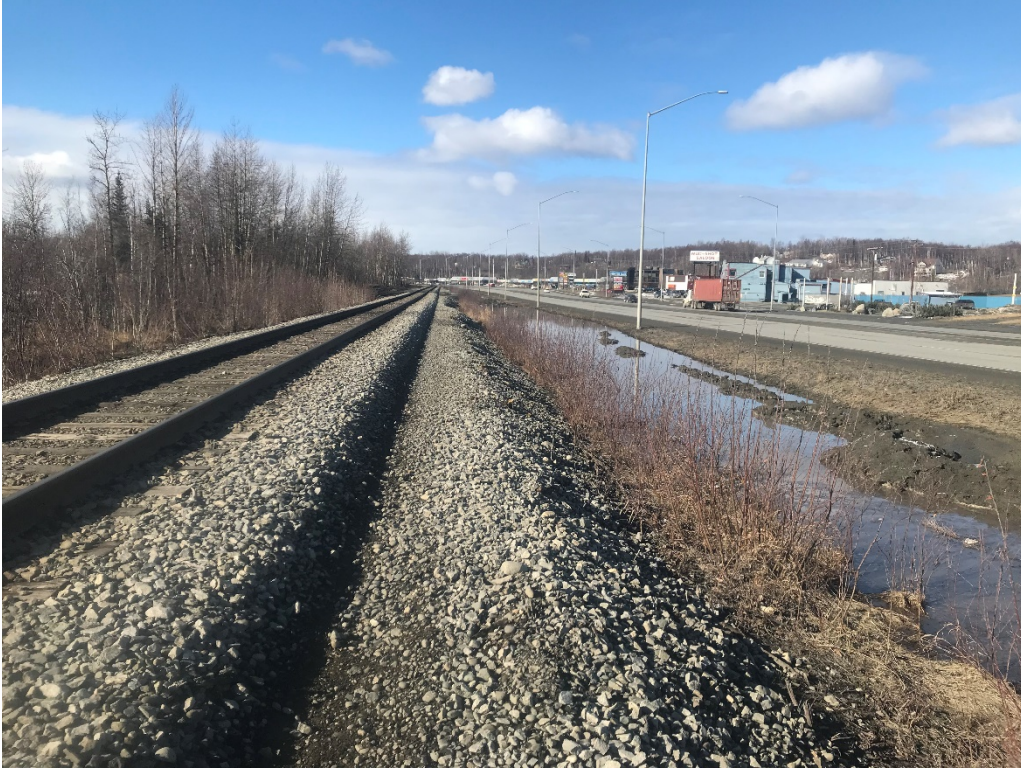
We are not certain if there are any storm drains within the vegetated swale south of the Parks Highway (between the highway and the railroad tracks). So it is not clear if runoff from snow storage in this area enters the storm drain system and Lake Lucile.

Photograph A5. Snow storage and runoff between the Parks Highway and the ARRC tracks near the east outfall. (3/19/19)

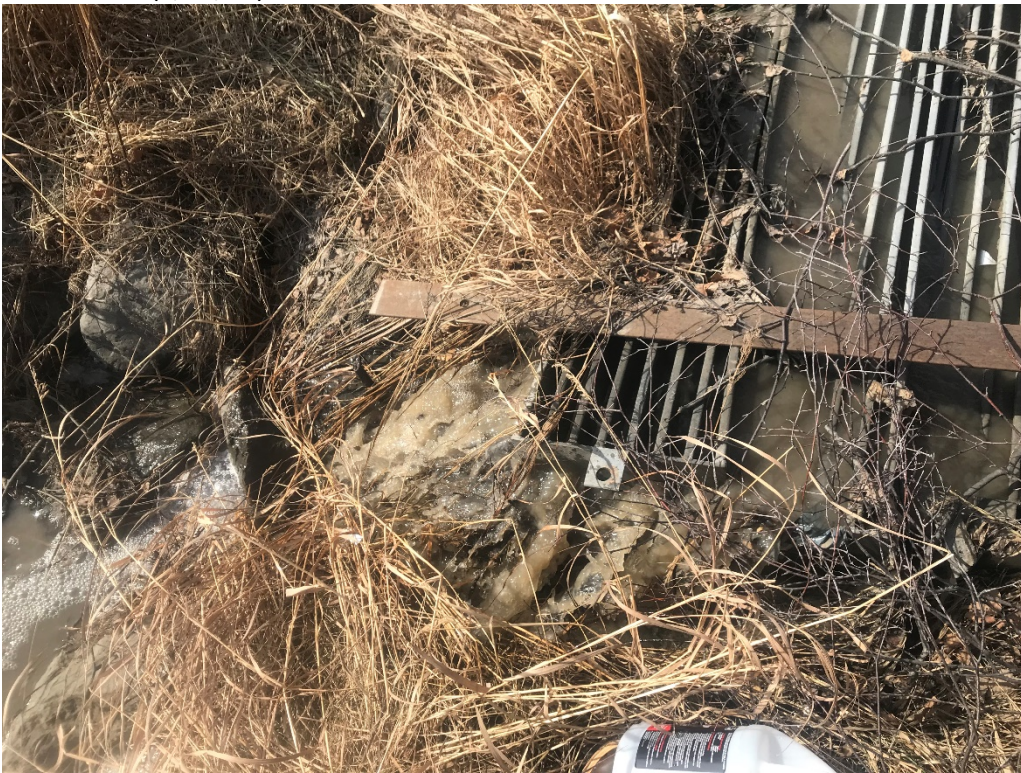
Discharge was first observed on March 18, 2019 in the east outfall but not the west outfall. West outfall discharge was present during two dates but likely extended over a 5 to 6 day period (March 19 - 24). West outfall discharge was extremely turbid with a maximum measured value over 1300 NTU (Table 3).

Photograph A6. Turbid runoff from west outfall on 3/22/19.

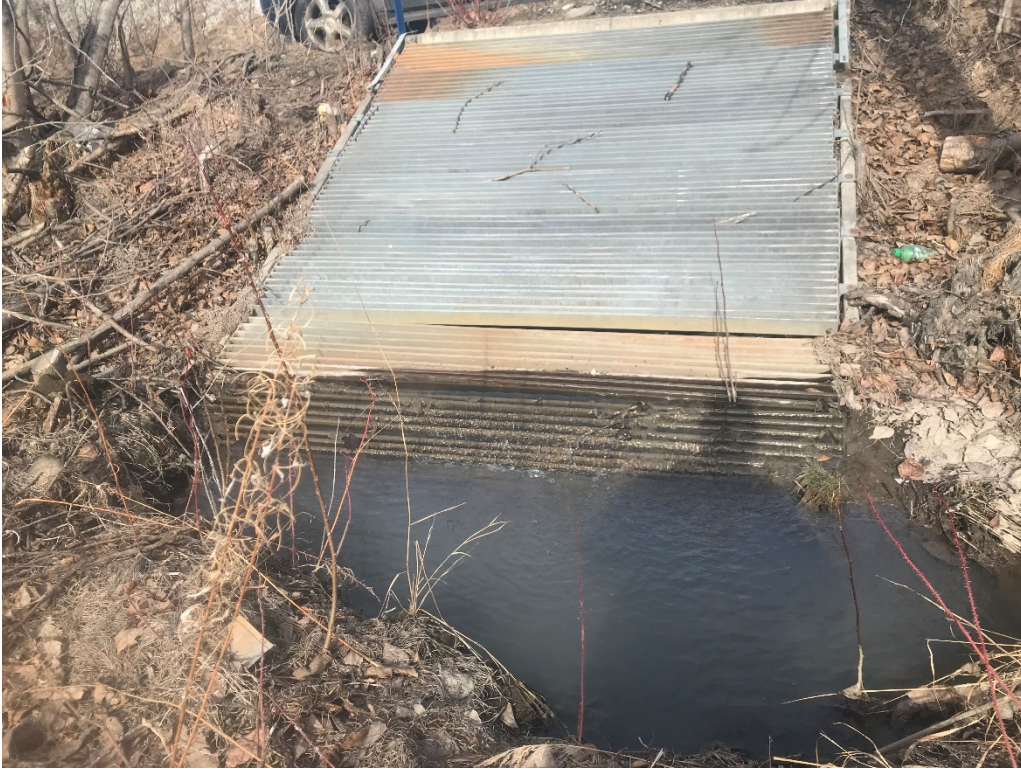
Photograph A7. Discharge from east outfall on 3/22/19.

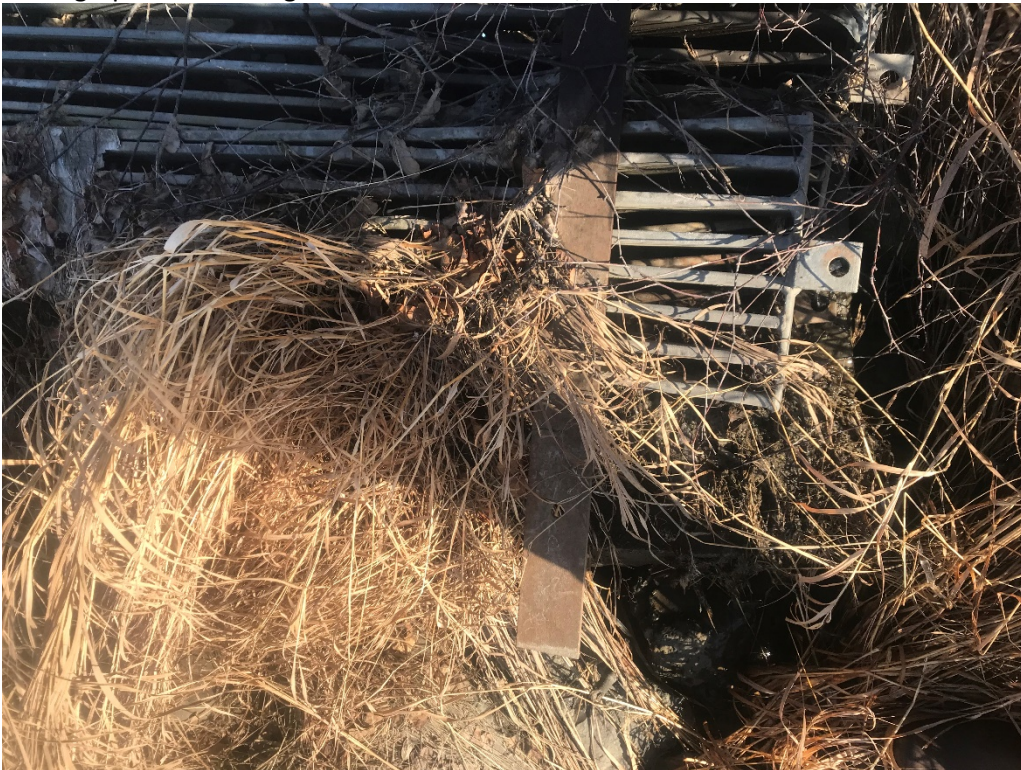
Photograph A7. No discharge from west outfall by 3/26/19.

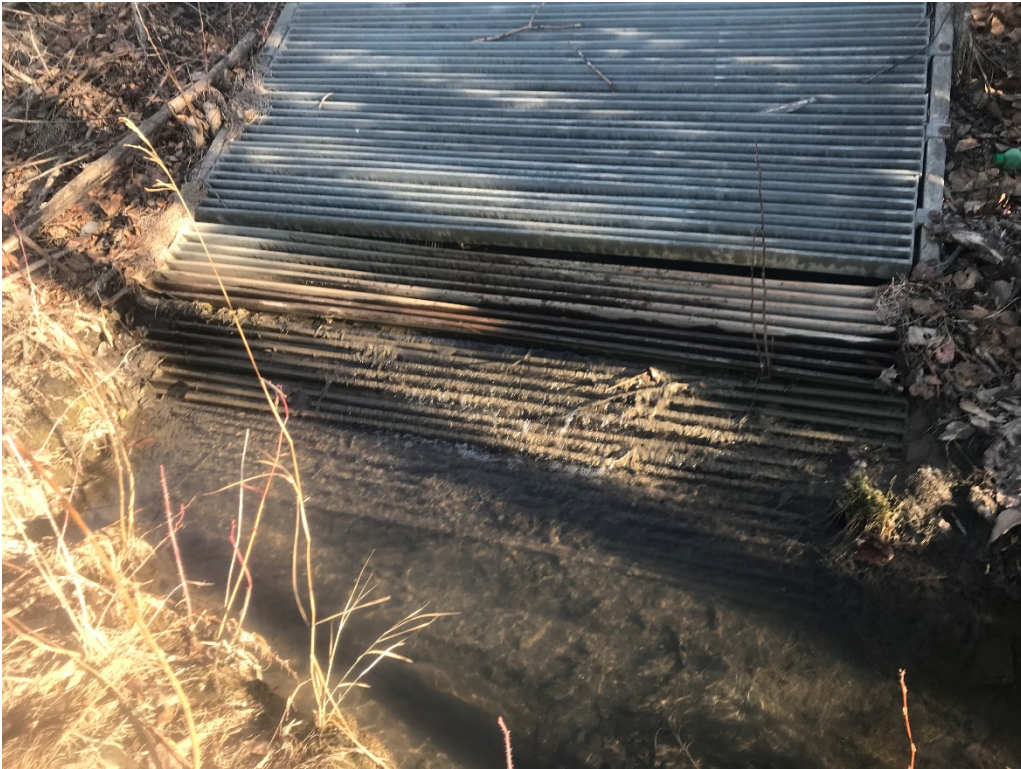
Photograph A8. Clear discharge from east outfall on 3/26/19.

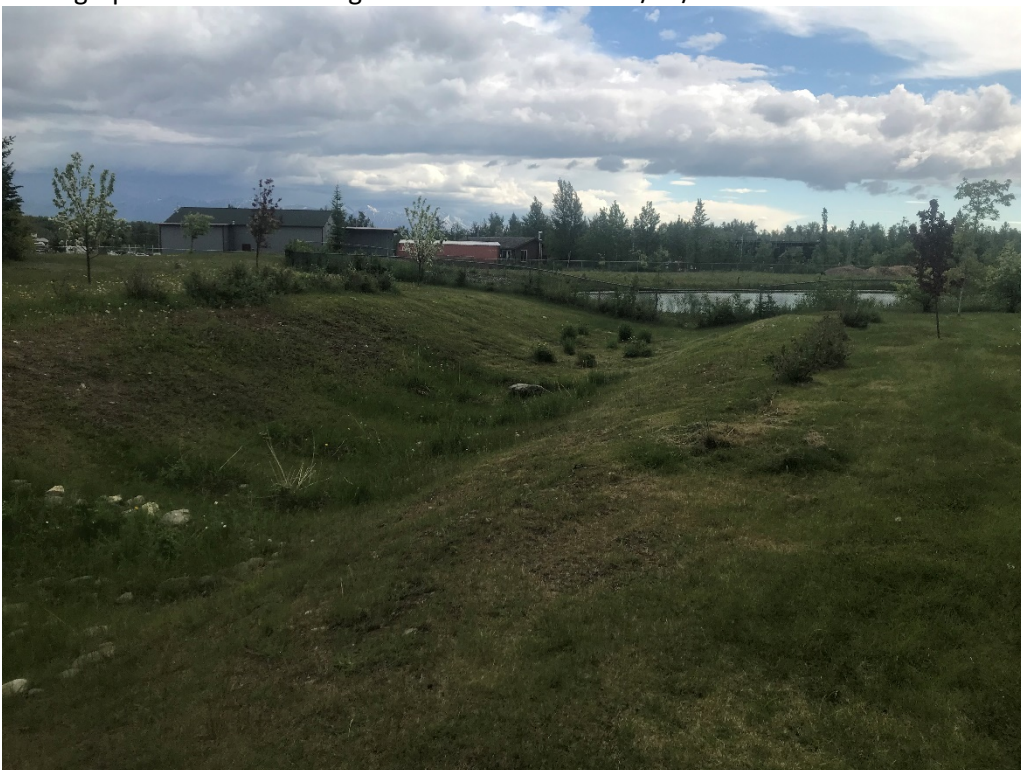
Photograph A9. Vegetated swale from Nelson Avenue to Iditapark Retention Pond. (6/3/19)

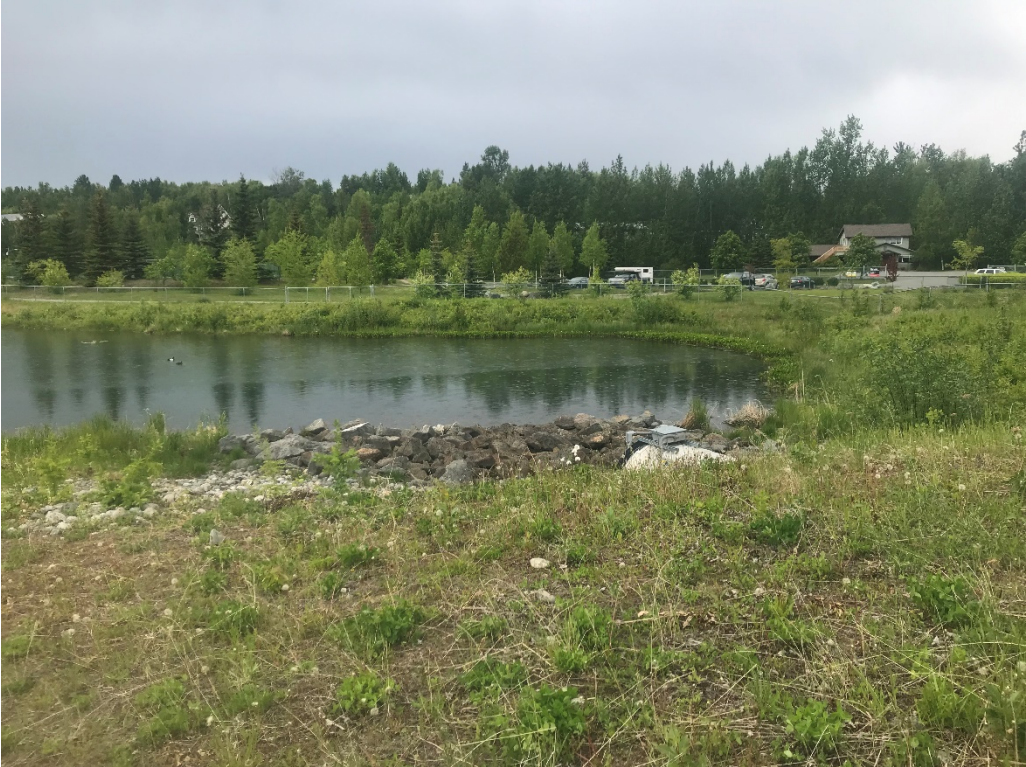
Photograph A10. Discharge outfall to Iditapark retention pond. (6/3/19)

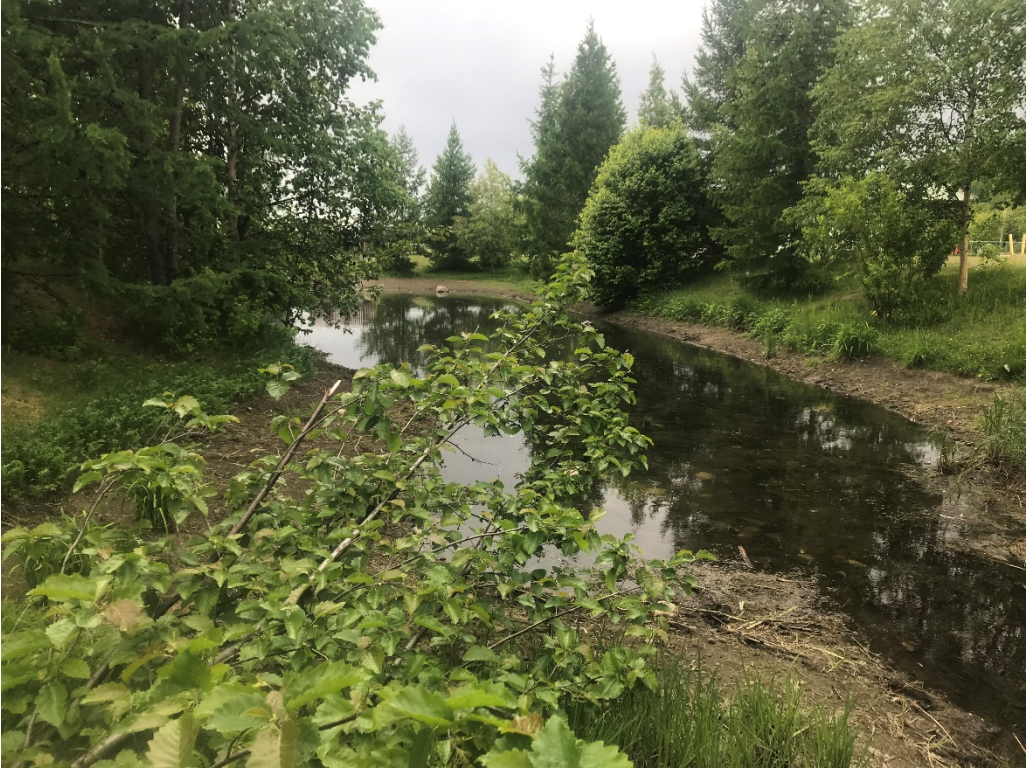
Photograph A10. Second retention pond in Iditapark. (6/3/19).
