ALASKA DEPARTMENT OF ENVIRONMENTAL CONSERVATION Division of Spill Prevention and Response

SITUATION REPORT (SITREP)

Port William Shuyak Island Bunker C Spill

SITREP #: 4

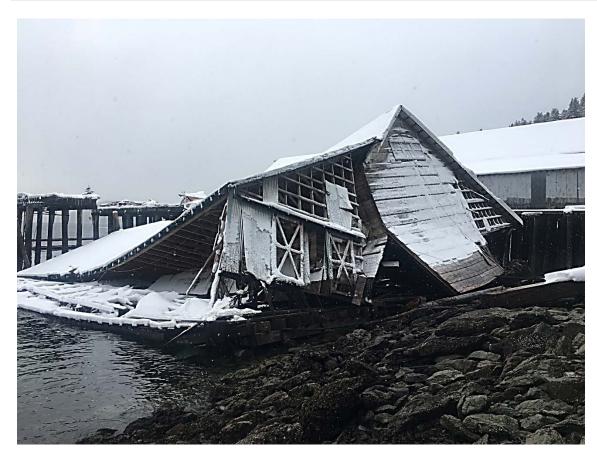
CAUSE OF SPILL: The dock structure supporting the building collapsed. This caused much of the building, along with the 3,000 gallon fuel bladder and the contents of building to fall to the shoreline and water below.

Photo of collapsed building containing bladder
Taken March 10, 2018 Photo credit: Global Diving and Salvage Inc.

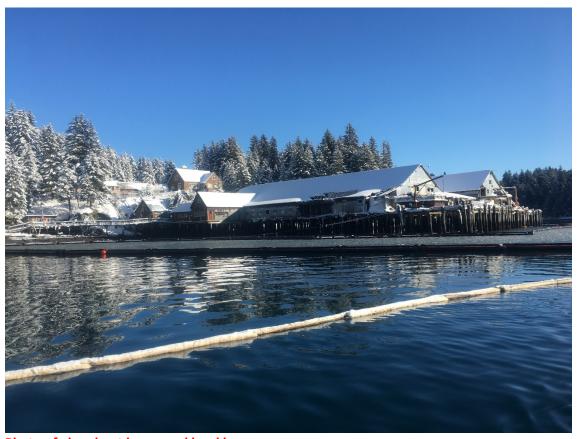
Photo of absorbent boom and hard boom
Taken March 10, 2018 Photo credit: Global Diving and Salvage Inc.

RESPONSE ACTION: Oil spill containment (hard) boom has been deployed to contain the Bunker C oil within the immediate area of the collapsed structures. Oil absorbent material has been placed inside of the hard boom and is successfully collecting oil at each tide cycle. To date, 209 bags of oiled absorbent material have been collected. Due to the collapse of the structure there is a large amount of contaminated debris that is collecting within the containment boom. Collection of debris within the boom has begun. Air monitoring for asbestos has been completed and analysis shows no airborne asbestos particles at this time. A multi-agency Shoreline Cleanup and Assessment Technique (SCAT) team has been deployed and will conduct shoreline assessment on March 12 and 13. A structural engineer and salvage specialist completed an assessment of the pier and buildings.
