**Phase I Environmental Site Assessment
Keku Cannery Main Building
Kake, Alaska**

February 2014

32-1-17631

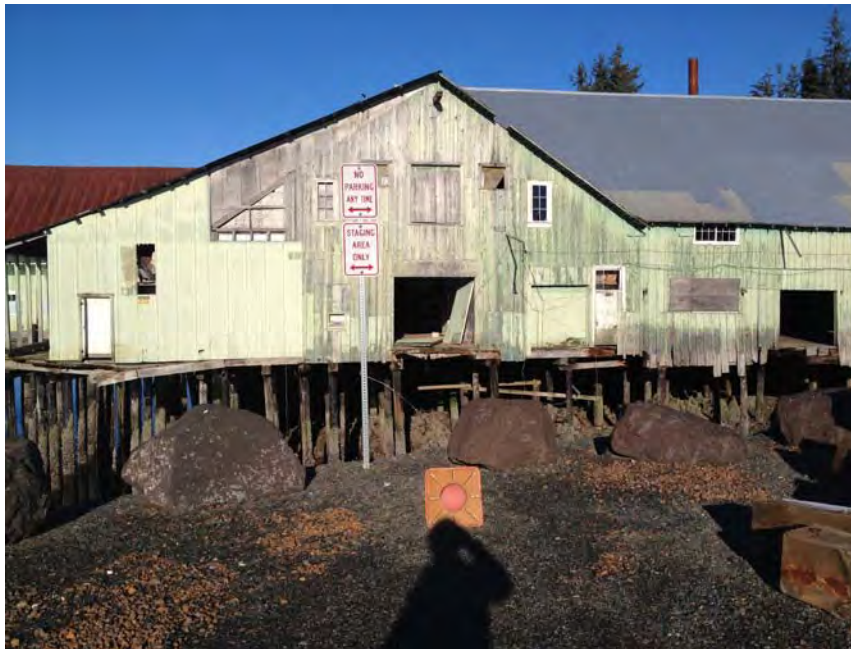
Photo 1: The south side of the main cannery building on piles.
(February 3, 2014)

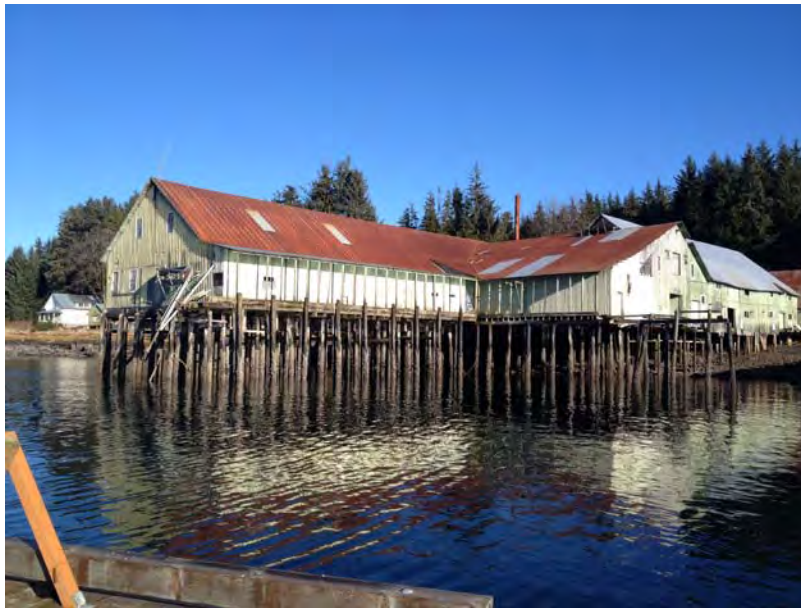
Photo 2: The Property, looking northeast. (February 3, 2014)

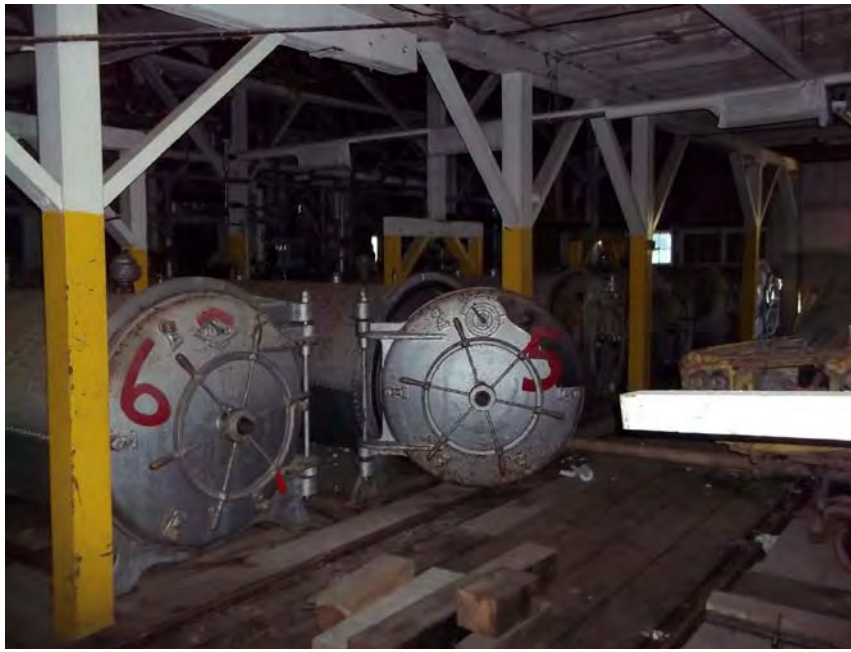
The boiler area contained retort and boilers that were previously used in the canning process (Photos 3 and 4). According to information provided by OVK, the retort held between five and seven retort car loads of canned salmon and the boilers are brick and cast iron. Reportedly, an old steam engine located behind the boilers was used as a backup generator in 1949. There were also several buses and cars stored near the retort (Photo 5) and an engine with staining around it (Photo 6). A white substance that appeared to have fallen off the pipes on the ceiling was also present (Photo 7). Many rusted containers and pieces of debris and trash were also present in the boiler area.

Photo 3: Retort in the boiler area. (February 3, 2014)

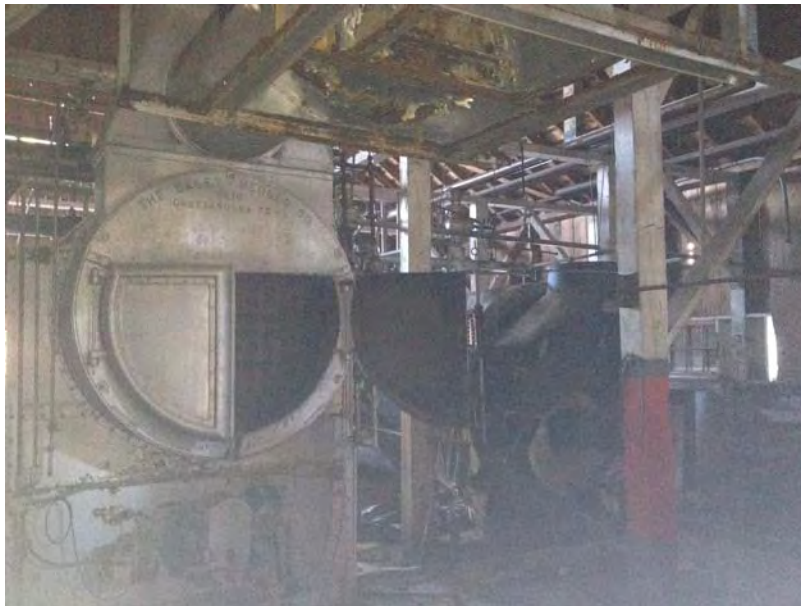
Photo 4: Boilers in the boiler area on the north side of the Property. (February 3, 2014)

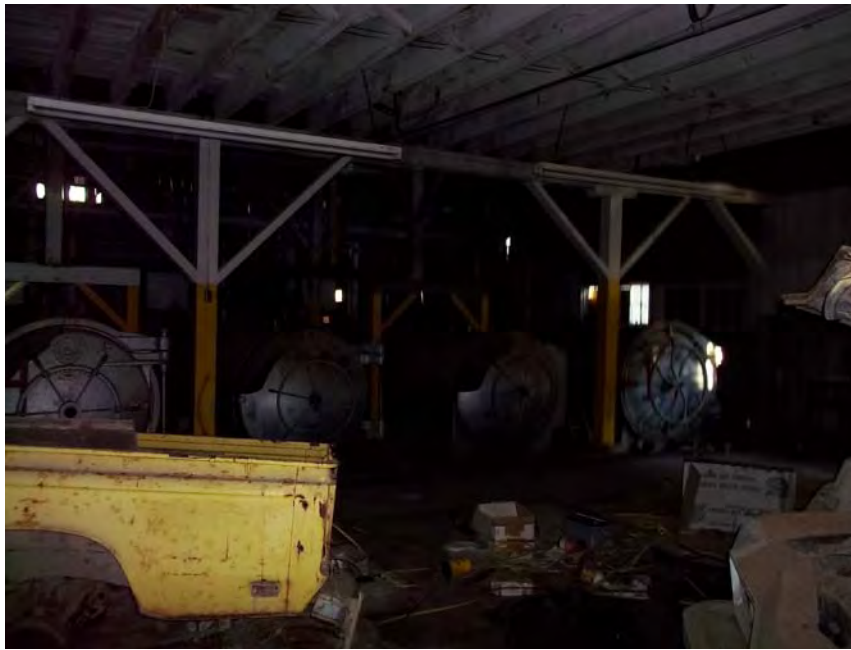
Photo 5: Cars and other discarded items near the retort in the boiler area. (February 3, 2014)

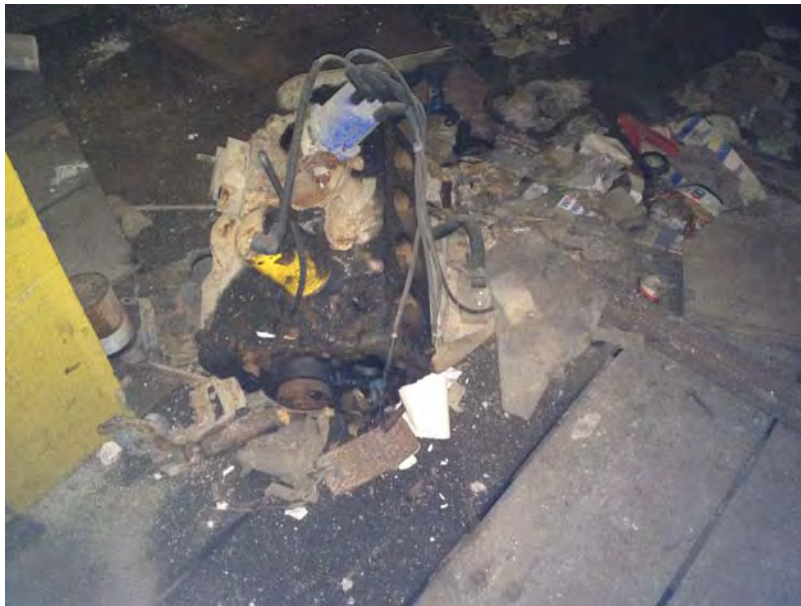
Staining was observed beneath the machine shop on the beach/shoreline and boiler area on the floor. This indicated a past release onto the ground surface and/or water at high tide.

Photo 6: Engine with staining on the floor in the boiler area. (February 3, 2014)

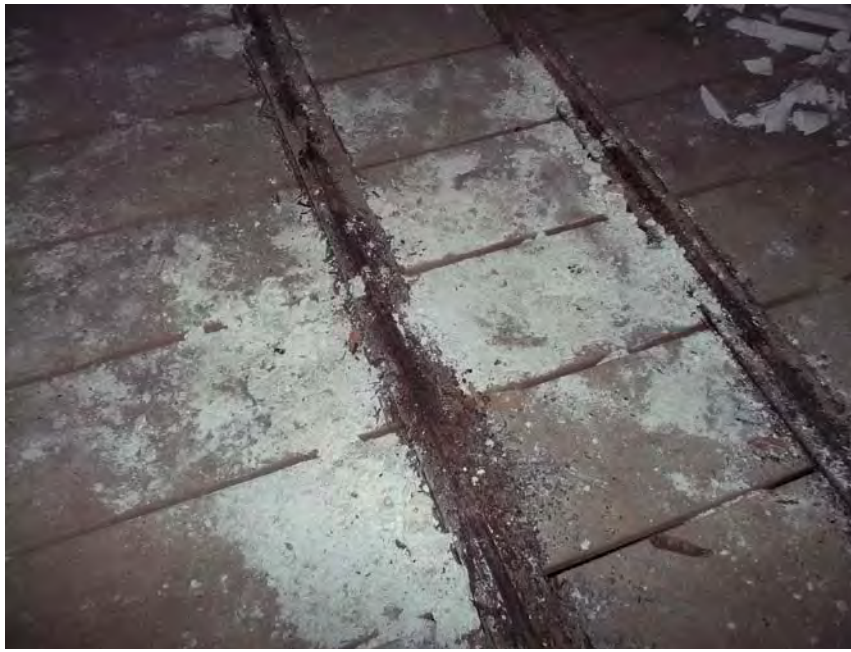
Photo 7: White substance on floor of boiler area. (February 3, 2014)

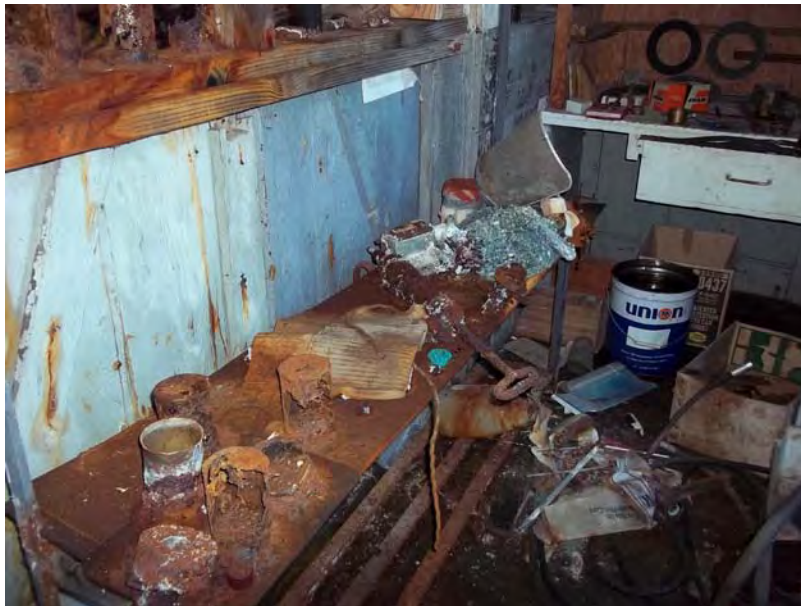
The shop largely contained rusted containers, trash, and debris (Photo 8). The bathrooms (Photo 9) and fish house were not entered due to the instability of the building.

Photo 8: Rusty containers and debris in shop. (February 3, 2014)

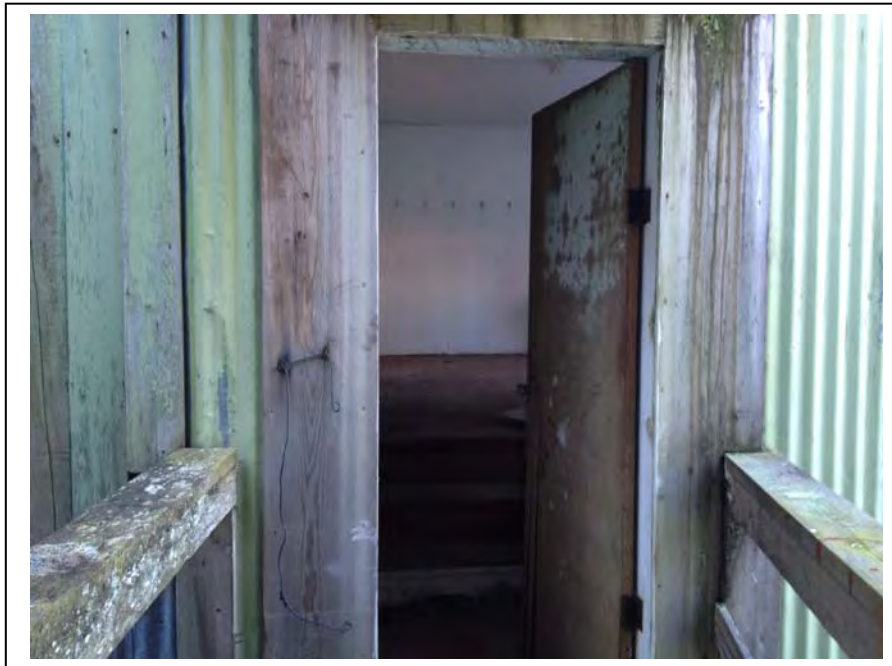
Photo 9: Bathrooms on the Property. (February 3, 2014)

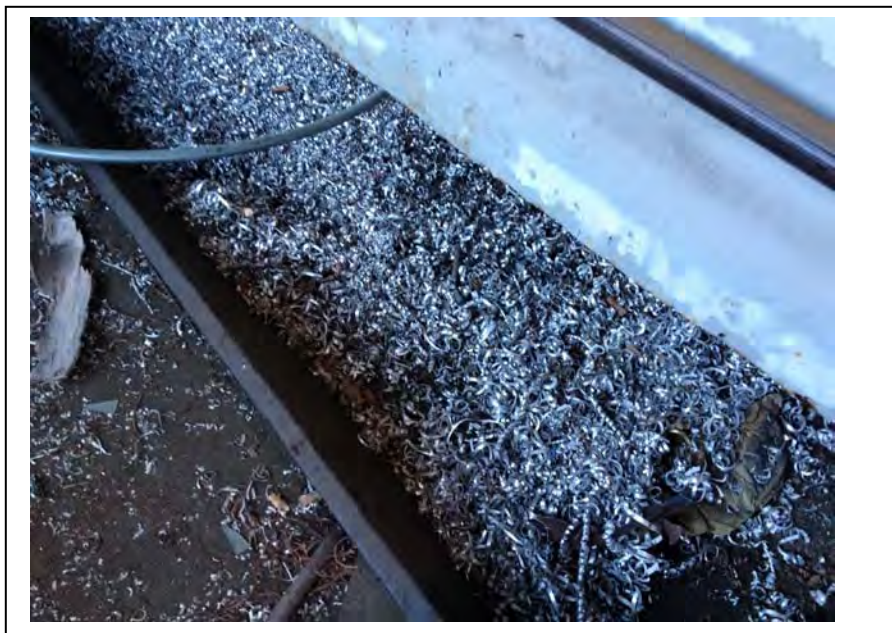
Metal scraps and empty containers were observed in the machine shop, along with other pieces of equipment (Photos 10 and 11). Cans connected to piping and used for capture of hydraulic oil and a hole in the floor beneath the equipment was also observed (Photo 12). Several holes associated with the deterioration of the building were also observed in the floor of the machine shop. Staining was observed under the machine shop (Photo 20).

Photo 10: Metal scraps in machine shop. (February 3, 2014)

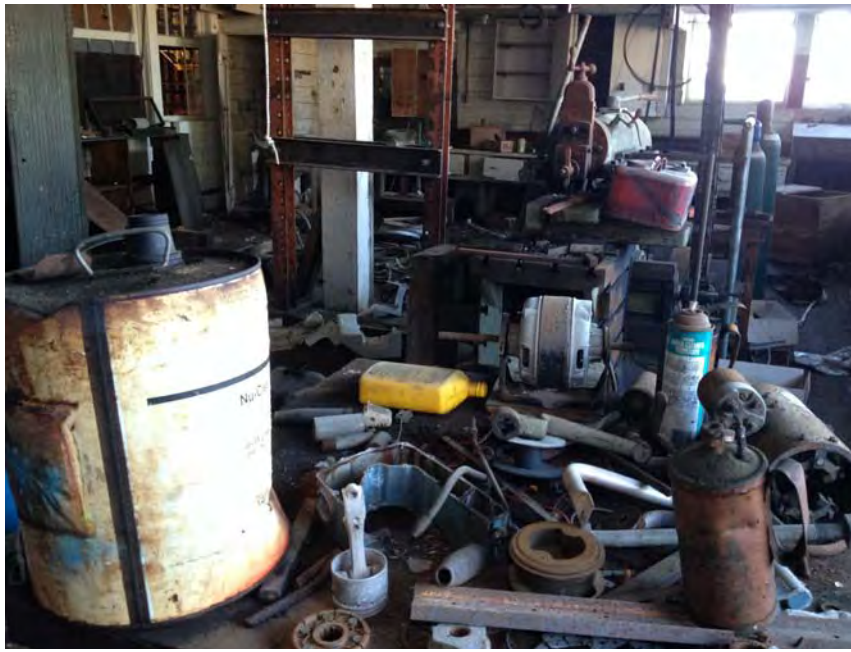
Photo 11: Rusted containers in machine shop. (February 3, 2014)

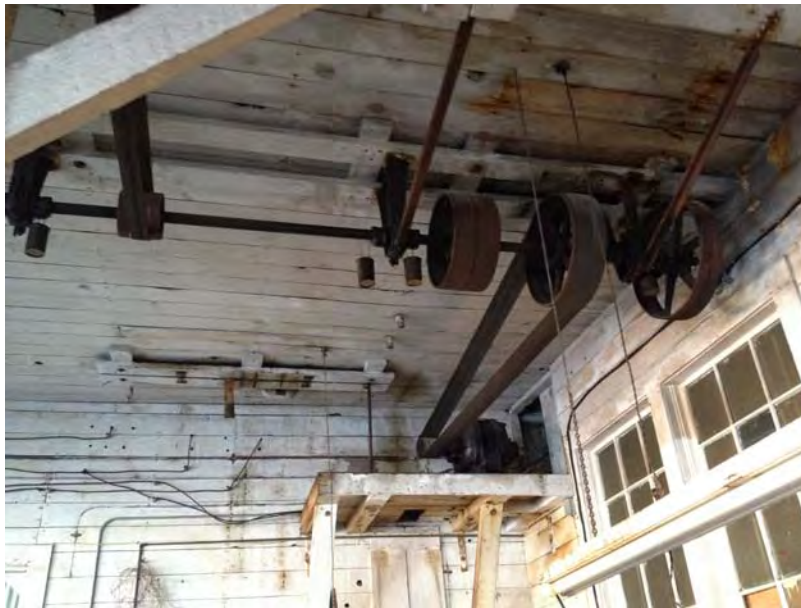
Photo 12: Cans for catching hydraulic oil in machine shop. (February 3, 2014)

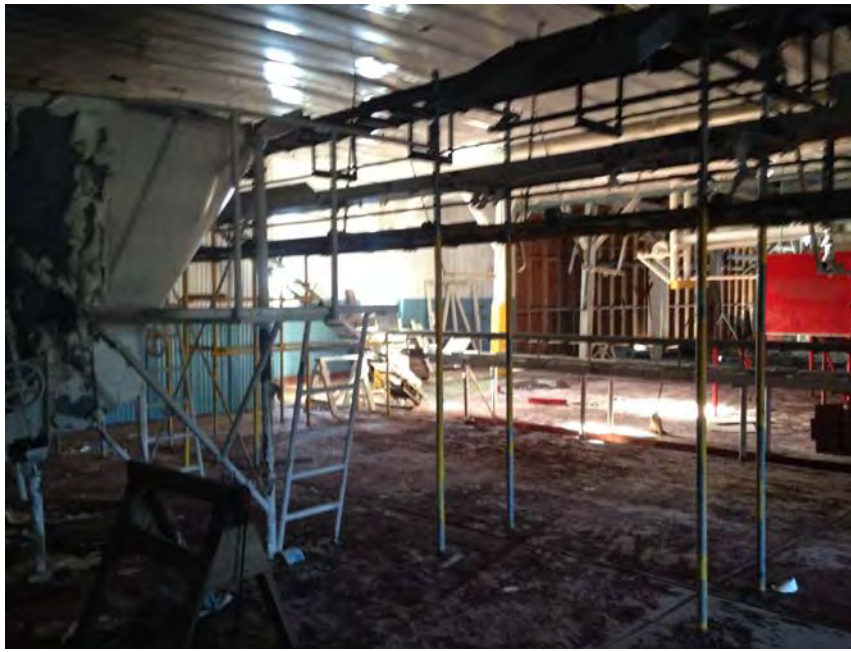
The cleaning room included several pieces of equipment for cleaning fish (Photo 13). Based on information provided by OVK, these pieces of equipment include two iron chinks (for fish processing) and a high speed canning line. Holes in the floor and strip drains were also observed in the cleaning room (Photo 14). Mr. Williams stated that he did not where the strip drains discharged.

Photo 13: Cleaning room. (February 3, 2014)

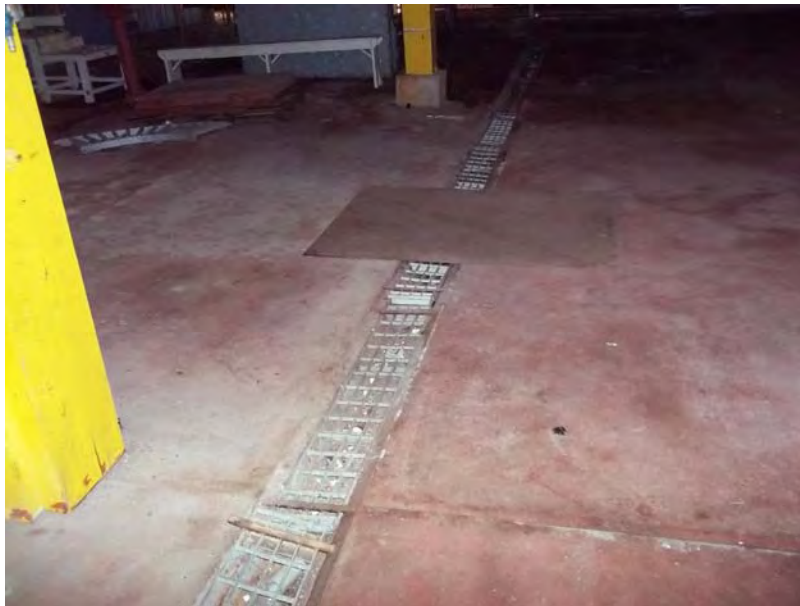
Floor drains were observed throughout the building. Mr. Gary Williams of OVK stated that he did not know where the floor drains discharged. It is possible, due to the condition and former use of the building that these drains dump directly into the water below the cannery. Releases of petroleum products or other chemicals discharged through the drain could potentially impact the Property's water.

Photo 14: Strip drains in cleaning room. (February 3, 2014)

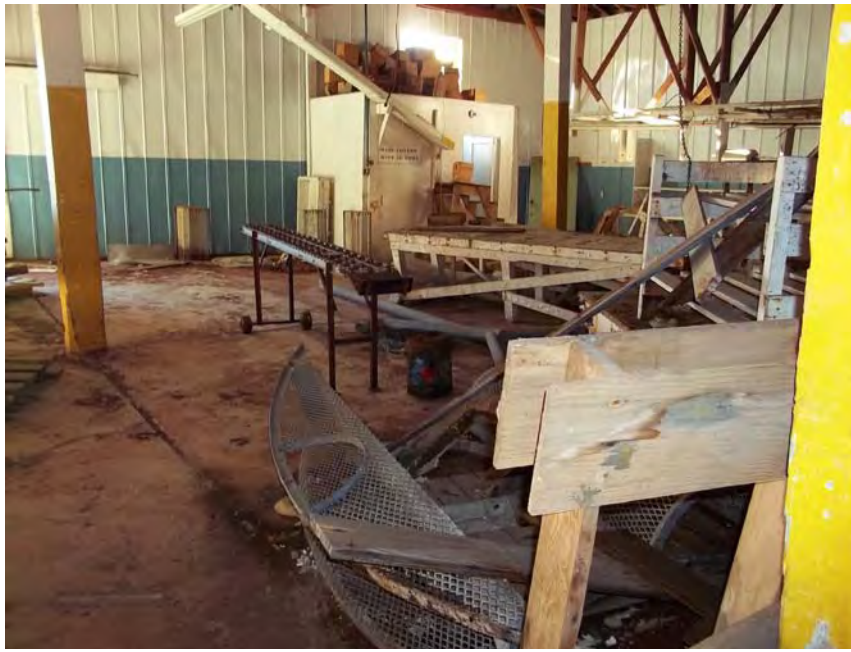
The egg room could not be entered due to structural instability. Various debris and fish cleaning equipment were observed in this room (Photo 15).

Photo 15: Egg room. (February 3, 2014)

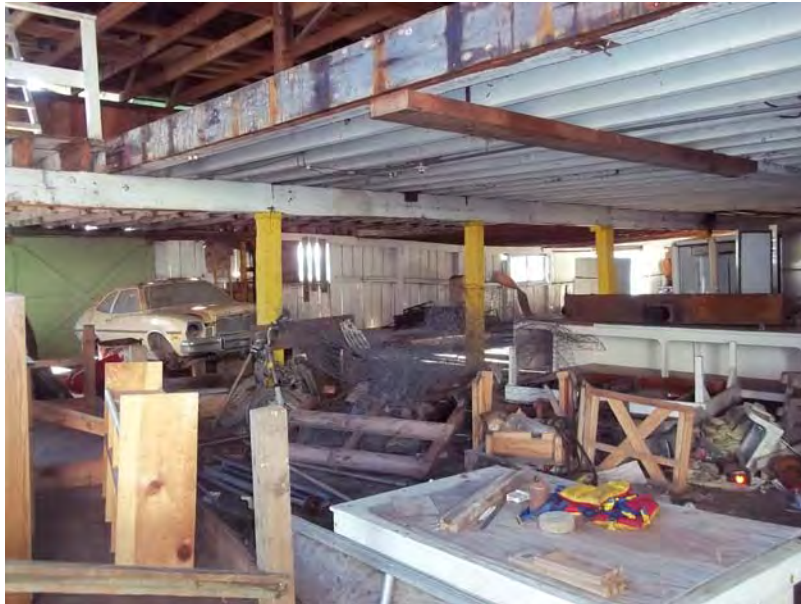
In the crating and storage room, a car and several motorcycles, discarded refrigerators, and other debris were observed (Photo 16). A representative of OVK also identified several boxes in the attic of the crating and storage area as asbestos siding from one of the collapsed warehouses.

An unlabeled drum was observed in the crating and storage area but could not be accessed due to structural instability (Photo 16). Two empty unlabeled drums were observed in the cleaning room (Photo 24). One drum was observed behind the boiler but also could not be accessed. According to information previously provided by OVK, several drums are located to the northwest of the boiler room and are presumed to contain oil and machine parts.

Photo 16: Car and other debris in crating and storage room. (February 3, 2014)

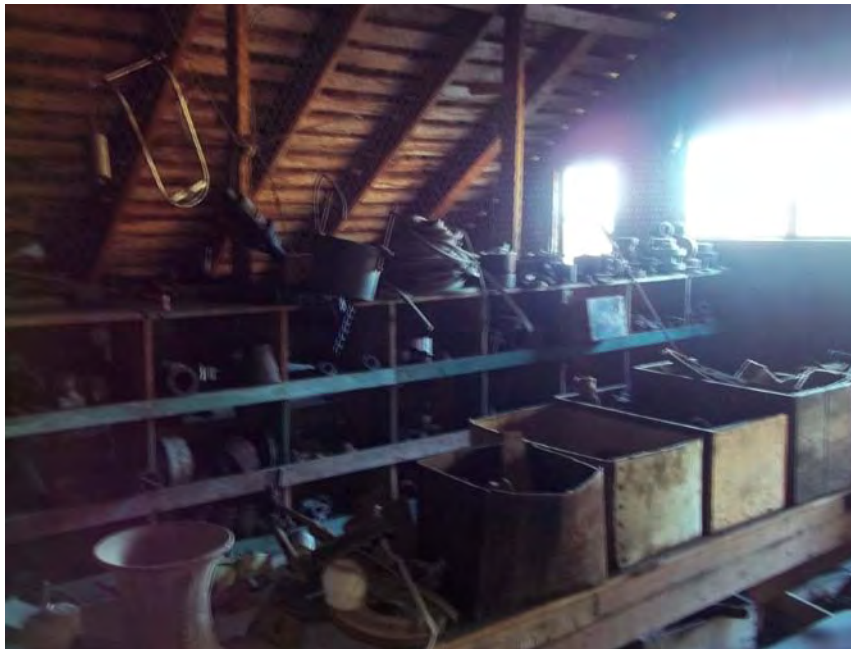
Only the portion of the attic above the cleaning room and egg room was entered. This portion of the attic contained a box making area and a can making area (Photo 17). A white substance was observed on the floor outside the can making area (Photo 18).

Photo 17: Can making area in attic. (February 3, 2014)

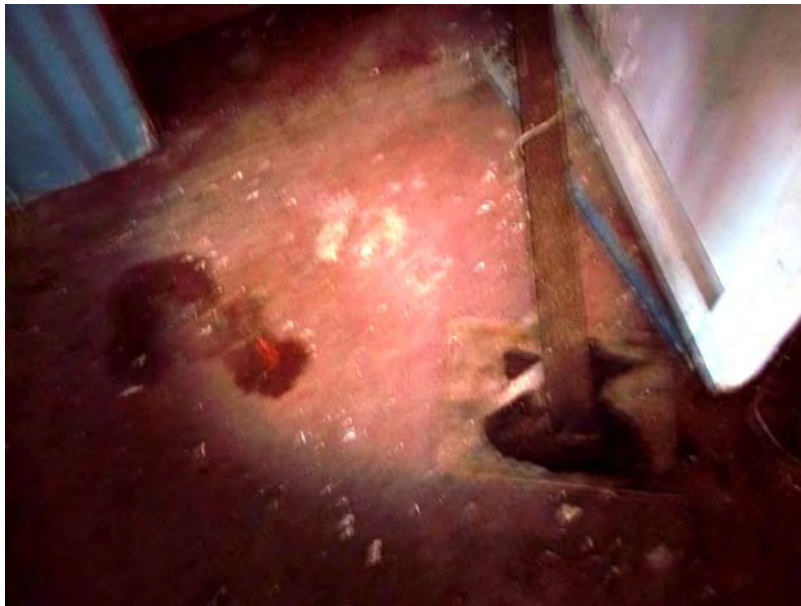
Photo 18: White substance on floor in attic. (February 3, 2014)

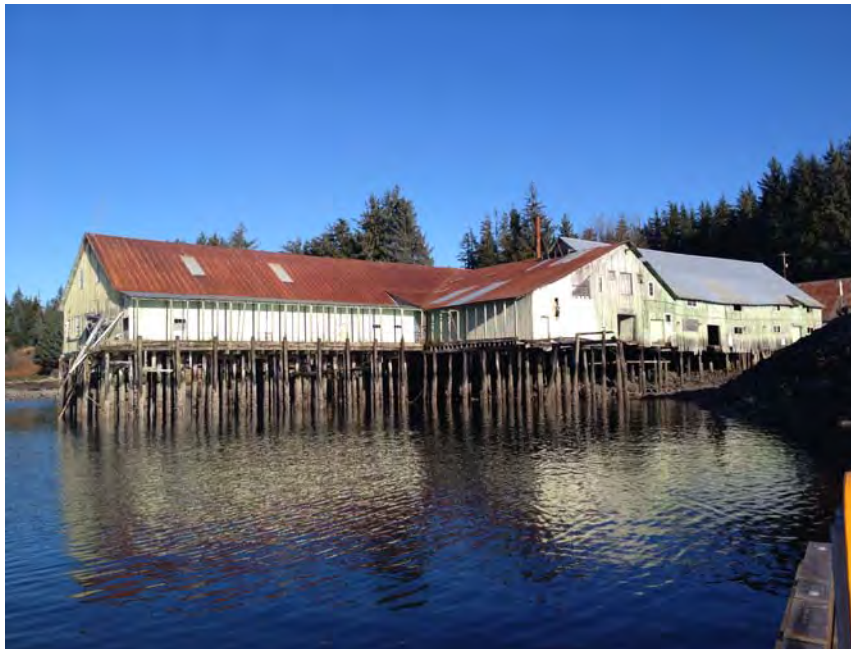
The Property sits on pilings above the beach/ocean (Photo 19). A boardwalk connects the main cannery building to the adjacent parcels. The pilings located in the water zone were in poor condition. Staining was noted on the pilings underneath the mechanic shop (Photo 20).

Photo 19: The Property, looking northeast. (February 3, 2014)

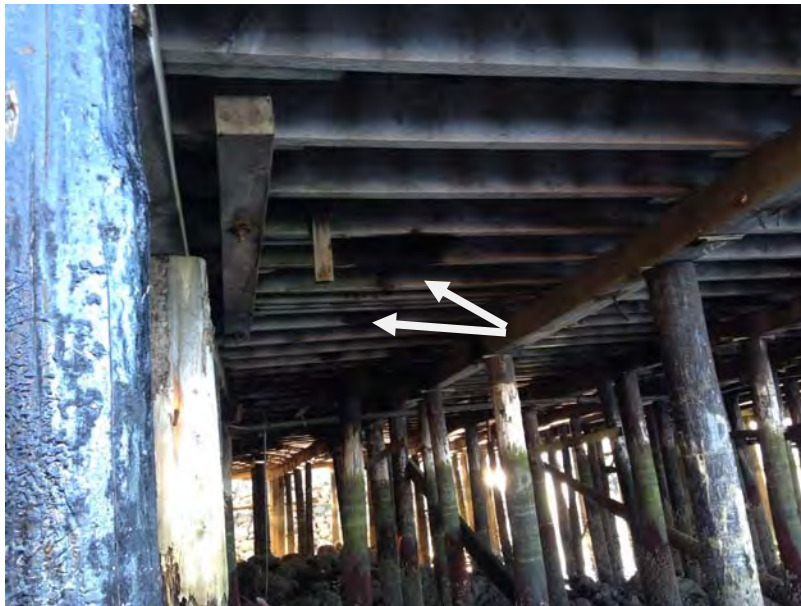
Photo 20: Staining under the machine shop. (February 3, 2014)

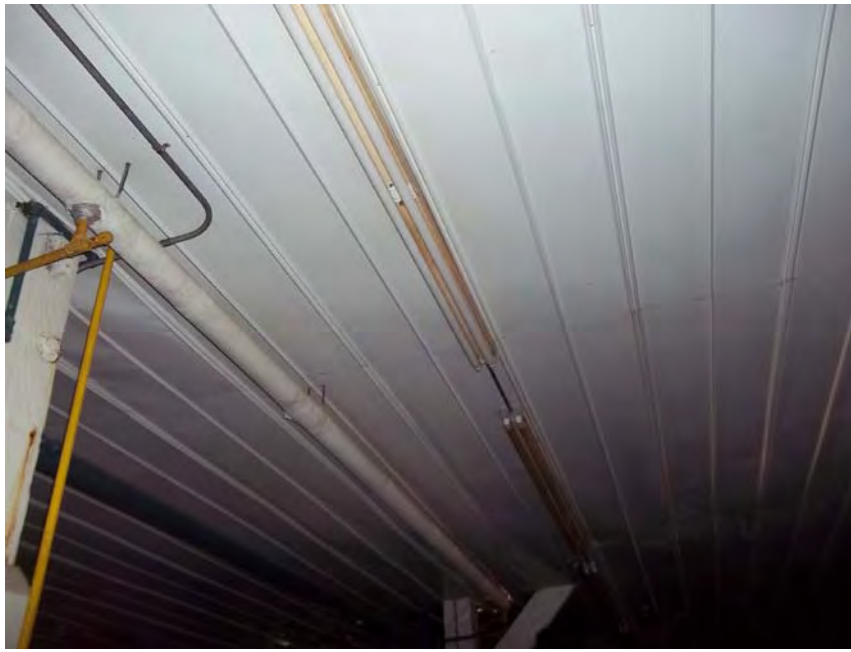
Ballasts were observed throughout the building (Photo 21). Due to the age of the building it is possible that these lights contain PCBs.

Photo 21: Presumed PCB-containing lighting in cleaning room.
(February 3, 2014)

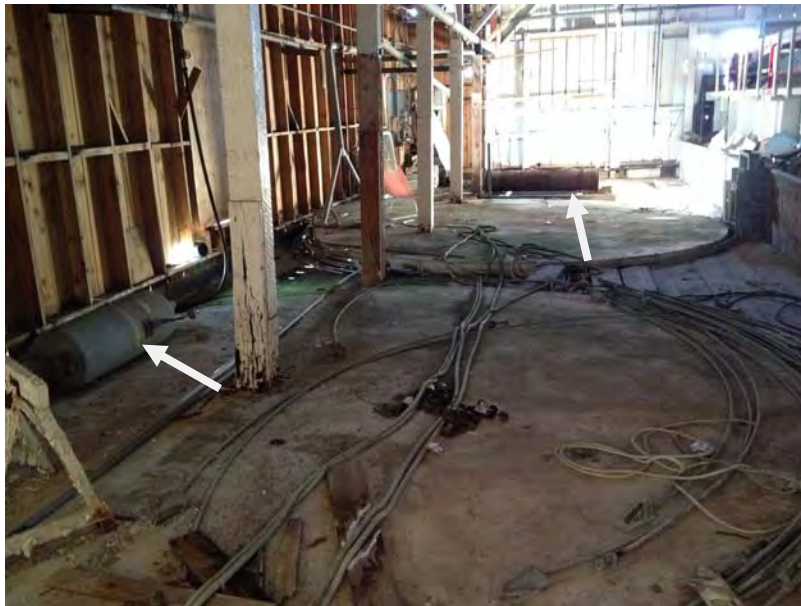
Two tanks were observed in the fish house (Photo 22) and Mr. Williams stated that he did not know what was in the tanks or if they are empty. Several tanks were observed in the egg room and Mr. Williams stated that they were empty (Photo 23).

Photo 22: Unlabeled tanks in fish house. (February 3, 2014)

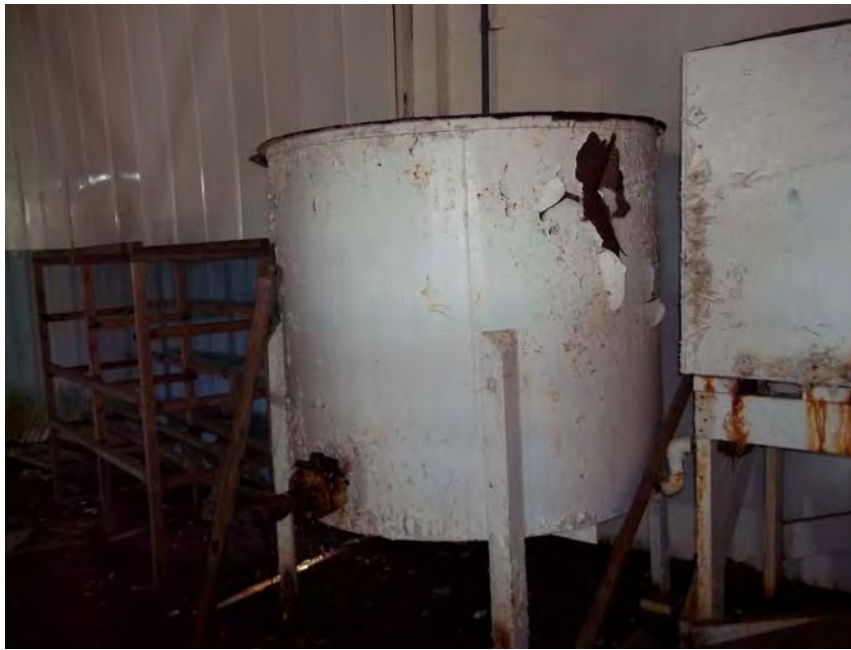
Due to the construction dates of the Property (1912), it is likely that ACM and lead-based paint are present. An asbestos survey performed in 1993 indicates that ACM are present on the Property (See Section 2.5). Paint was observed to be flaking off of various objects inside and outside the building (Photo 23).

Photo 23: Unlabeled tank in egg room. (February 3, 2014)

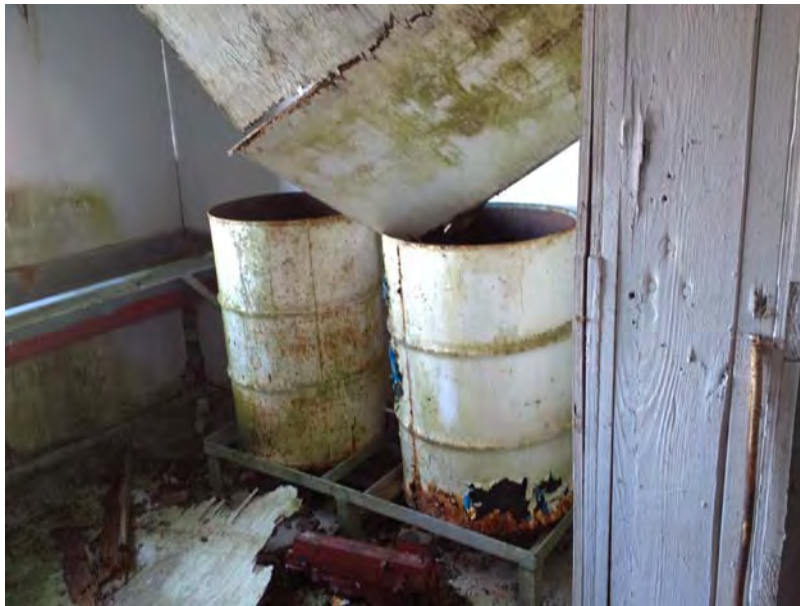
Photo 24: Empty unlabeled drums in cleaning room. (February 3, 2014)
