Phase I Environmental Site Assessment Report
Chevak AVEC Power Plant
Chevak, Alaska

Job Number:APCS-14-04

September 26th , 2014

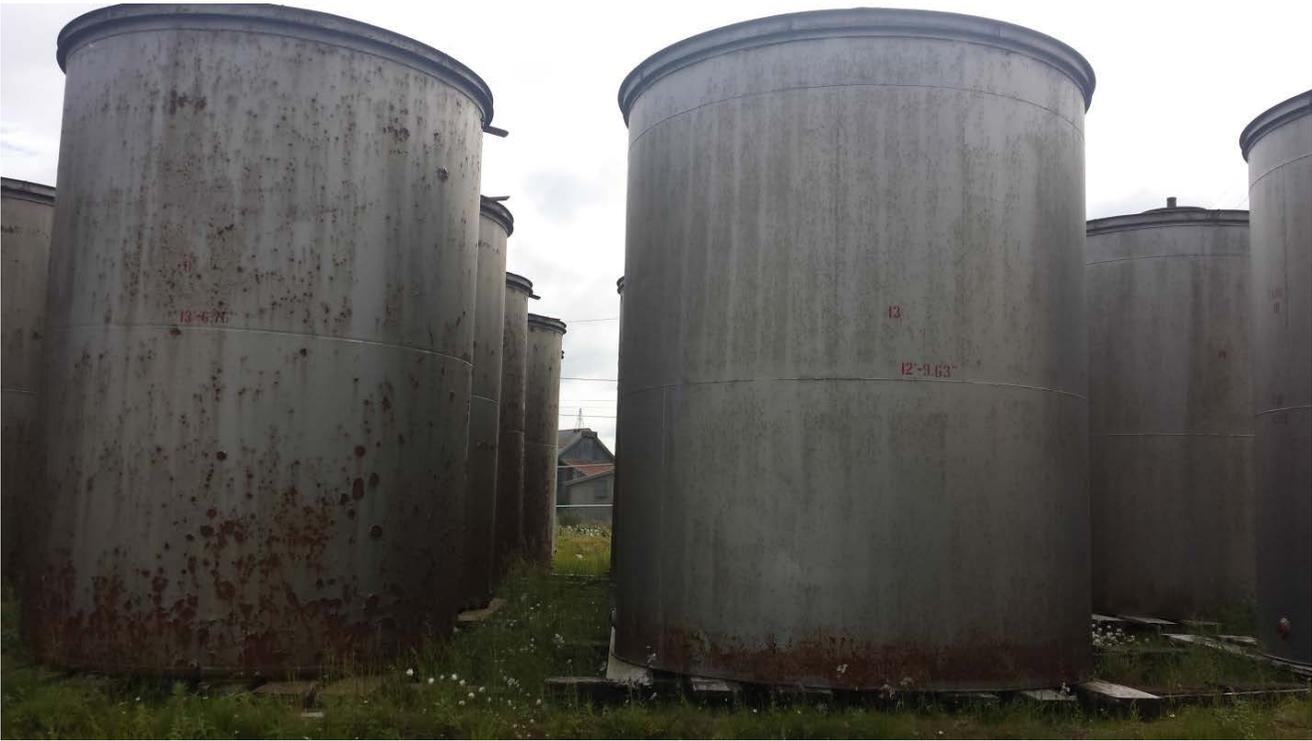
There are 18 vertical ASTs on the property (Photograph 1). The tanks are approximately 13' tall, have a capacity of between 7,000 and 10,000 gallons of fuel and are supported by wooden platforms within a berm that has been reinforced by sandbags. The ground surrounding the tanks was obscured by water and mud due to recent rainfall, however, sheen was seen in several of the puddles around the ASTs. The tanks appear to be in good condition. No holes or similar damage were observed during the inspection and the hose connections were secured with metal plugs. It appears that all of the wiring and pipe work connecting the tanks to the generator housing building has been removed. The tanks were filled via a hose that ran from a barge up Mukluk Street to the tanks. Mr. Stamm and Mr. Jones have said that all of the tanks were emptied. The site of the tank farm has been labeled as S3 on Figure 3 in Appendix A.

Numerous ASTs were found to still be on the property, including 18 large fuel tanks that made up the tank farm (Photograph 1).

Photograph 1 – The tank farm ASTs located on the property.

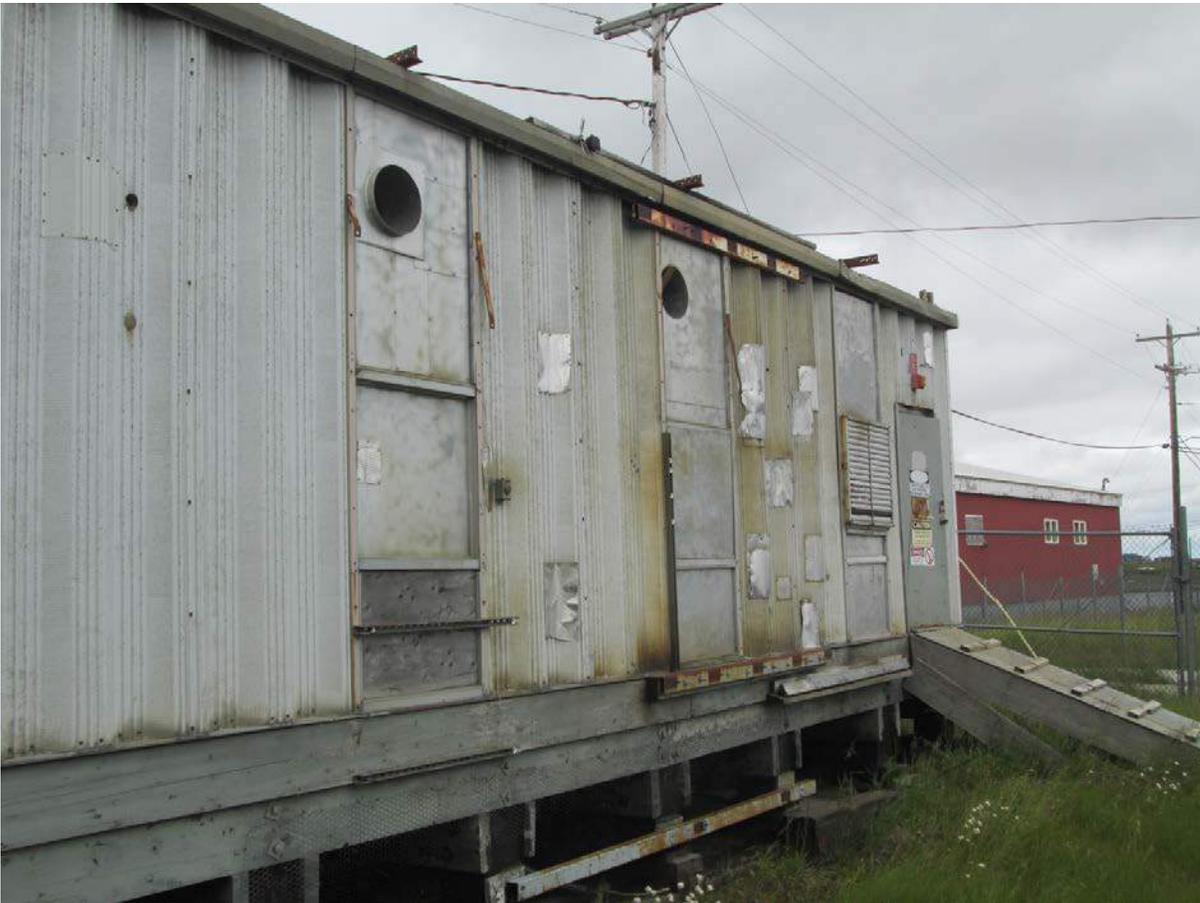
The former generator building is in a dilapidated state (Photograph 2). The outside is rusty and patched. There are two doors but neither were secured. There is a ramp up to the door into the building closest to the conex trailers and the second door facing the abandoned BIA school complex to the north has a porch built onto it but the stairs leading from the porch to the ground have been removed. Once the plant was decommissioned, AVEC drained all oil and fluids from the 2 generators and removed them from the building, placing them outside of the fenced in area next to the road for disposal in the village landfill. They can still be found next to the road. Several additional pieces of equipment and pipes are still in the building but have been disconnected and are lying unused in the building (Photograph 3). In addition, large pieces of drywall have been removed, exposing the insulation, which appears to be moldy in places (Photograph 4). The floor is rotting and in fact, has rotted through completely in several places against the north wall. While the power plant was built between 1968 and 1969, it is unknown if this building was the original generator housing or if it had been added at a later date. The site former generator building has been labeled as S1 on Figure 3 in Appendix A.

Photograph 2 – Former generator building located on the property.

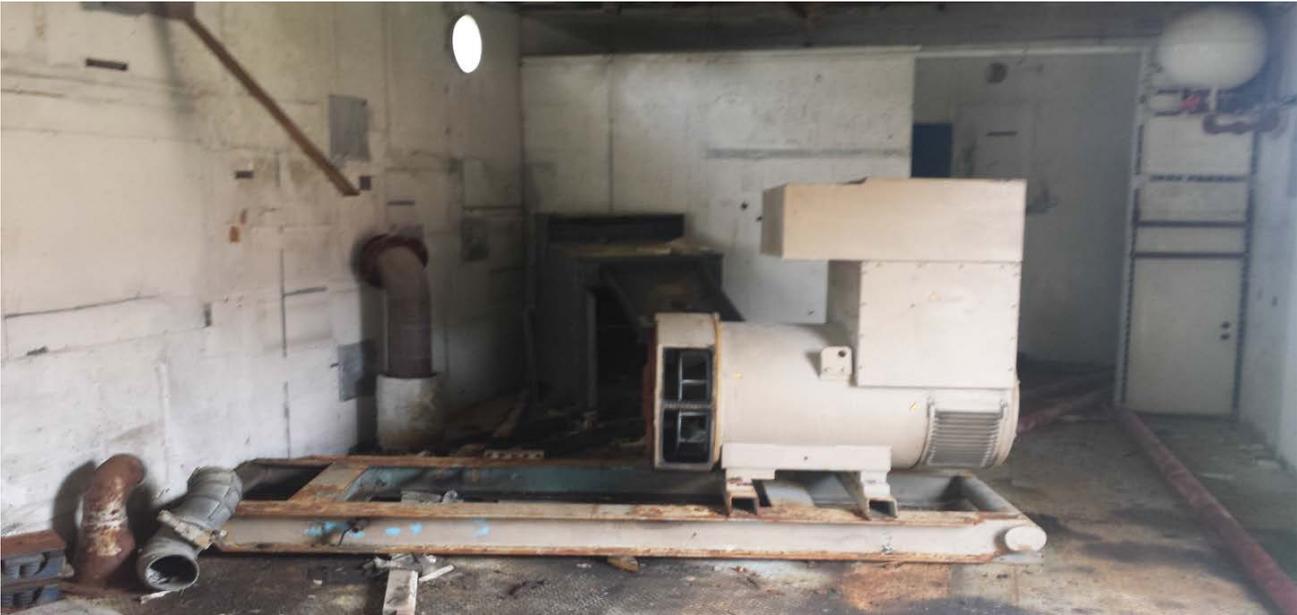
Photograph 3 – Inside the former generator building.

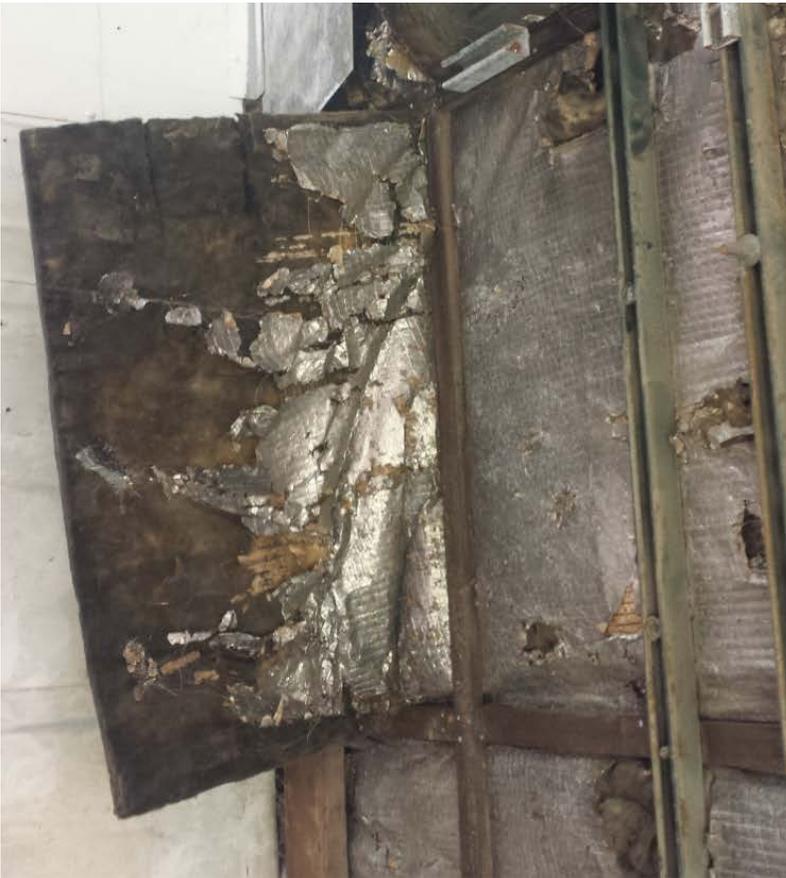
Photograph 4 – Exposed insulation in the former generator building.

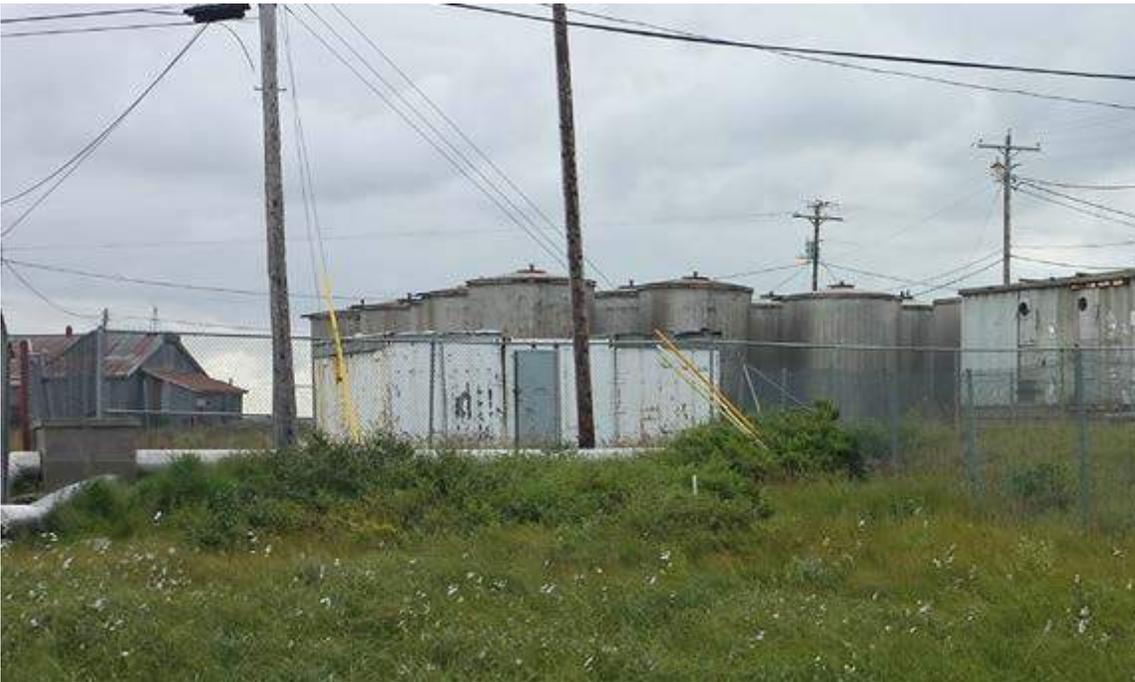
There are three conex trailers located just south of the former generator building (Photograph 5). They are abandoned but appear to be in fair condition. The outsides are rusty and have peeling paint but the insides seem to be in fair condition. All three were found to be empty. Their former usage were not determined during the reconnaissance visit, but were likely to have been used for storage. The conex trailer closest to the former generator building has been wired for electricity but does not appear to currently be connected to the electrical. The site of the conex trailers has been labeled as S2 on Figure 3 in Appendix A.

The outside of the conex trailers had paint peeling in places and rusted. The interior of the conex trailers were in fair condition, with a few rust stains and some graffiti found in conex trailer 3. No stains were seen on the floors of any of the conex trailers. The old generator building was rusty and decrepit looking with metal patches covering where pipes had been connected from the trailer to the power plant. The interior of the old generator building had several pieces of drywall missing, exposing the insulation, which looked to have large patches of mold in places. The floor had been rotted through in a few places against the north wall, exposing daylight.

Photograph 5 – Conex trailers located on the property.

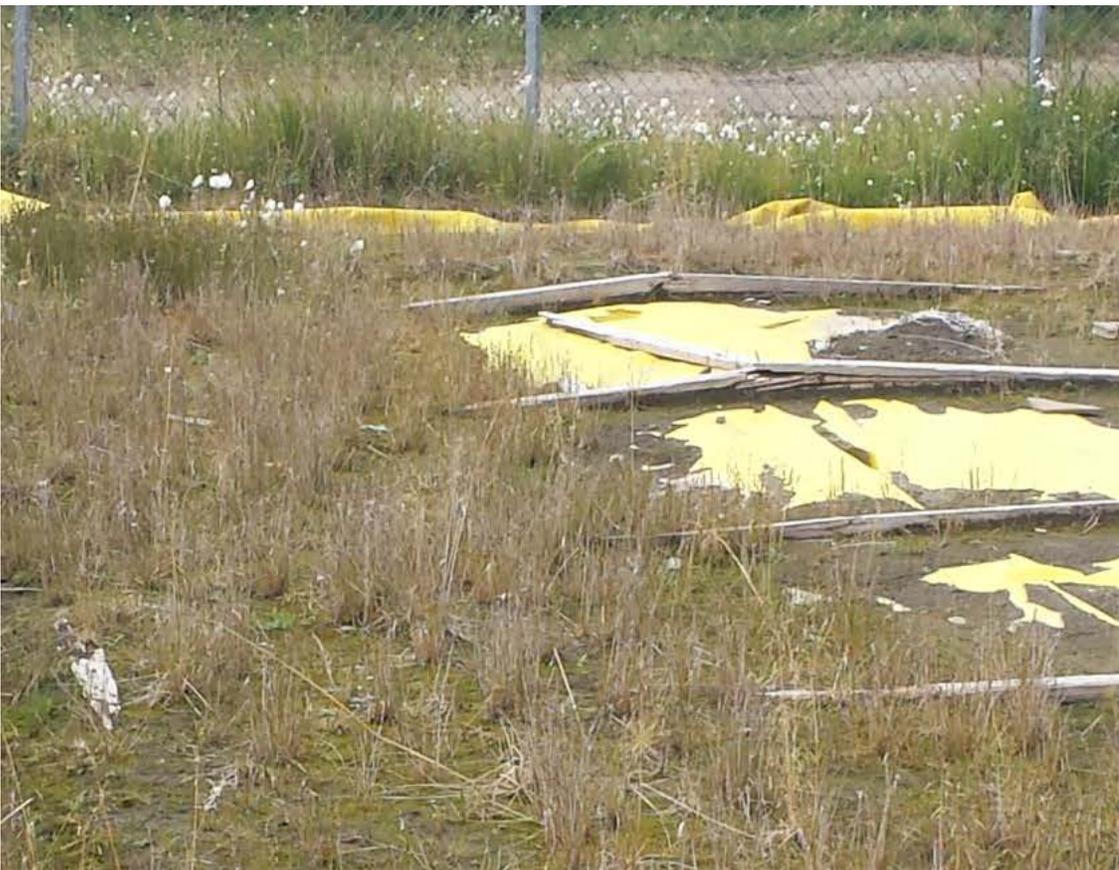
Between 2009 and 2013, 2 5,000-gallon diesel tanks were removed by AVEC for use at the new power plant. The liners that had been under the tanks are still at the property (Photograph 6). A visual survey of the area around the liners show much of the grass has died but new grass is slowly starting to grow back. No signs of any soil stains were seen around the liners either. A piece of pvc pipe was found sticking up several feet out of the ground to a few feet to the south of the site located west of the tank farm. Mr.

Photograph 6 – One of the 5,000 gallon tank liners left on the property after it was moved to the new power plant.

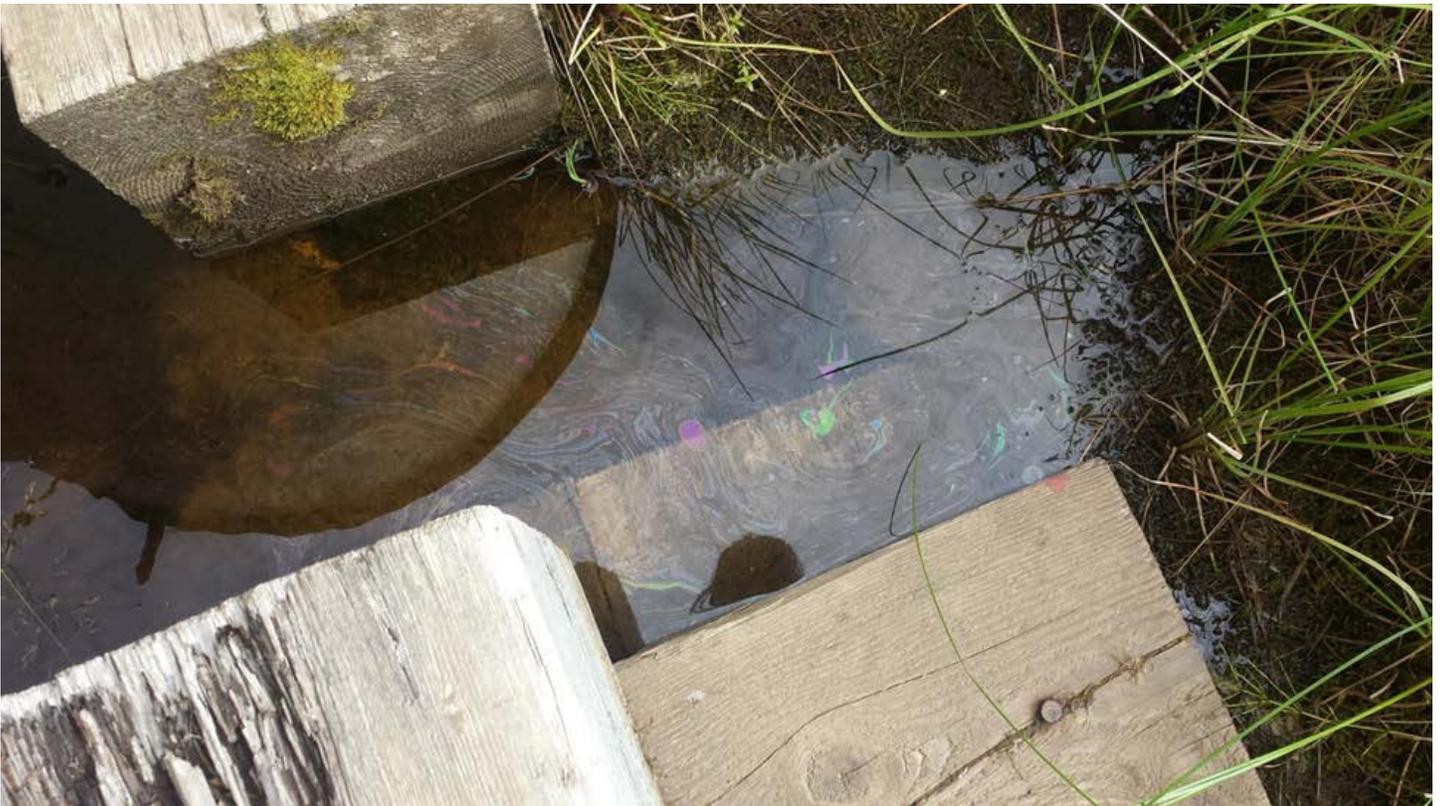
Standing water with sheen was observed around and under the tank farm (Photograph 10).

Photograph 10 – Standing water with a sheen found around and under the property's tank farm.

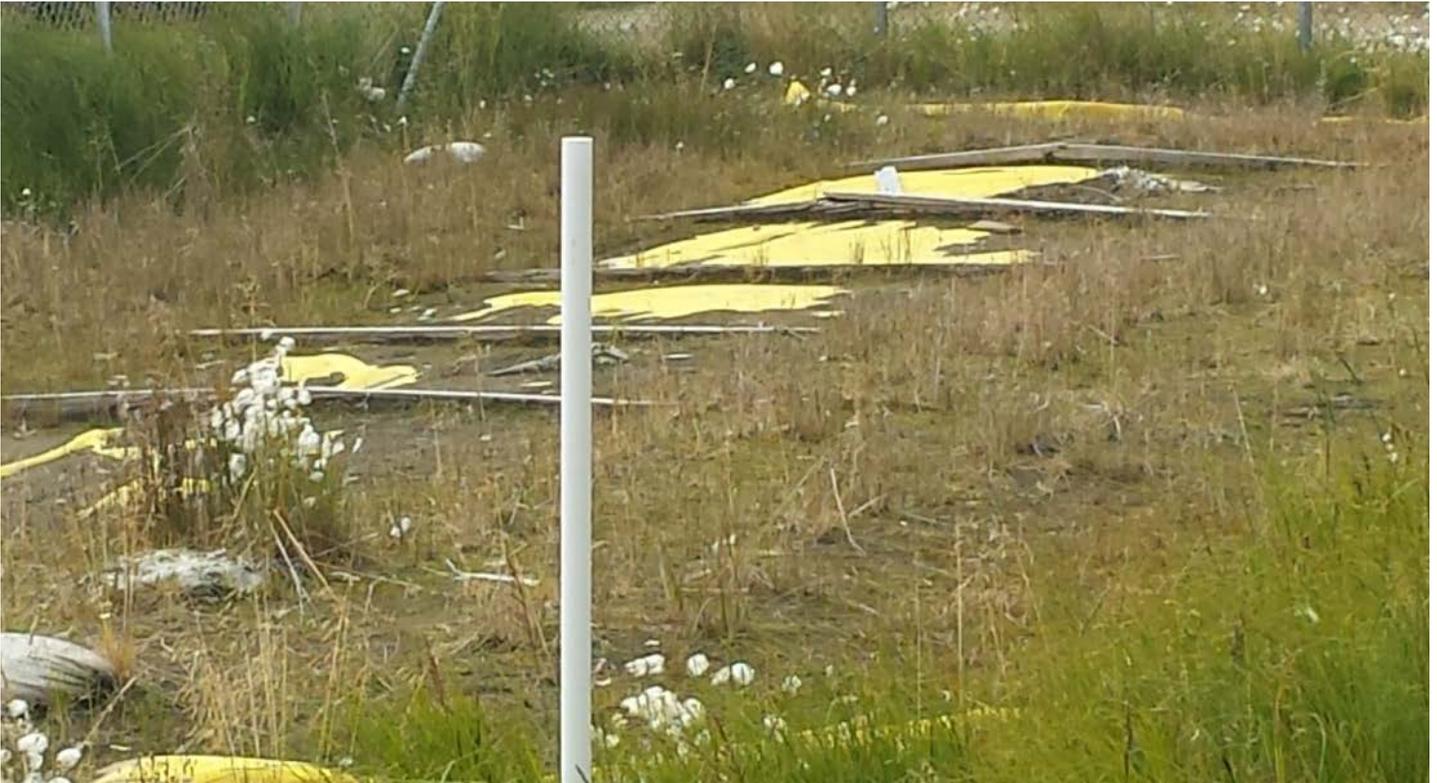
Photograph 11 – Distressed vegetation around the tank liner on the west side of the property closest to the BIA school complex.

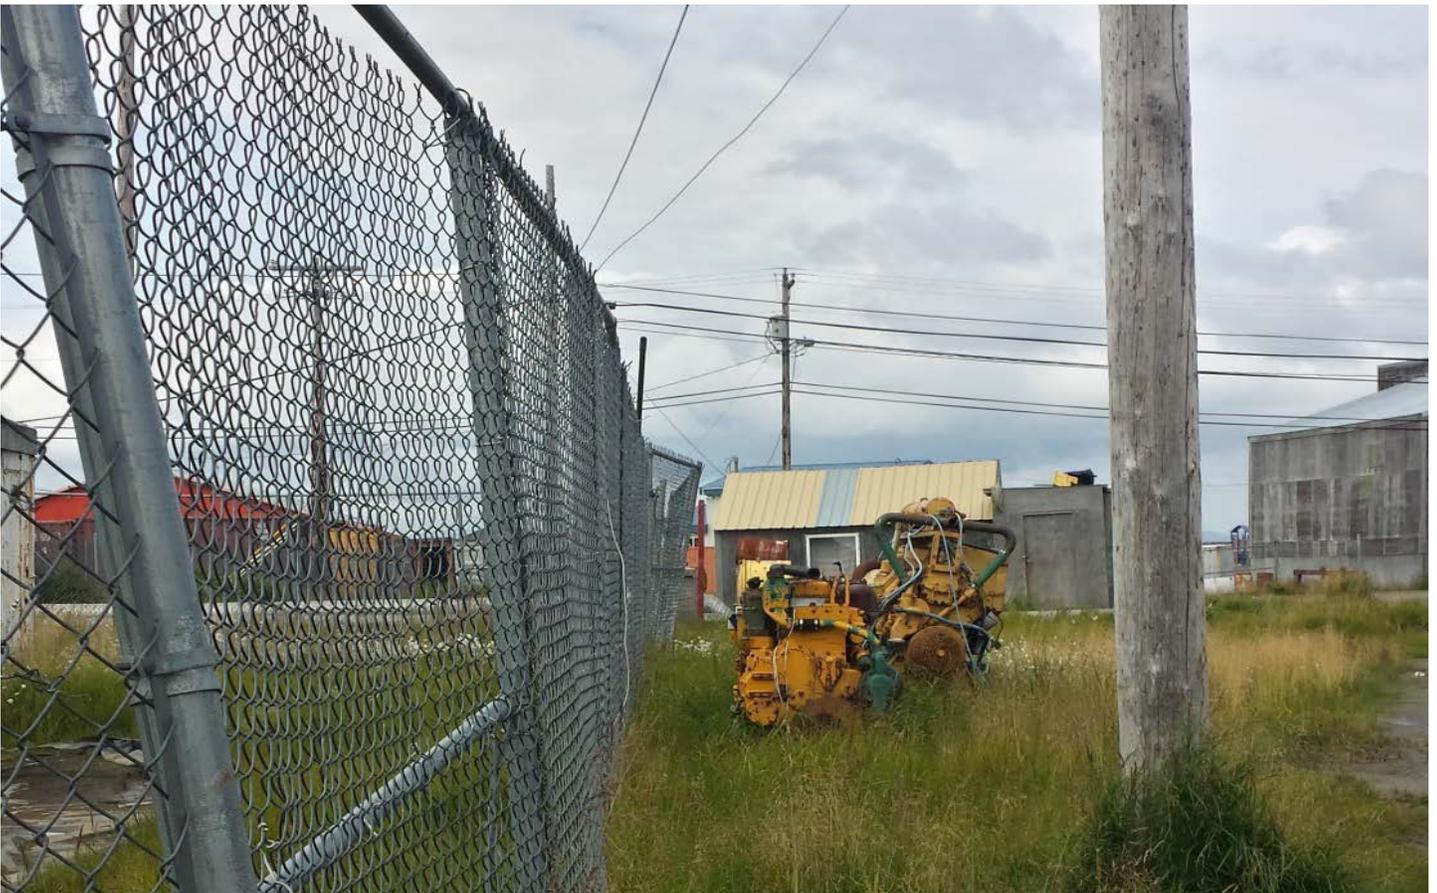
Solid waste is present on the edge of the property. Just outside of the fence, two large pieces of equipment, most likely generators, were removed from the old generator building and left outside of the fence for disposal (Photograph 12). An examination of the equipment and the ground surrounding the equipment found no oil stains or stressed vegetation.

Photograph 12 – Generators removed from the former generator building placed outside of the property's fence for disposal.

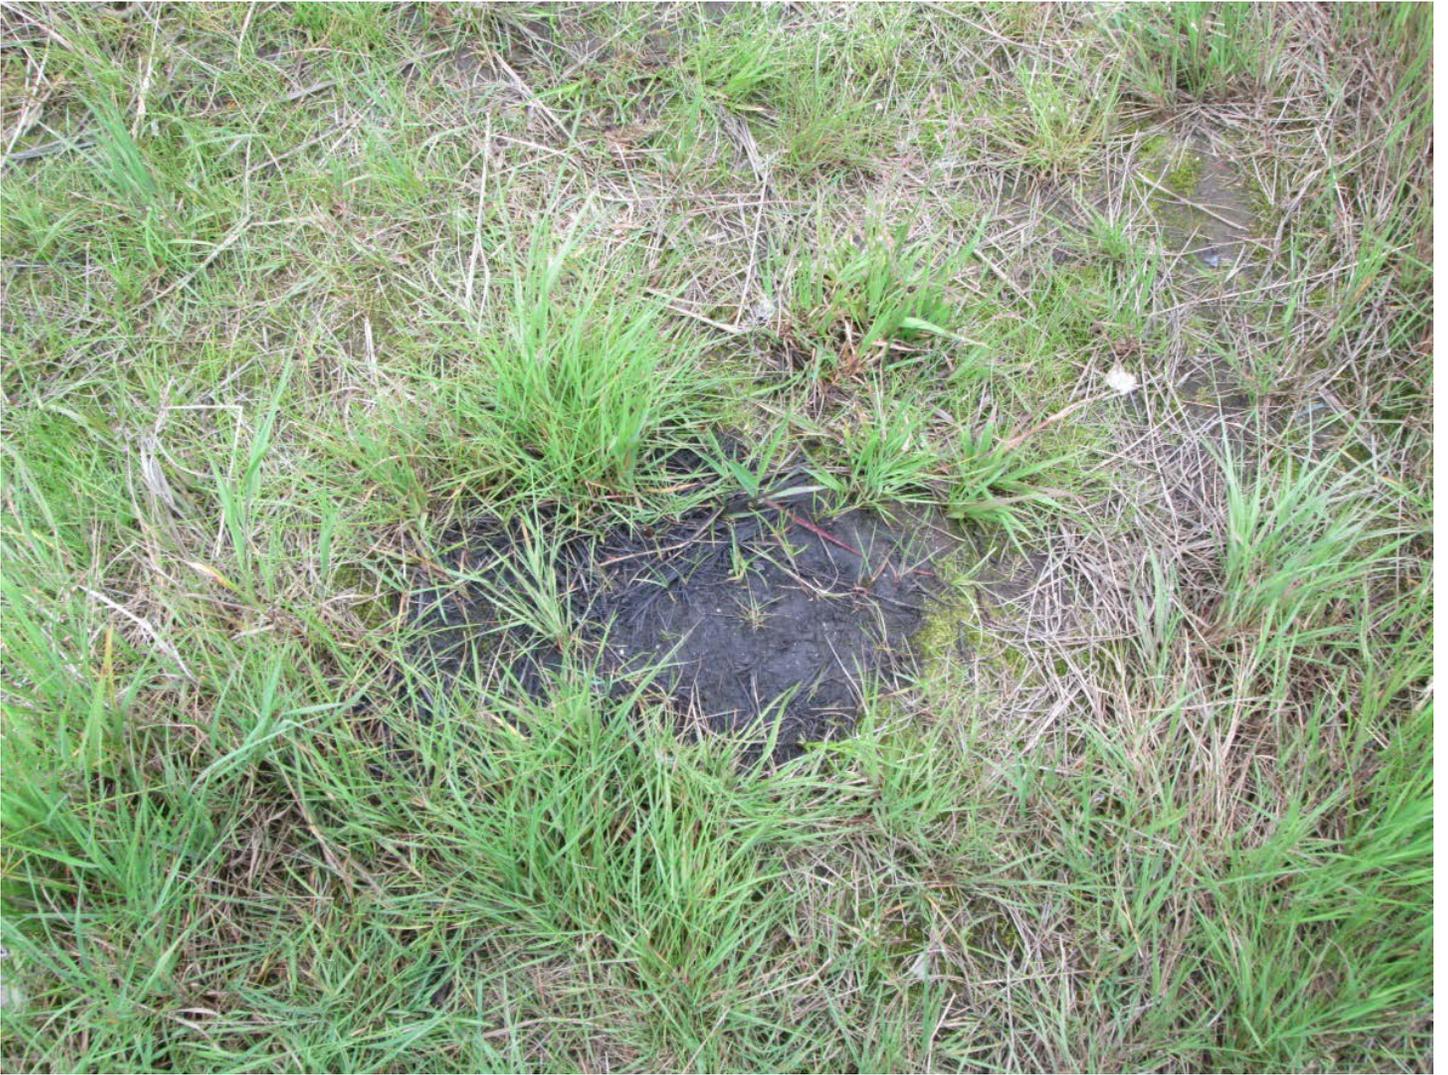
No significant oil stains were observed during the reconnaissance of the property. A small patch of what looked to be oil stained soil was observed (Photograph 13).

Photograph 13 – Small stain located on the property.

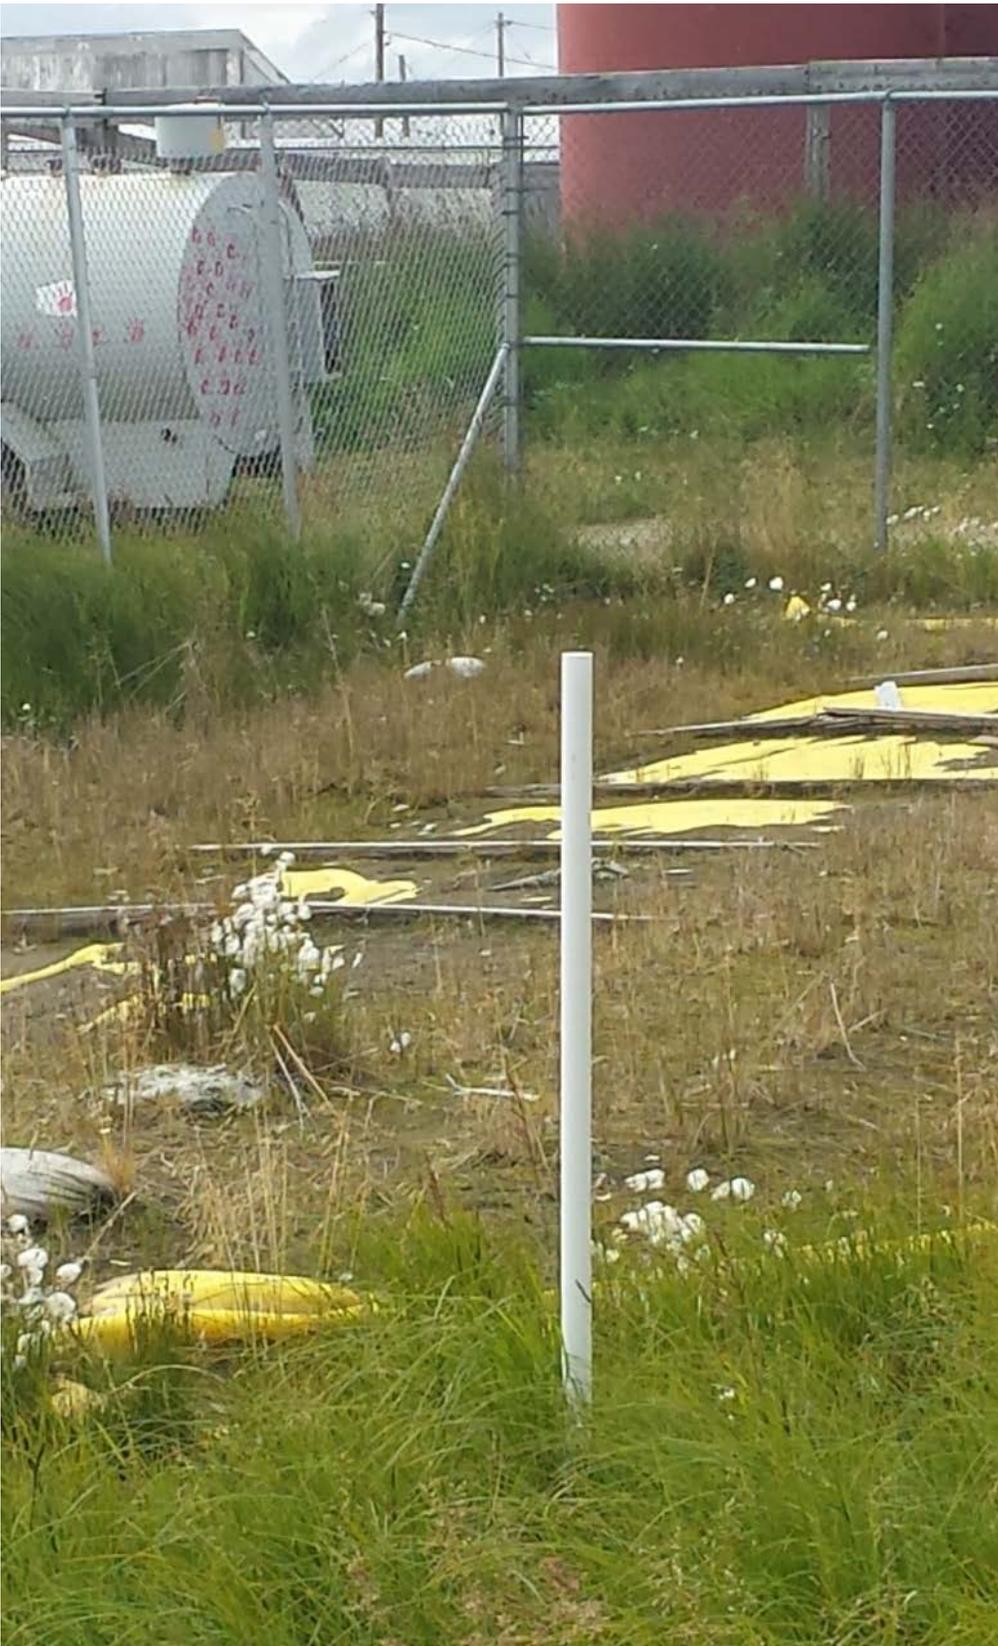
Photograph 14 – Site of a former 5,000 gallon diesel tank removed between 2007 and 2009. An interview with Mr. Stamm of AVAC indicated that he believed the pvc to be a monitoring well.

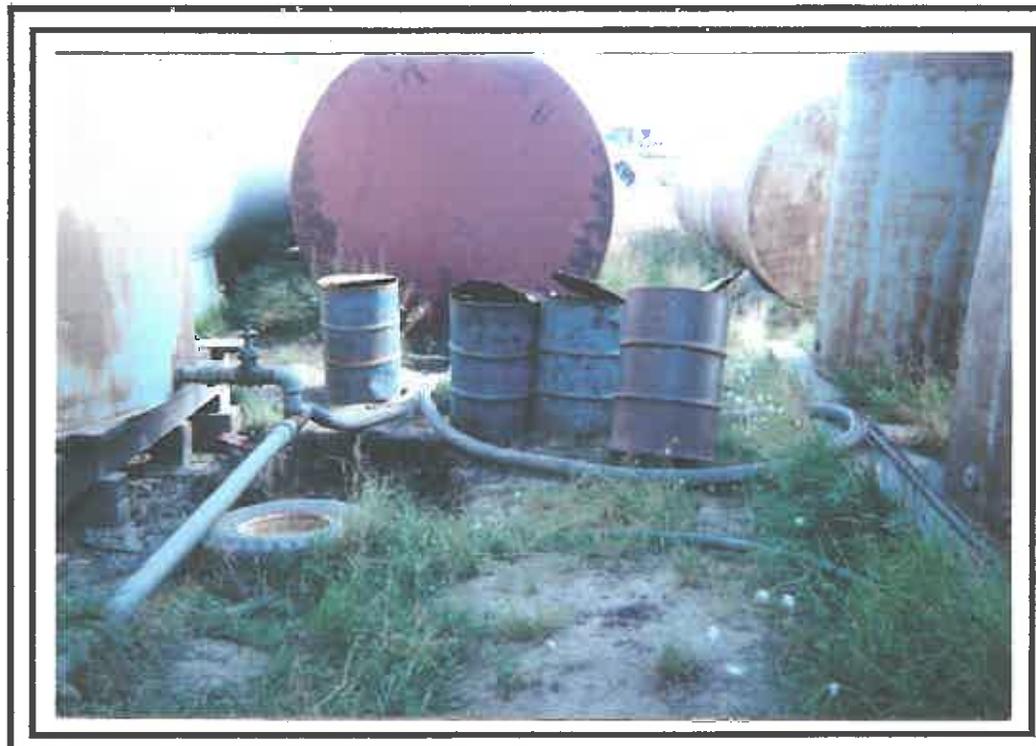
Photo 2: Contaminated soil containing 55-gallon drums; looking east. (August 2002)
