DETAILED ACTION PLAN

ALAKANUK SOUTH SIDE DUMP SITE

WASTE EROSION ASSESSMENT & REVIEW (WEAR)

MAY 2015

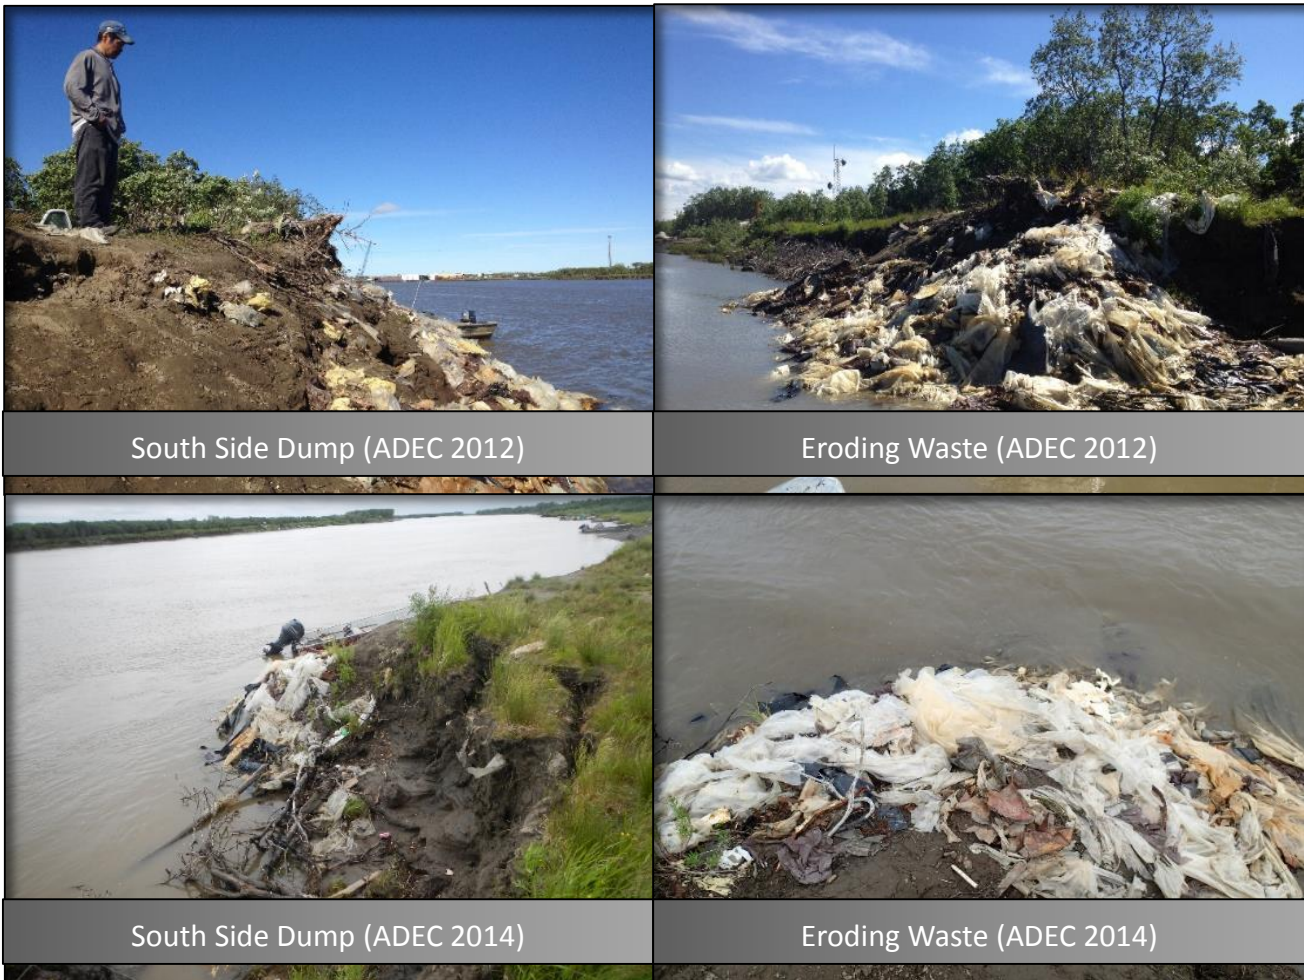
This site contains construction and demolition (C&D) debris that is a concern due to the possible presence of asbestos-containing materials. Asbestos was widely used in construction materials prior to the 1980s and remains in many rural communities in their older structures. Asbestos is known to cause lung cancer, but does not pose a health risk if it remains contained and is not released to the environment. Asbestos released to water due to erosion is less of a health concern; however, asbestos fibers released to the air pose a more significant risk to human health and the environment. Once asbestos fibers are released they are difficult to clean up, which can result in both short term and long term impacts.

The dump is within the drinking water protection zone for the Alakanuk Water System, which is a surface water supply whose summer intake is downstream of the site. The south side dump site is actively eroding into the Alakanuk Pass which is a subsistence area. The site is located 160 feet from the nearest residences. During the 2014 inspection, it was noted that a significant amount of plastics had eroded since the 2012 WEAR inspection.

As the Alakanuk South Side Dump Site is actively eroding, immediate action is recommended. As this site is near the community, erosion mitigation in this area may protect community infrastructure; however, since the site is actively eroding and a portion is already gone, removal of the site is recommended to prevent further contaminant release. Necessary steps include: determine the location of all the debris, complete an asbestos survey, locate a permitted landfill to accept the debris or permit a new landfill, and find funding and equipment to remove the debris.

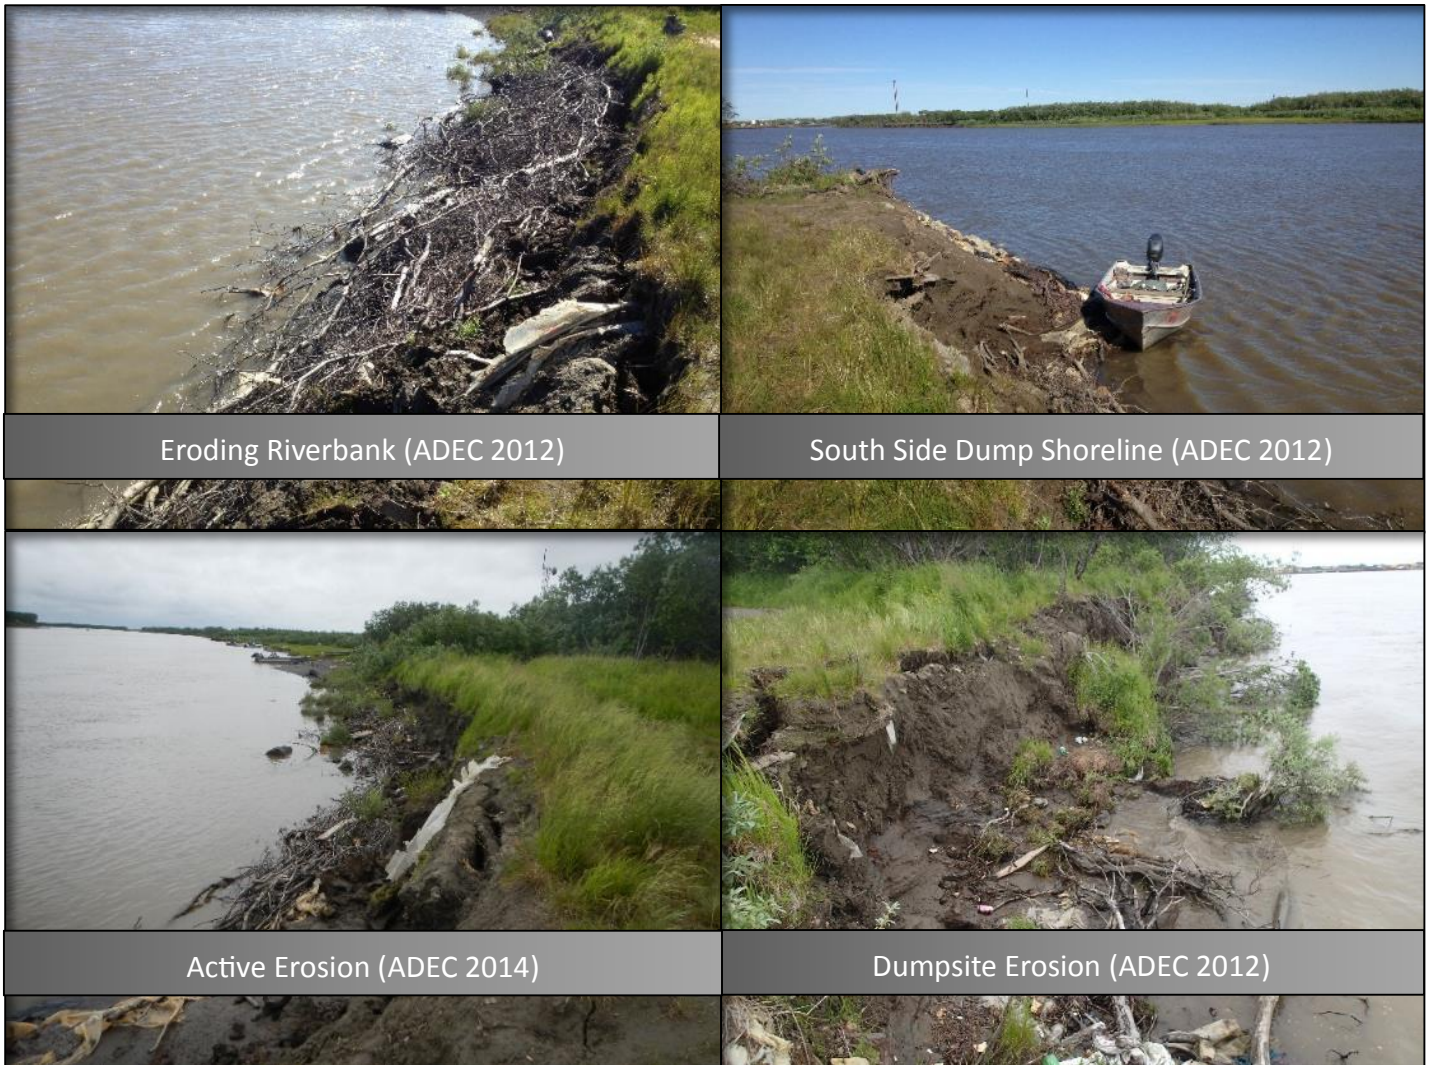
The US Army Corps of Engineers 2009 study, *Alaska Baseline Erosion Assessment (BEA)*, lists an estimated erosion rate of 2 feet per year for Alakanuk. During the 2012 and 2014 WEAR site inspections, the south side dump site was actively eroding into the river. According to the BEA, erosion occurs during two times of the year: break-up and fall storm season. During breakup, the Yukon River experiences high flows due to thawing snow and ice as well as surges caused by the failure of ice jams upriver. During the WEAR inspection residents reported that ice was the main contributor to erosion. The soil at this site is silt and sand which is more easily eroded by the river current and spring breakup than other soil types.

This site is actively eroding into Alakanuk Pass.
