DETAILED ACTION PLAN

CHEVAK COMPANY CORPORATION TANK FARM

WASTE EROSION ASSESSMENT & REVIEW (WEAR)

MAY 2015

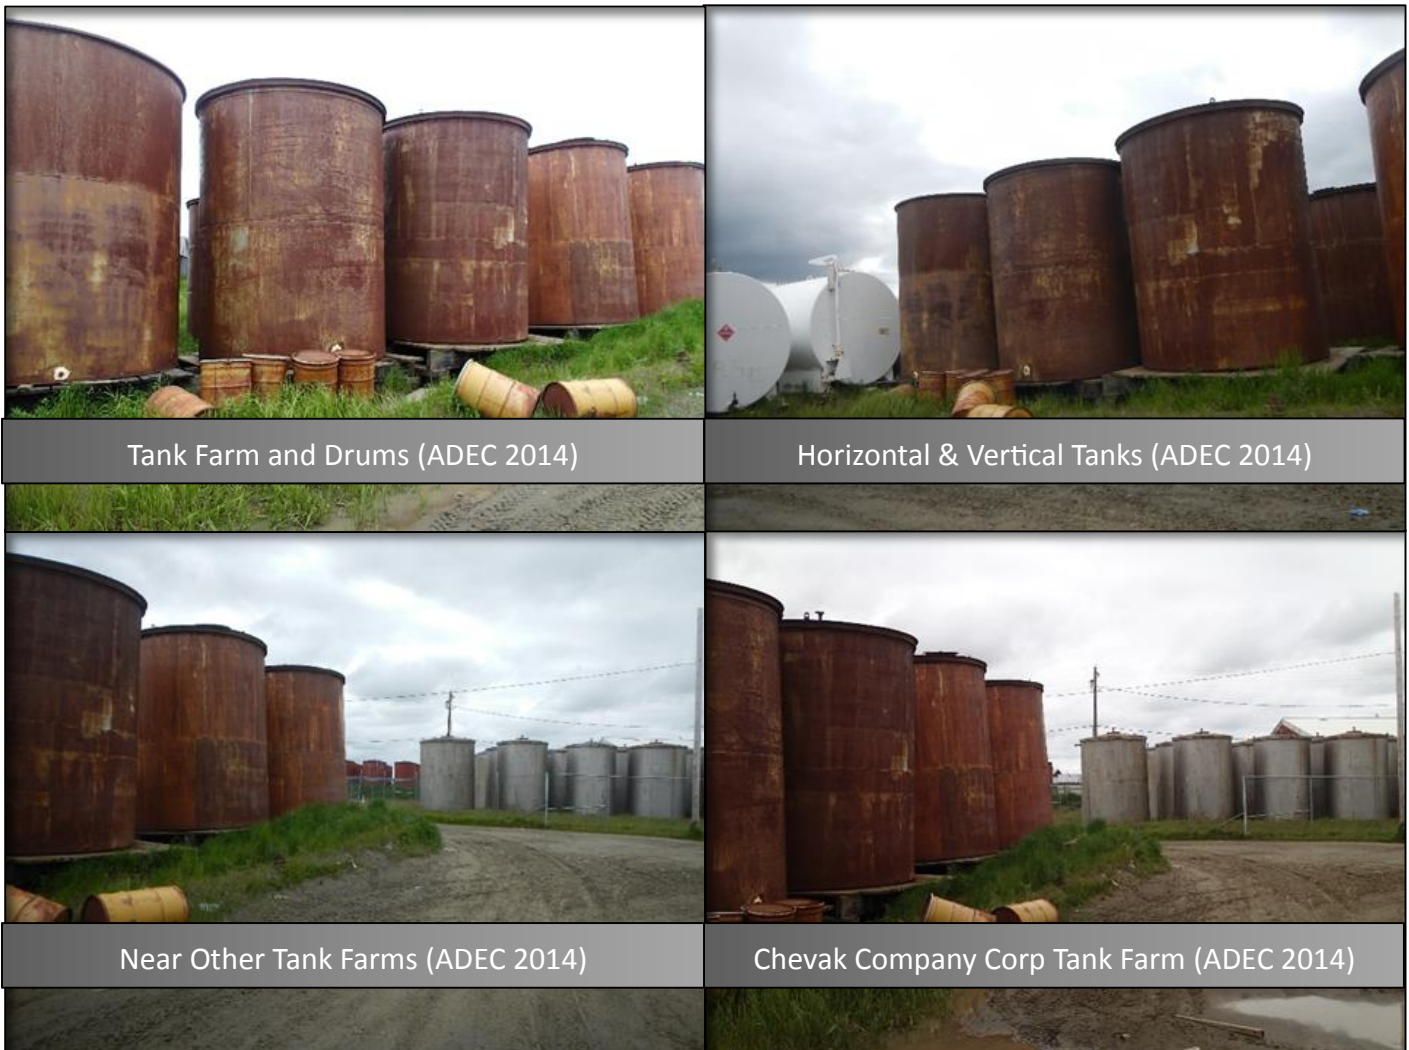
The Chevak Company Corporation Tank Farm was in operation from the 1970s to 2010. This site is located centrally within the community and is 160 feet from the Ninglikfak River. The tank farm is considered a small site measuring approximately 0.13 acres. It is also a known Contaminated Site (File ID 2409.38.001) due to heating oil and gasoline spills. Site characterization work was completed in 2003, but no further remediation work has been done. The nearest residences are 200 feet from the tank farm. There was no stressed vegetation observed. It is approximately 160 feet from a subsistence area and 4,000 feet from a critical habitat area for Spectacled and Steller’s Eiders.

Contaminants associated with fuels include benzene, polycyclic aromatic hydrocarbons (PAHs), and possibly lead from leaded gasoline. These contaminants are known to cause cancer and other chronic diseases. The tank farm is within the drinking water protection zone for the Chevak Water System Main Well, which draws from groundwater. According to the Alaska Department of Environmental Conservation’s (ADEC), Drinking Water Watch database, the system is monitored every 3 years for a group of volatile organic compounds (VOCs) related to fuel products. Over the years, VOCs including benzene have not been detected; however, lead has been detected.

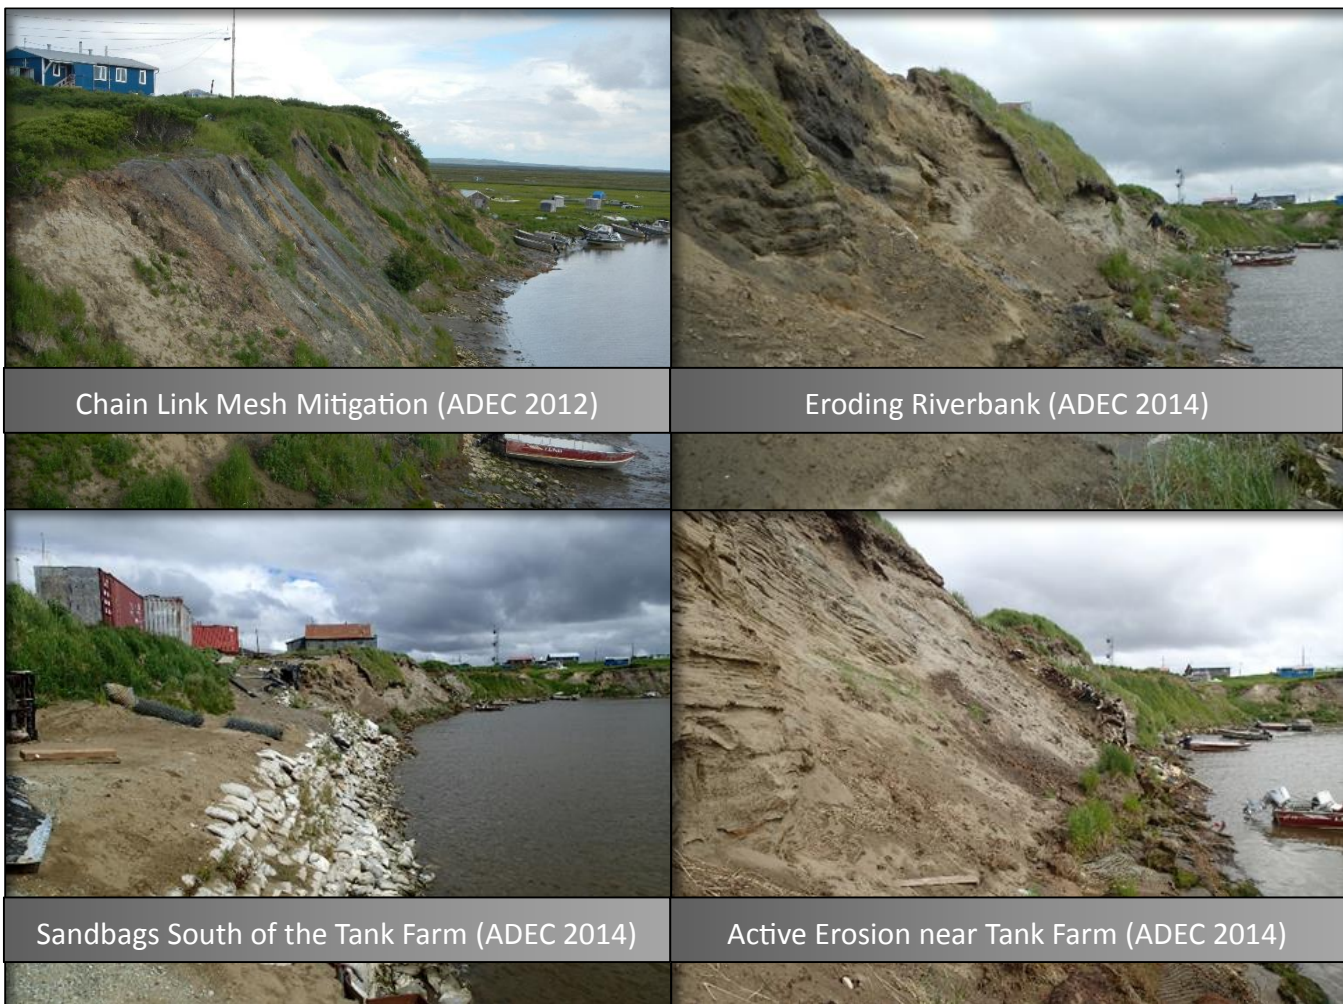
The US Army Corps of Engineers 2009 study, *Alaska Baseline Erosion Assessment (BEA)*, lists an estimated erosion rate of 5 to 10 feet per year for Chevak. This area of the riverbank is reported by community residents to be eroding at 5 feet per year and is said to be caused by river currents, ice jams, and melting permafrost. The community has constructed a sandbag retaining wall in one section and utilized chain link mesh in another section. However, these attempts have limited effect. The soil at this site is sand and silt which is more easily eroded from river current and storms than other soil types.

The Chevak Corporation Tank Farm was 135 feet from the Ningliak River according to 2007 aerial imagery. Using the 5 feet per year erosion rate calculated by the BEA and reported by community residents, it is estimated that the site will be impacted by erosion in 2034.

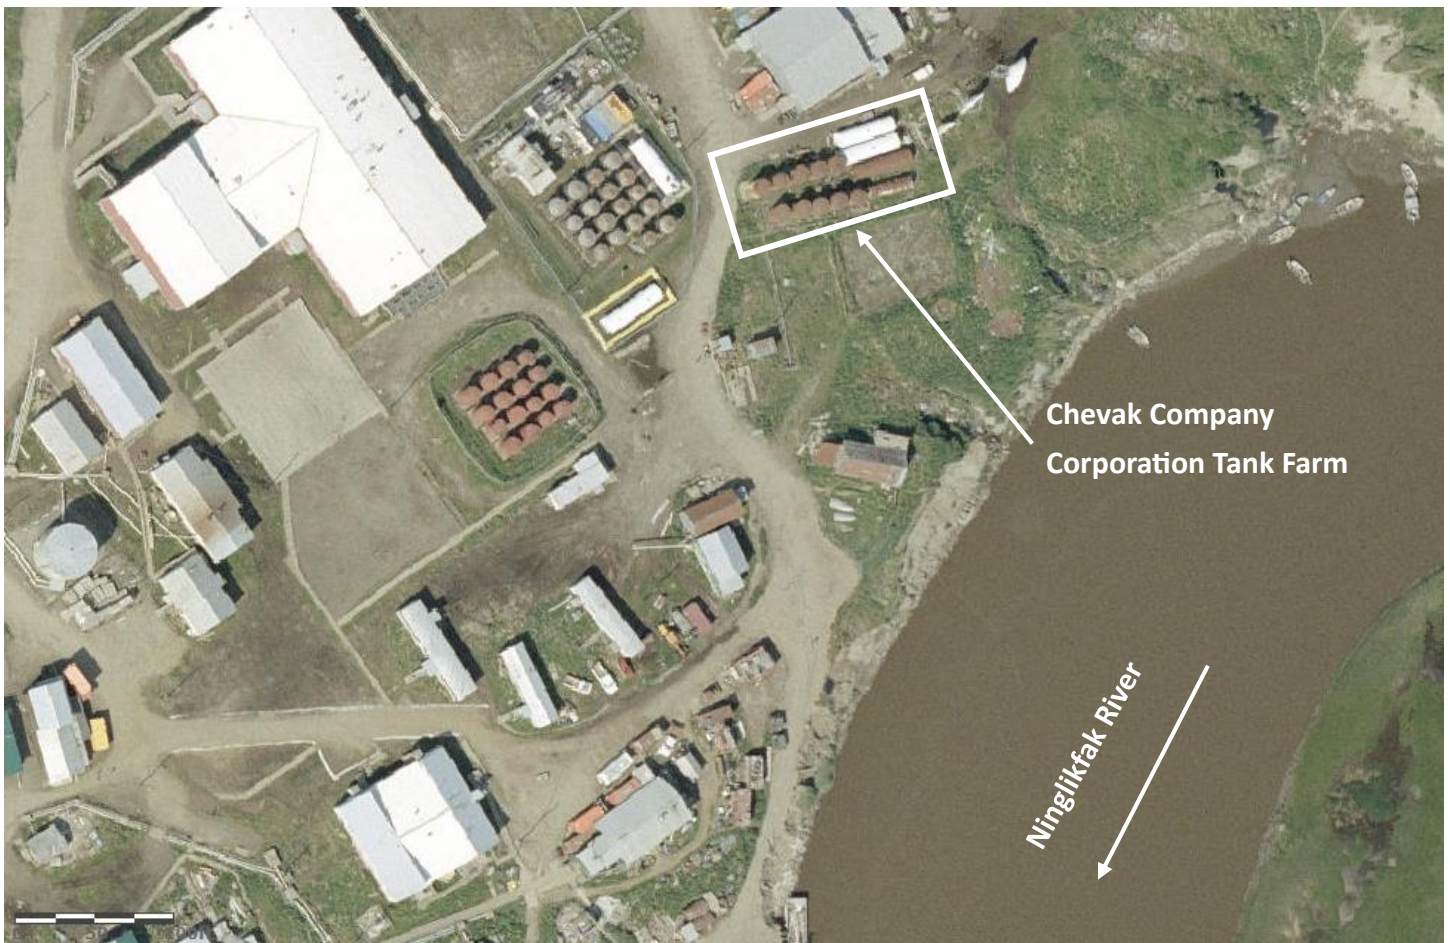
Imagery Dated 2007. WEAR Map at <http://dec.alaska.gov/eh/sw/wear.html>

There are currently some local erosion mitigation efforts for this site. A sand bag wall and chain link mesh were the primary techniques employed. Erosion is still occurring as these measures have not been effective.

As the Chevak Company Corporation Tank Farm is no longer in service, it is recommended to remove the site. It has been inactive since the construction of the new consolidated tank farm in 2010 and is unlikely to be in service in the future. The empty fuel tanks could be cut into smaller pieces for easier transport to and disposal at the permitted Chevak Landfill. After the site has been cleared, the underlying soil should be characterized to determine if any contamination remains and then, if needed, a plan developed for cleanup. A sampling plan and cleanup plan would need to be approved by the ADEC Contaminated Sites Program.
