# DETAILED ACTION PLAN

## CHEVAK FORMER AVEC TANK FARM

### WASTE EROSION ASSESSMENT & REVIEW (WEAR)

MAY 2015

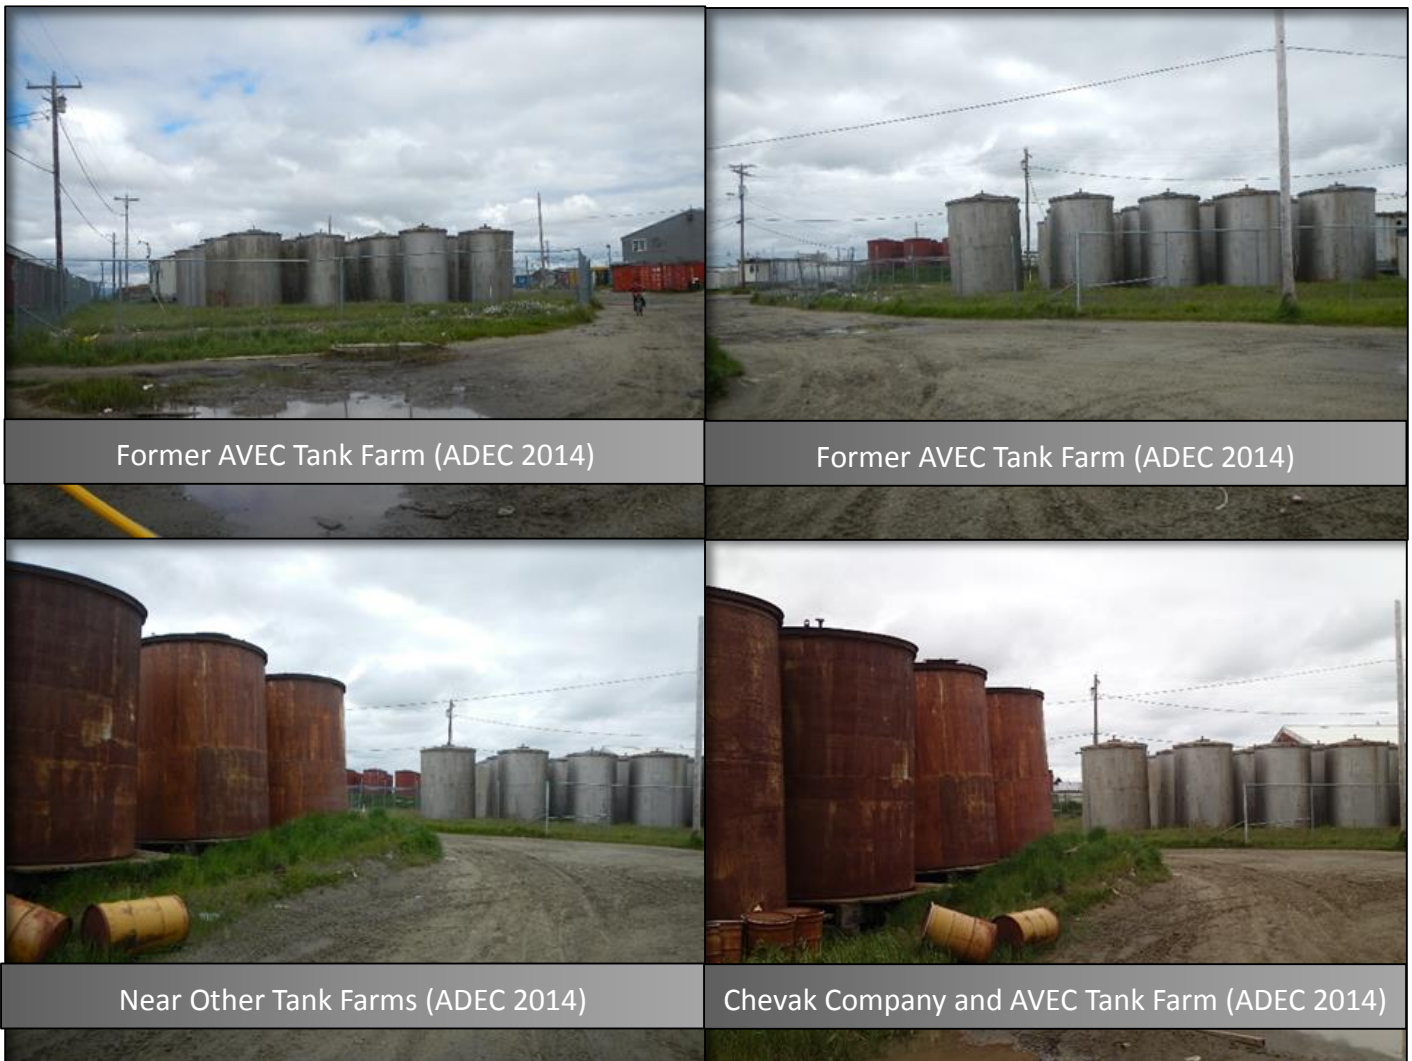
The Chevak Former AVEC Tank Farm was in operation from the 1970s to 2010. This site is located centrally within the community and is 235 feet from the Ninglikfak River. The tank farm is considered a small site measuring approximately 0.1 acres. It consists of 18 grey, single-walled, vertical, diesel fuel tanks within a fenced area. The tanks are reported to be empty. The nearest residences are 160 feet from the tank farm. There was no stressed vegetation observed. It is approximately 235 feet from a subsistence area and 4,000 feet from a critical habitat area for Spectacled and Steller’s Eiders.

Possible contamination at the Chevak Former AVEC Tank Farm is diesel fuel. Contaminants associated with diesel fuel include benzene and polycyclic aromatic hydrocarbons (PAHs), and possibly lead from leaded gasoline. These contaminants are known to cause cancer and other chronic diseases. Any contamination at this site could impact nearby soil, water, and subsistence resources. The tank farm is within the drinking water protection zone for the Chevak Water System Main Well, which draws from groundwater. According to the Alaska Department of Environmental Conservation’s (ADEC), Drinking Water Watch database, the system is monitored every 3 years for a group of volatile organic compounds (VOCs) related to fuel products. Over the years, VOCs including benzene have not been detected; however, lead has been detected.

The Chevak Former AVEC Tank Farm is no longer in service. Removal of the site is recommended as it has been inactive since the construction of the new consolidated tank farm in 2010 and likely will not be used in the future. The empty fuel tanks could be cut into smaller pieces for easier transport to and disposal at the permitted Chevak Landfill. After the site has been cleared, the soil should be characterized to determine if any contamination exists and, as needed, a plan developed for cleanup.

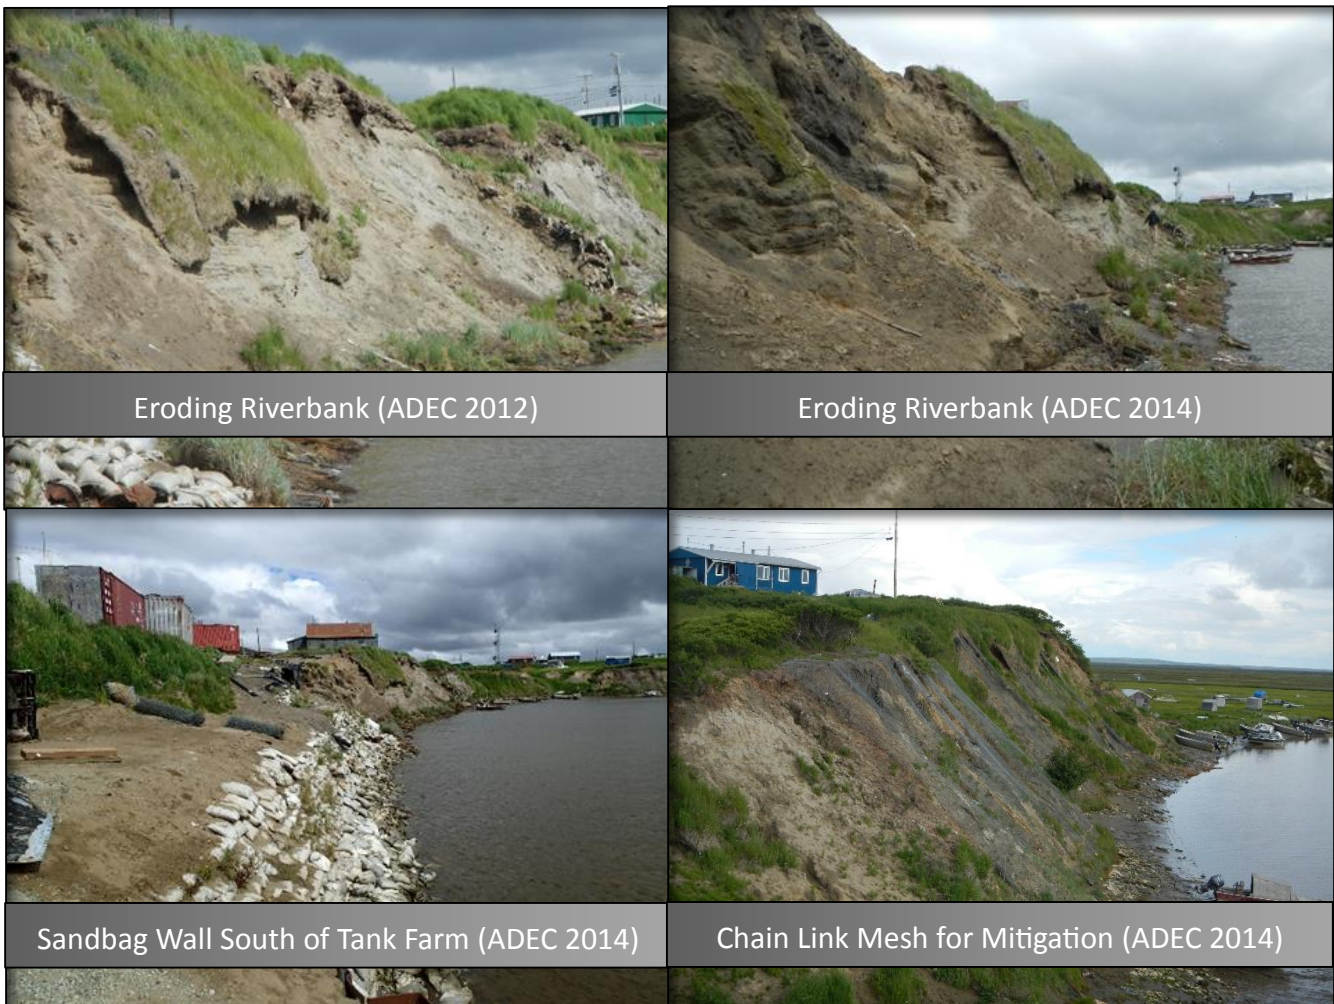
## EROSION RISK

The US Army Corps of Engineers 2009 study, *Alaska Baseline Erosion Assessment (BEA)*, lists an estimated erosion rate of 5 to 10 feet per year for Chevak. This area of the riverbank is reported by community residents to be eroding at 5 feet per year and is said to be caused by river currents, ice jams and melting permafrost. The community had constructed a sandbag retaining wall at one section of riverbank and utilized chain link mesh in another section to mitigate erosion. However, both methods have limited effectiveness. The soil at this site is sand and silt which is more easily eroded from the river current and storms than other soil types.

The Chevak Former AVEC Tank Farm is 225 feet from the Ninglikfak River according to 2013 aerial imagery. Using the 5 feet per year erosion rate calculated by the BEA and reported by community residents, it is estimated that the site will be impacted by erosion around 2058.

- C. **Erosion Mitigation** – Strong river currents, ice jams and spring breakup are the primary causes of erosion on this riverbank. Further study should be conducted to evaluate what erosion mitigation is best for the Ninglikfak River. The Department of Commerce, Community, and Economic Development’s Division of Community and Regional Affairs handbook, *Understanding and Evaluating Erosion Problems*, suggests the best methods for protecting against erosion from these causes as beach fill or relocation. The full list of suggested methods is provided in Table 2 of the document which is available online at <http://commerce.state.ak.us/dnn/dcra/PlanningLandManagement.aspx>.
