# DETAILED ACTION PLAN

## CHEVAK FORMER CITY TANK FARM

### WASTE EROSION ASSESSMENT & REVIEW (WEAR)

MAY 2015

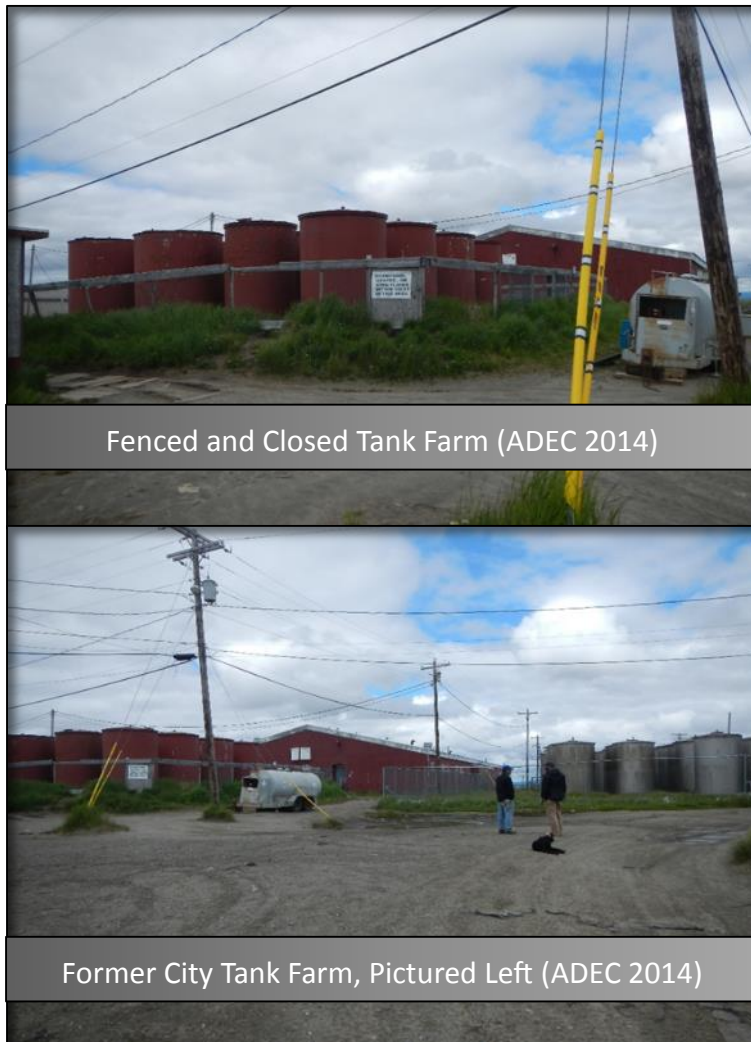
The Chevak Former City Tank Farm was in operation from the 1970s to 2010. This site is located centrally within the community and is 30 feet from the nearest residence. The tank farm is considered a small site measuring approximately 0.13 acres. It contains 16 red, single-walled, vertical diesel tanks. There was no stressed vegetation observed. It is approximately 215 feet from a subsistence area and 4,000 feet from a critical habitat area for spectacled and Steller's eider.

Possible contamination at the Chevak Former City Tank Farm is fuels. Contaminants associated with fuels include benzene, polycyclic aromatic hydrocarbons (PAHs), and possibly lead from leaded gasoline. These contaminants are known to cause cancer and other chronic diseases. Any contamination at this site could impact nearby soil, water, and subsistence resources. The tank farm is within the drinking water protection zone for the Chevak Water System Main Well, which draws from groundwater. According to the Alaska Department of Environmental Conservation's (ADEC), Drinking Water Watch database, the system is monitored every 3 years for a group of volatile organic compounds (VOCs) related to fuel products. Over the years, VOCs including benzene have not been detected; however, lead has been detected.

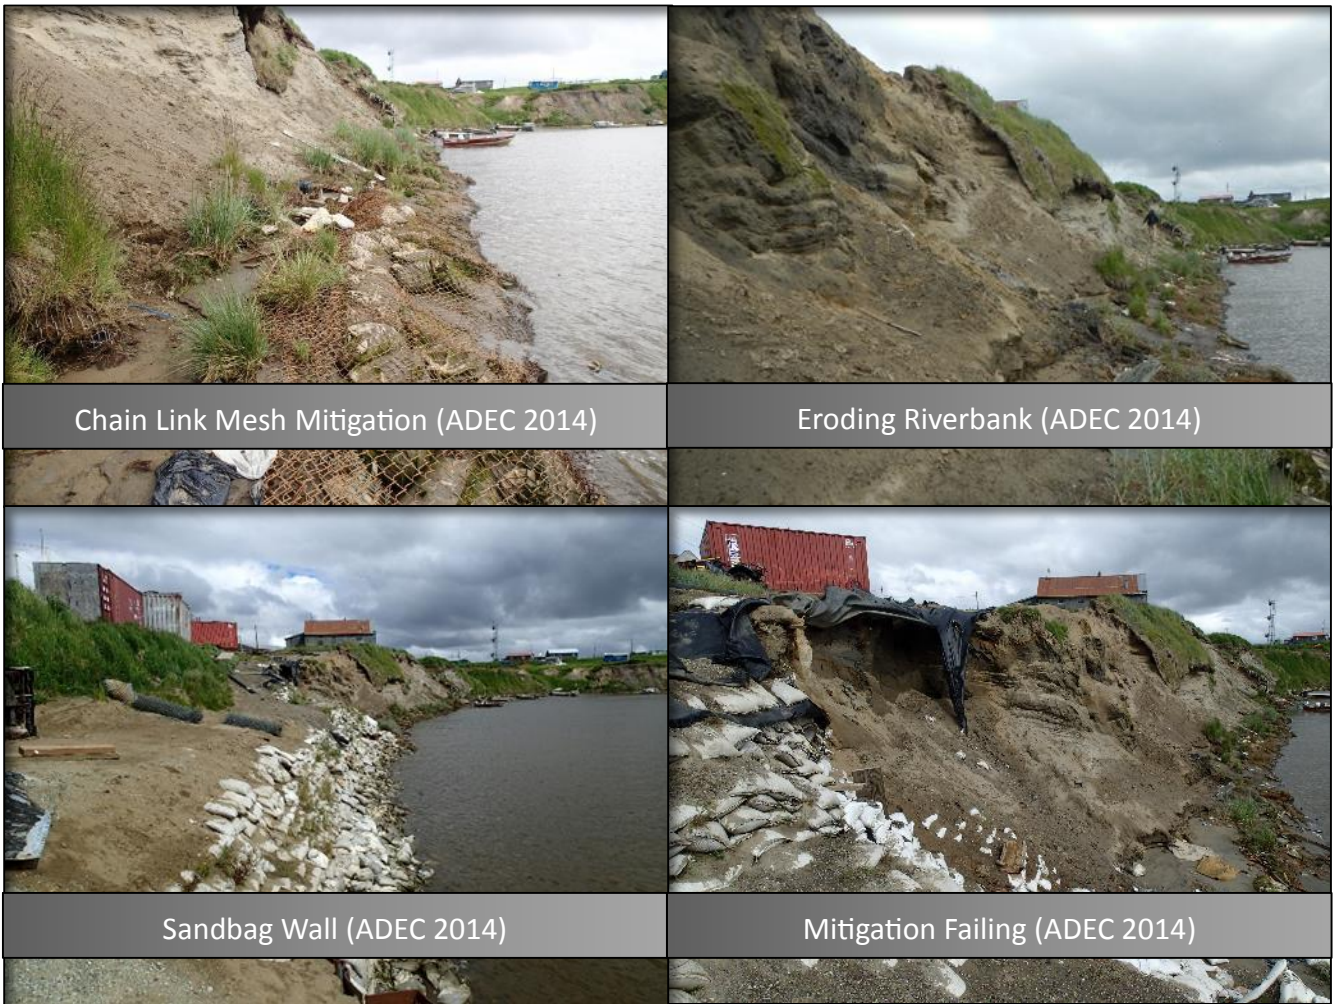
The US Army Corps of Engineers 2009 study, *Alaska Baseline Erosion Assessment (BEA)*, lists an estimated erosion rate of 5 to 10 feet per year for Chevak. This area of the riverbank is reported by community residents to be eroding at 5 feet per year and is said to be caused by river currents, ice jams and melting permafrost. The community had constructed a sandbag retaining wall in one section of riverbank and chain link mesh in another to mitigate erosion. However, these attempts have limited effect, although the sandbag wall is performing better than the fencing mitigation. The soil at this site is sand and silt which is more easily eroded from the river current and storms than other soil types.

The Chevak Former City Tank Farm was 215 feet from the Ningliktak River according to 2013 aerial imagery. Using the 5 feet per year erosion rate calculated by the BEA and reported by community residents, it is estimated that the site will be impacted by erosion in 2056.

There are currently some local erosion mitigation efforts for this site. A sand bag wall and chain link mesh were the primary techniques employed. Erosion is still occurring as these measures have not been effective.
