DETAILED ACTION PLAN

CHEVAK OLD RIVER LANDFILL

WASTE EROSION ASSESSMENT & REVIEW (WEAR)

MAY 2015

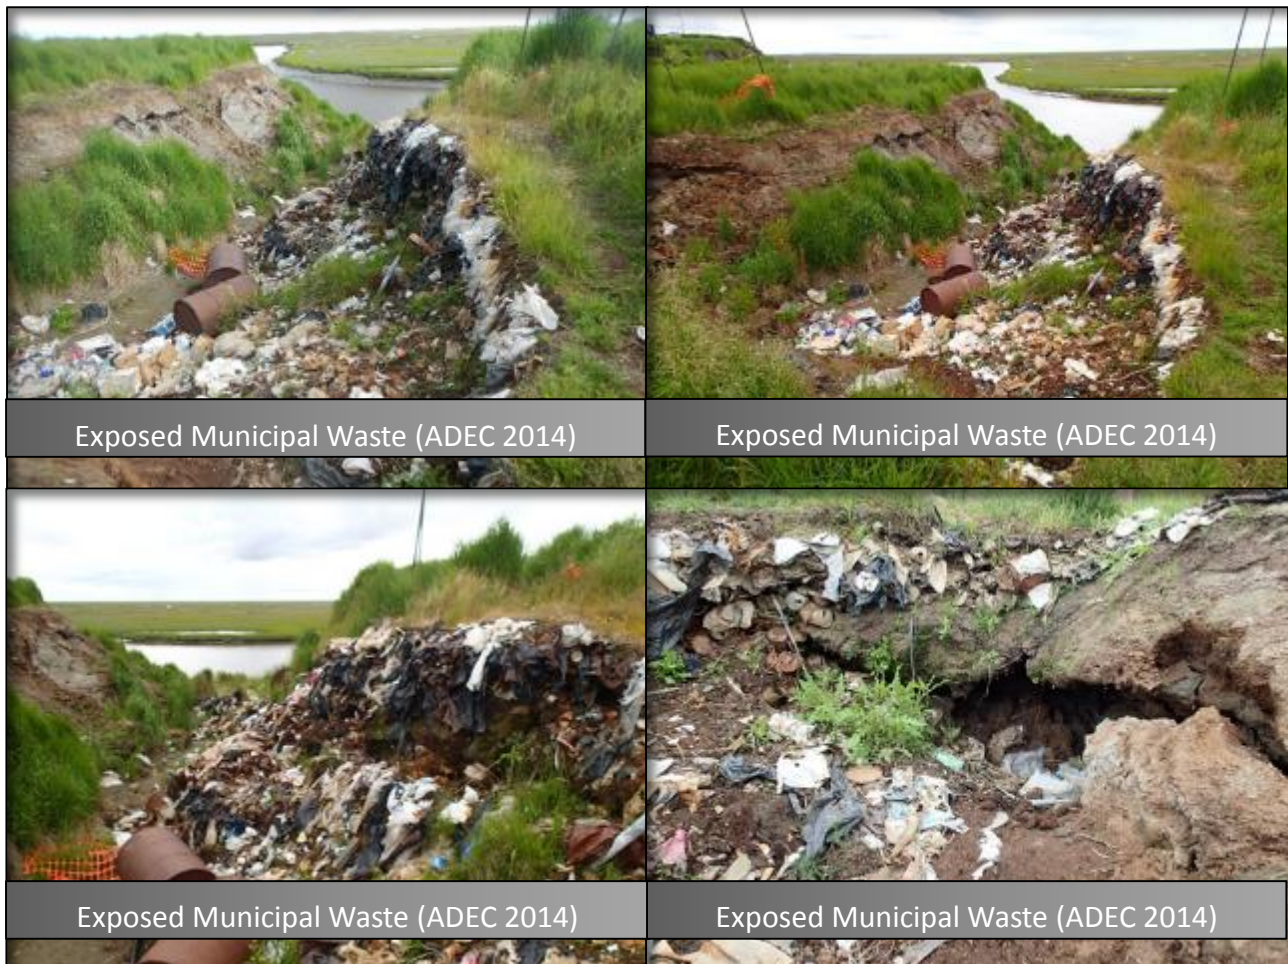
The MSW has been covered for several decades but, within the last ten years, the river has been eroding this area. During the 2014 inspection, MSW was uncovered and falling into the river. Local residents placed posts to indicate where the ground drops off, but no measures had been taken to remove the MSW. The MSW was spread along the riverbank downstream of this eroding site.

Removal of the Old Chevak River Landfill is recommended as the site is currently eroding. Further erosion of this site may spread contaminants associated with HHW, potentially damaging water quality and subsistence resources, while debris in the river could cause navigation hazards. Much of the waste is already exposed and would be relatively easy to remove. The waste should be taken to the permitted Chevak Landfill or another ADEC-permitted landfill. Since the site is actively eroding and a portion is already gone, removal of the site should be a priority. Planning for and finding ways to fund the removal and cleanup of this site should begin soon to minimize the impact of continued erosion of this landfill. Foot and boat traffic along this stretch of the riverbank should be minimized to reduce human-influenced erosion. Fencing, or some other barrier, should be placed near the end of the waste to prevent further waste erosion until full removal can take place.

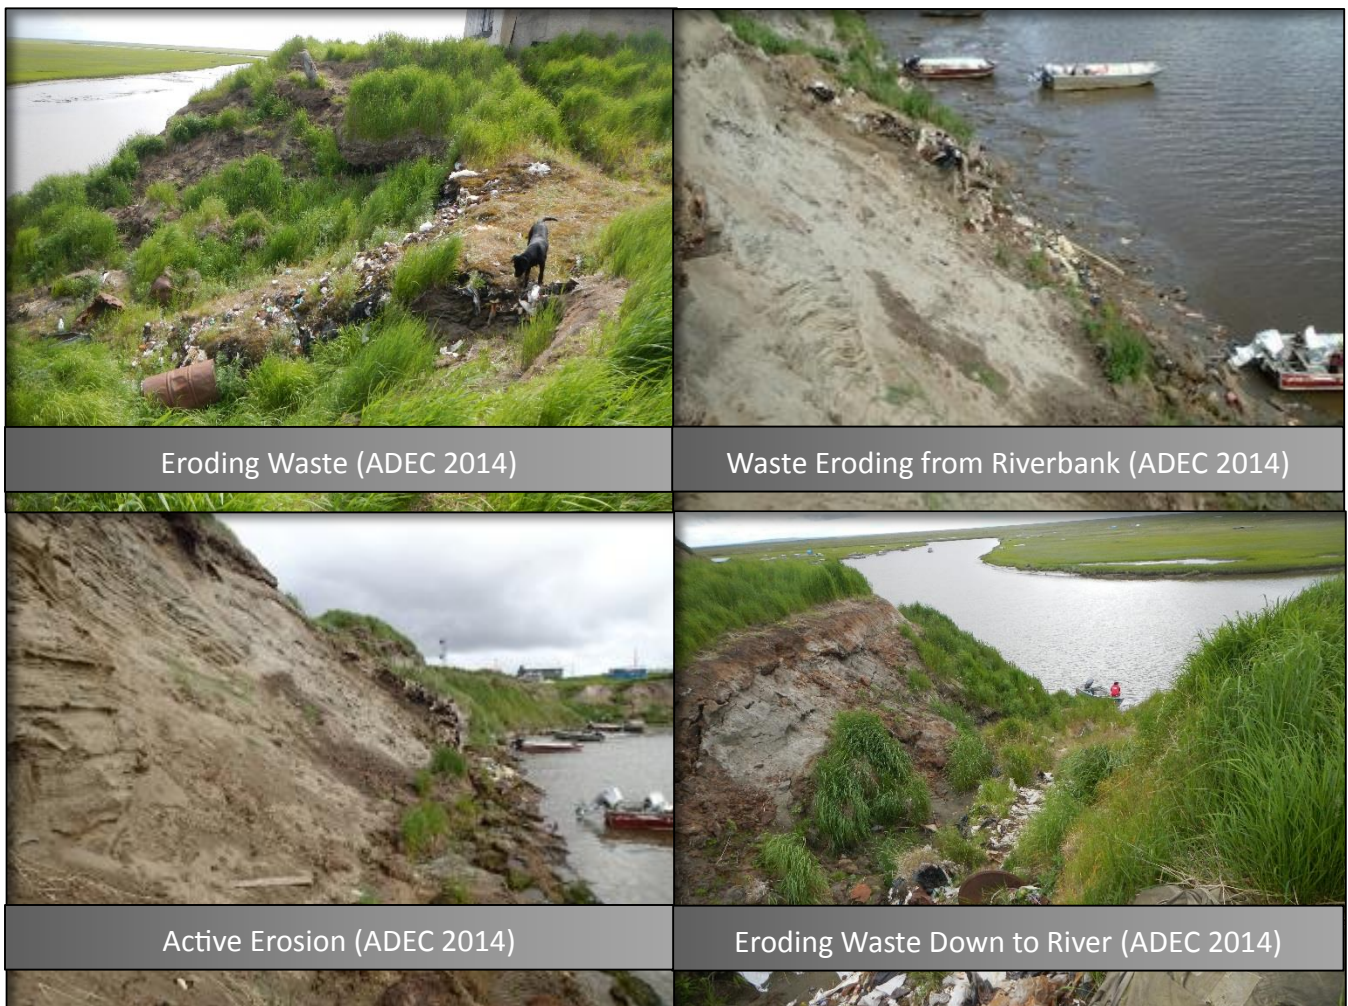
The US Army Corps of Engineers 2009 study, *Alaska Baseline Erosion Assessment (BEA)*, lists an estimated erosion rate of 5 to 10 feet per year for Chevak. This area of the riverbank is reported by community residents to be eroding at 5 feet per year and is said to be caused by river currents, ice jams and melting permafrost. The community has constructed a sandbag retaining wall in one area and utilized chain link mesh to mitigate erosion in other areas. However, these attempts have limited effect and the riverbank continues to erode. The soil at this site is sand and silt which is more easily eroded from the river current and storms than other soil types.

During the 2014 WEAR inspection this site was actively eroding into the Ninglikfak River.
