DETAILED ACTION PLAN EMMONAK LANDFILL

WASTE EROSION ASSESSMENT & REVIEW (WEAR) MAY 2015

The **Emmonak Landfill** is located at latitude 62.775086 and longitude -164.505094. The landfill is on the east side of the community along the airport access road. This site was inspected for the Waste Erosion Assessment and Review (WEAR) project on July 9, 2012 and was re-visited on July 10, 2014.

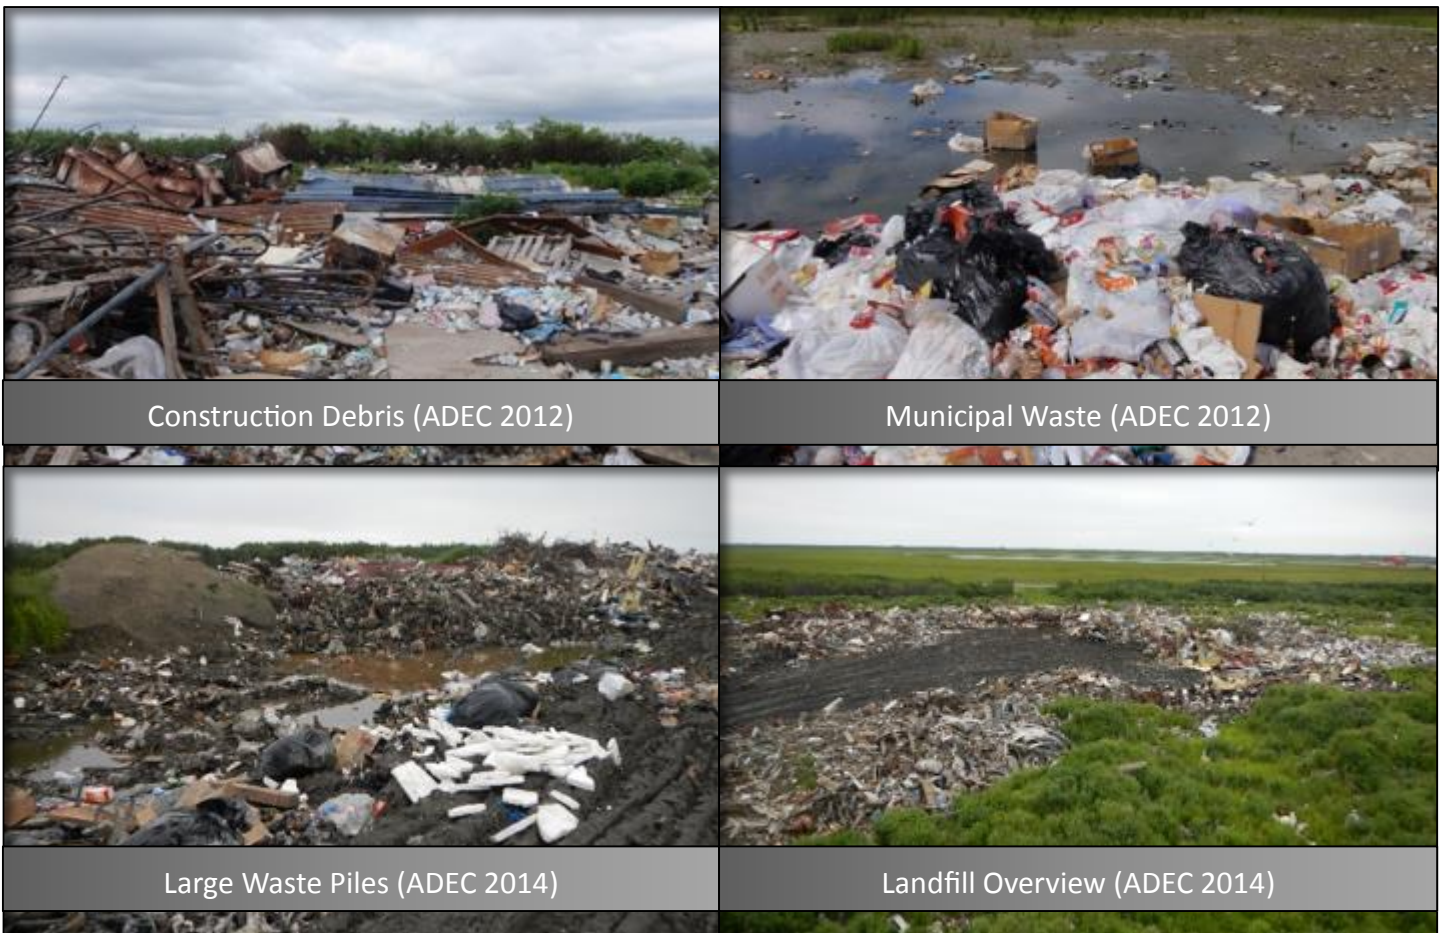
The Emmonak Landfill is within the drinking water protection zone for the Emmonak Water System, which is a surface water supply whose summer intake is 4,500 feet downstream of the site. According to the Alaska Department of Environmental Conservation's (ADEC), Drinking Water Watch database, the system is tested for heavy metals, volatile organic compounds (VOCS), and other contaminants per the ADEC Drinking Water Program. To date, none of those contaminants have been detected.

The Emmonak Water System should continue to monitor for VOCs and heavy metals to ensure no contaminants are impacting it.

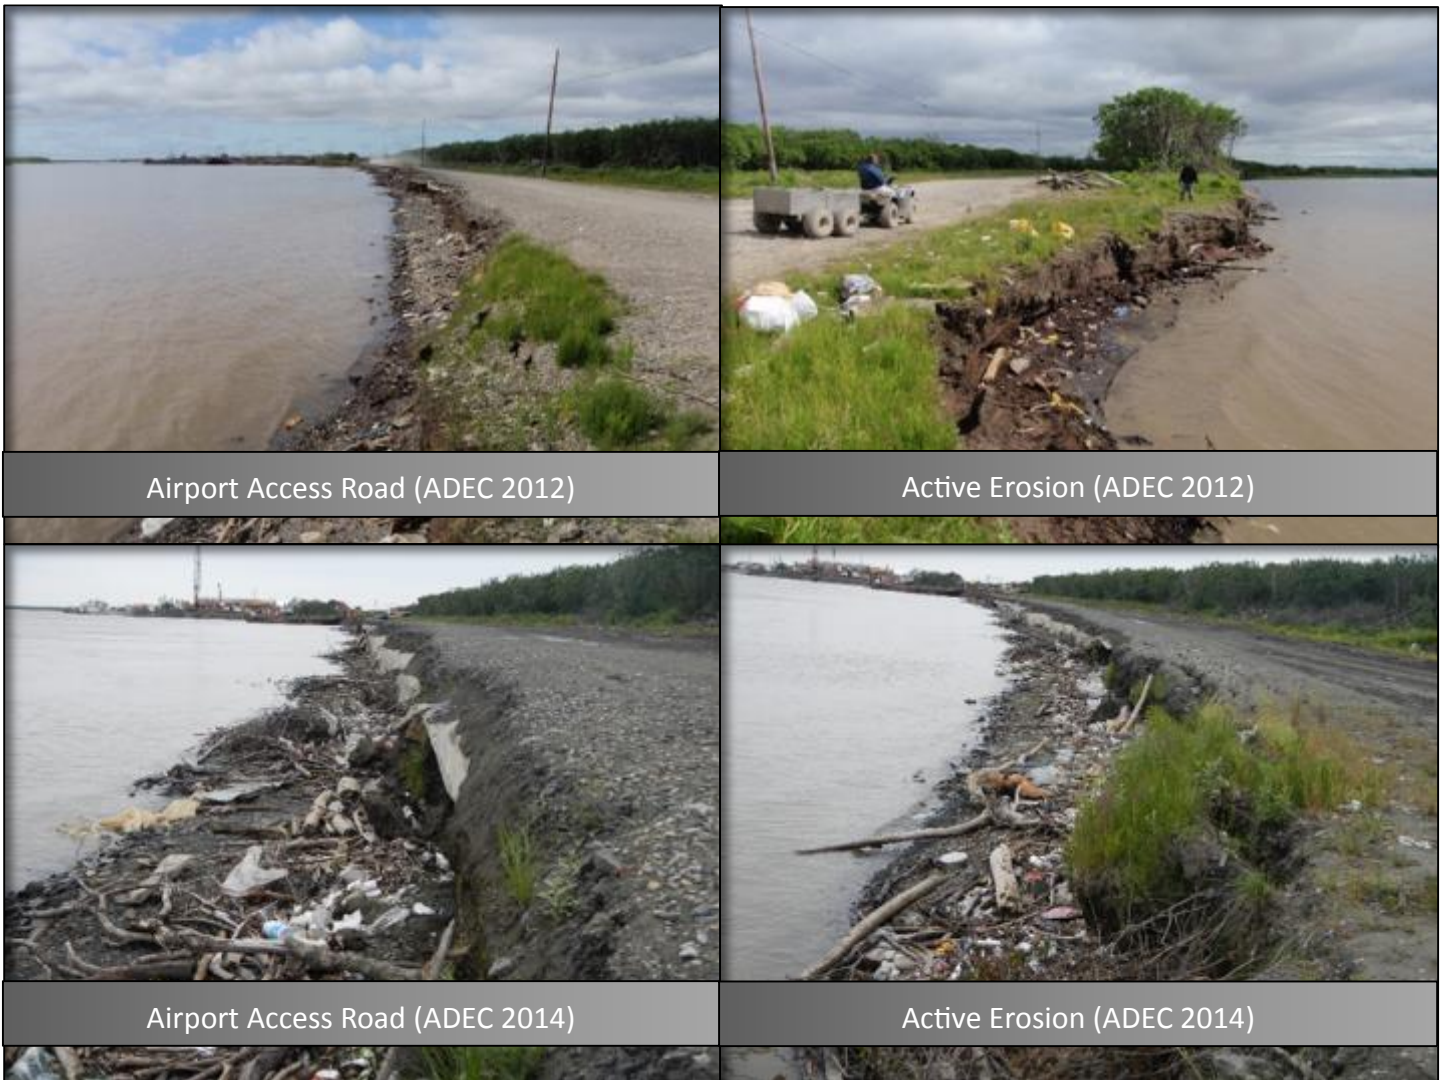
The Emmonak Landfill was 350 feet from the Yukon River in aerial imagery from 2006. GPS coordinates taken in 2014 were compared with the 2006 imagery. From this, ADEC estimates that land along the airport access road is eroding at 7 feet per year. Based on this erosion rate estimate, the landfill will be impacted by 2056.

The Emmonak Landfill provides key infrastructure as it is the community's waste disposal site. Erosion mitigation is recommended not only to protect the landfill, but to also protect the airport access road that is actively eroding. Riprap is installed just west of this site. Extending this protection, or the revetment of armor stone, would likely be effective as it has been successful in their current locations.
