DETAILED ACTION PLAN KOTLIK LANDFILL

WASTE EROSION ASSESSMENT & REVIEW (WEAR) MAY 2015

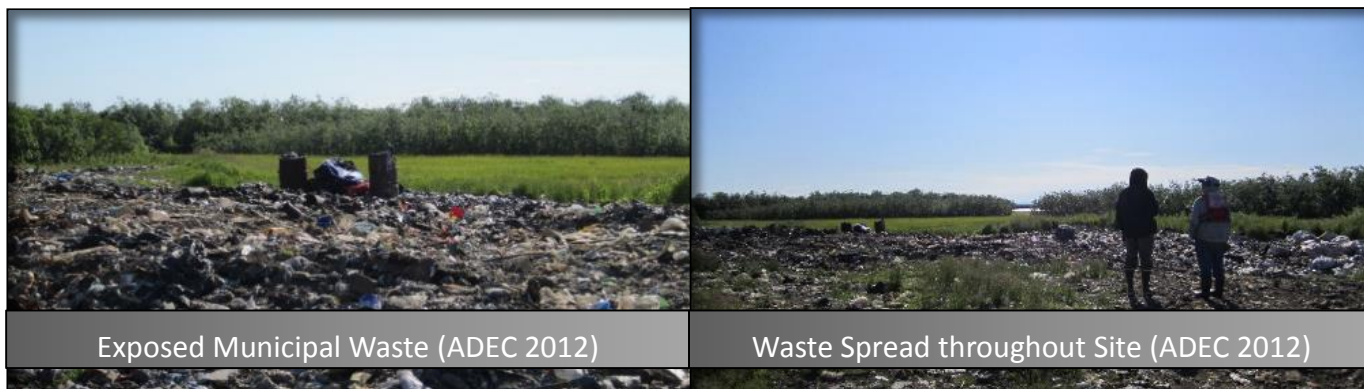
Exposed Municipal Waste (ADEC 2012)

Waste Spread throughout Site (ADEC 2012)

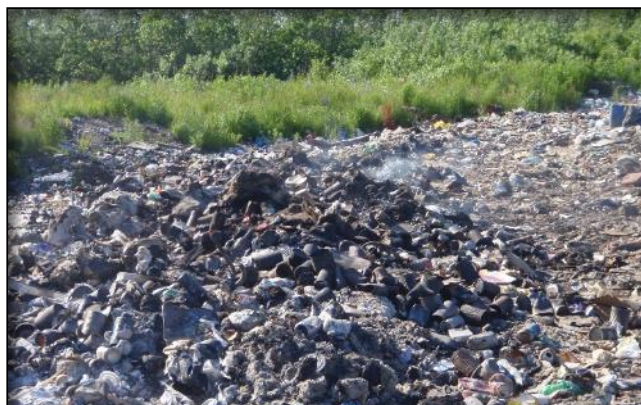
Smoldering Waste (ADEC 2012)

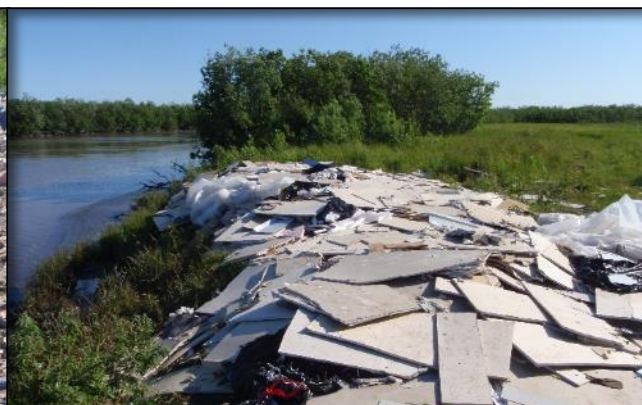
Construction and Demolition Debris (ADEC 2012)

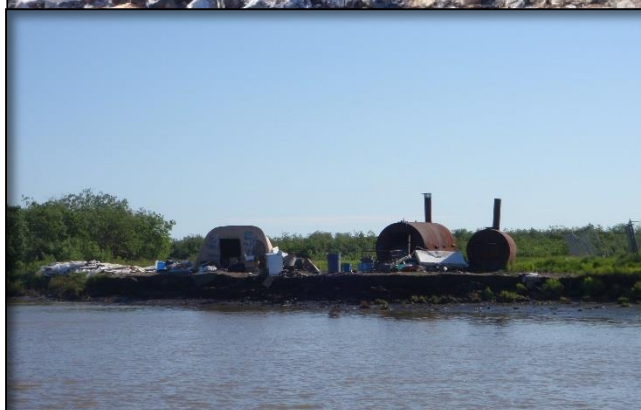
River Access to Landfill (ADEC 2012)

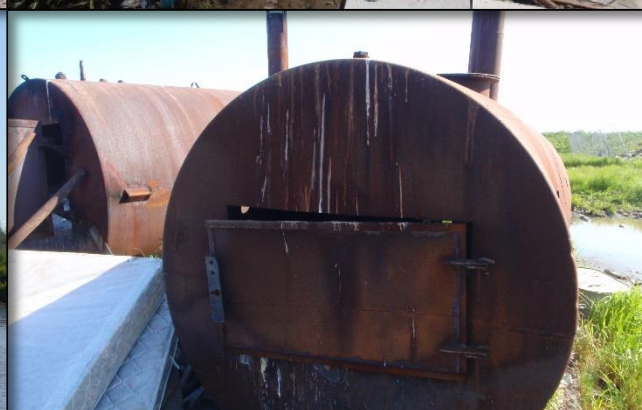
Burn Units (ADEC 2012)

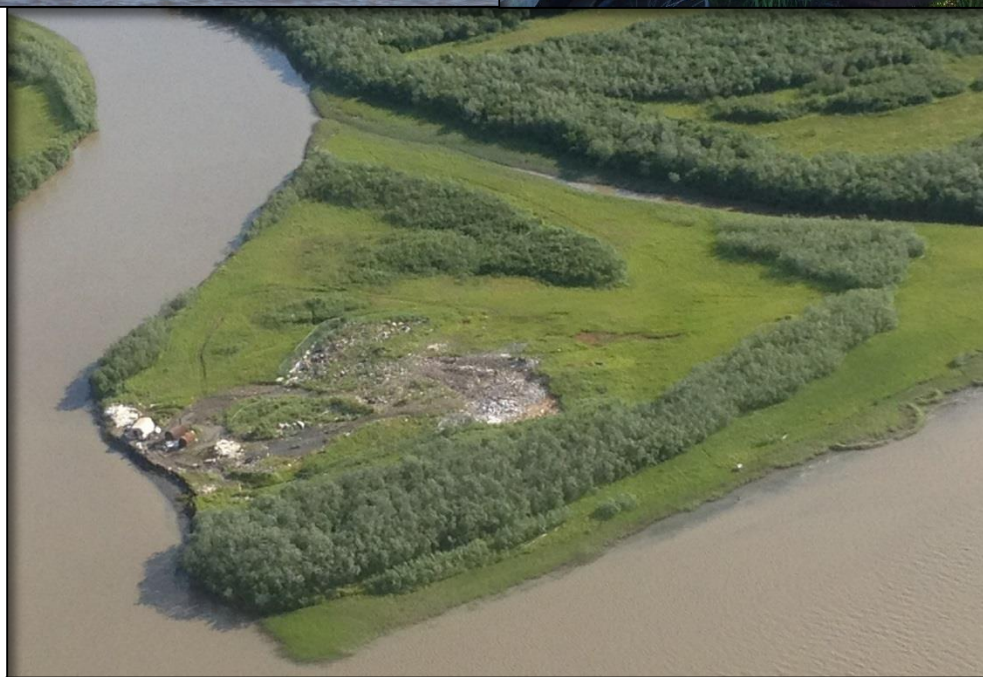
Aerial of Landfill (ADEC 2012)

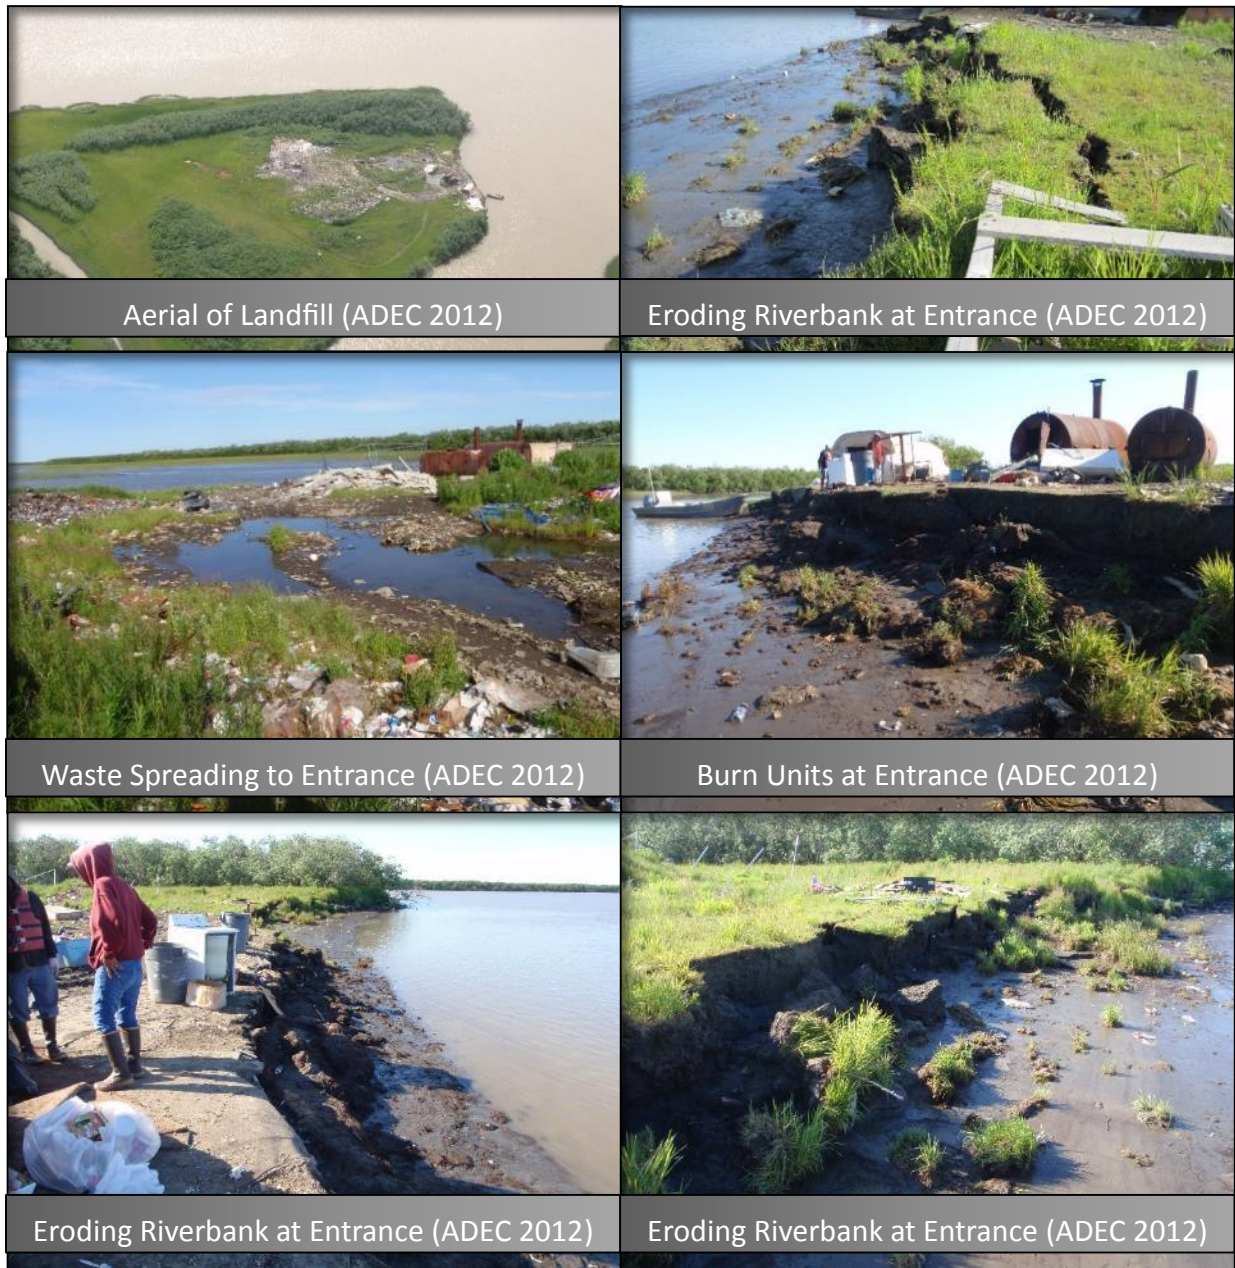
The US Army Corps of Engineers 2009 study, *Alaska Baseline Erosion Assessment (BEA)*, lists an estimated erosion rate of 3 feet per year along the banks of the landfill. During the 2012 WEAR site inspection, the landfill was only 15 feet from the eroding riverbank. According to the BEA, natural fluctuations in flows and water levels, flooding, ice jams, spring break up, and wave action from boat wakes and wind reportedly contribute to bank erosion. The soil structure of silt and clay is more likely to erode than other soil types and is weakened with the semi-annual thaw-freeze cycle.

Erosion is estimated to impact the landfill by 2016.

Until a new landfill can be constructed, the community should continue to use the current landfill, and move the waste away from the encroaching riverbank several times a year using heavy equipment. Signs should be posted along the river bank informing residents to take waste to the interior of the site.
