# DETAILED ACTION PLAN

## KOTLIK LYSD FORMER TANK FARM

### WASTE EROSION ASSESSMENT & REVIEW (WEAR)

MAY 2015

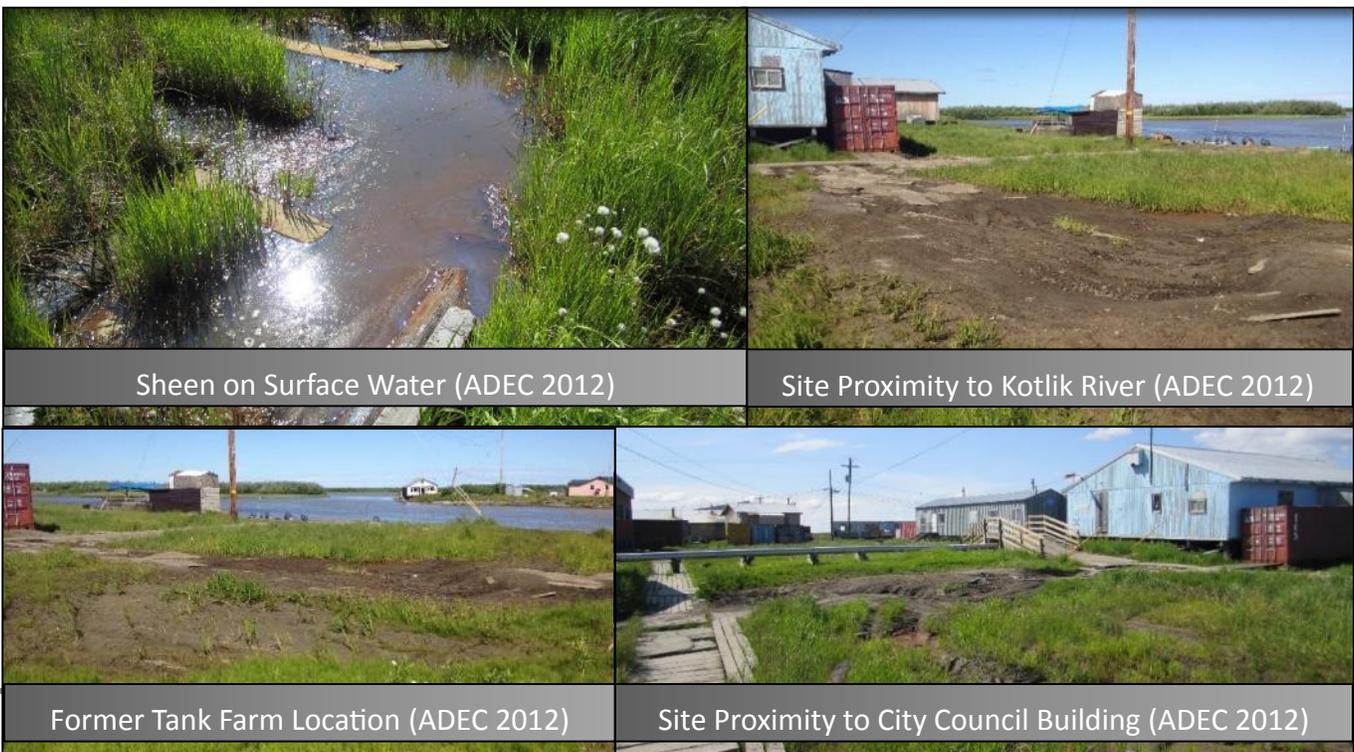
Soil and surface water testing conducted in 2008 suggests the tank farm is the source of contamination on the adjacent property to the south of the site. Soil samples from the adjacent site contained diesel range organics (DRO) up to 4,590 mg/kg, which is above soil cleanup levels. The surface water samples also exceeded surface water cleanup standards. Sheen was noted on the surface water adjacent to creosoted logs to the south of the property in 2008 and during the 2012 WEAR site visit.

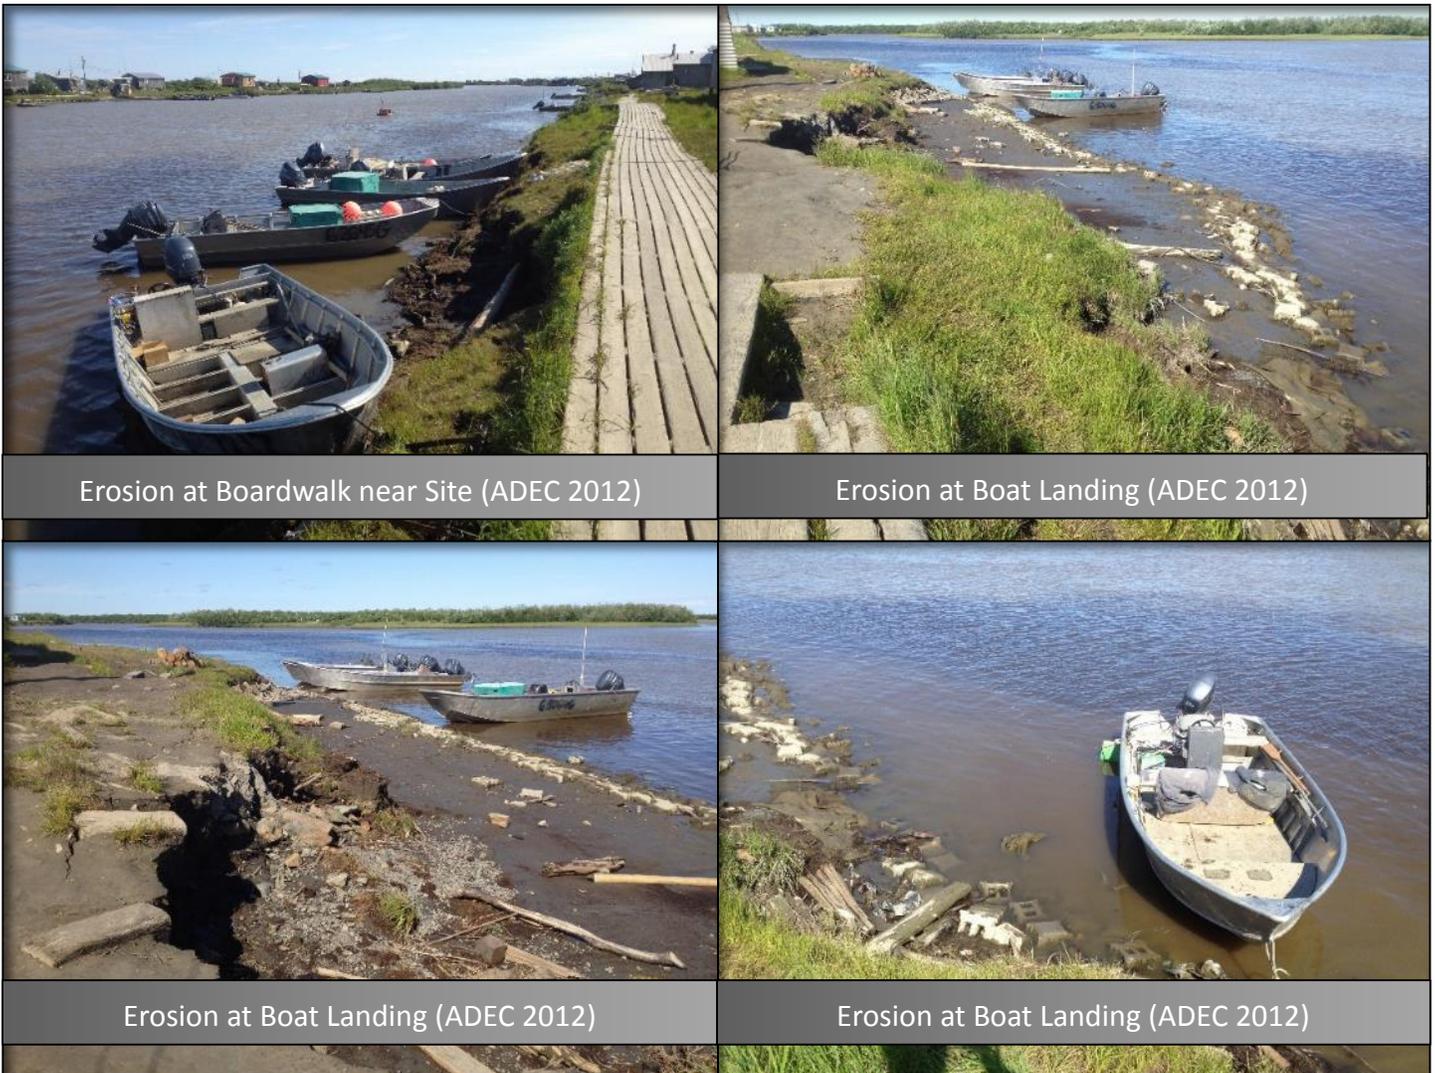
This former tank farm is located 110 feet away from an eroding area of the Kotlik River. The US Army Corps of Engineers' 2009 study, *Alaska Baseline Erosion Assessment (BEA)*, indicates that the riverbank in this area is eroding at 3 feet per year. Recent major erosion events have been recorded in the community in 2002, 2003, 2005, 2011 and 2013. The 2011 and 2013 events resulted in presidential disaster declarations for Kotlik. The BEA lists the primary causes of erosion as natural fluctuations in flows and water levels, flooding, ice jams, spring break up, and wave action from boat wakes and wind. Erosion is occurring in the form of scarps and undercutting along the entire riverbank near the site. This area is used as a boat landing, which also helps to accelerate erosion. The silty soil, with its finer granules, at the site and riverbank is more likely to erode than other soil types. The soil is further destabilized with the semi-annual thaw-freeze cycle.

Erosion is estimated to impact the site in approximately around 2040.
