DETAILED ACTION PLAN NELSON LAGOON LANDFILL

WASTE EROSION ASSESSMENT & REVIEW (WEAR) MAY 2015

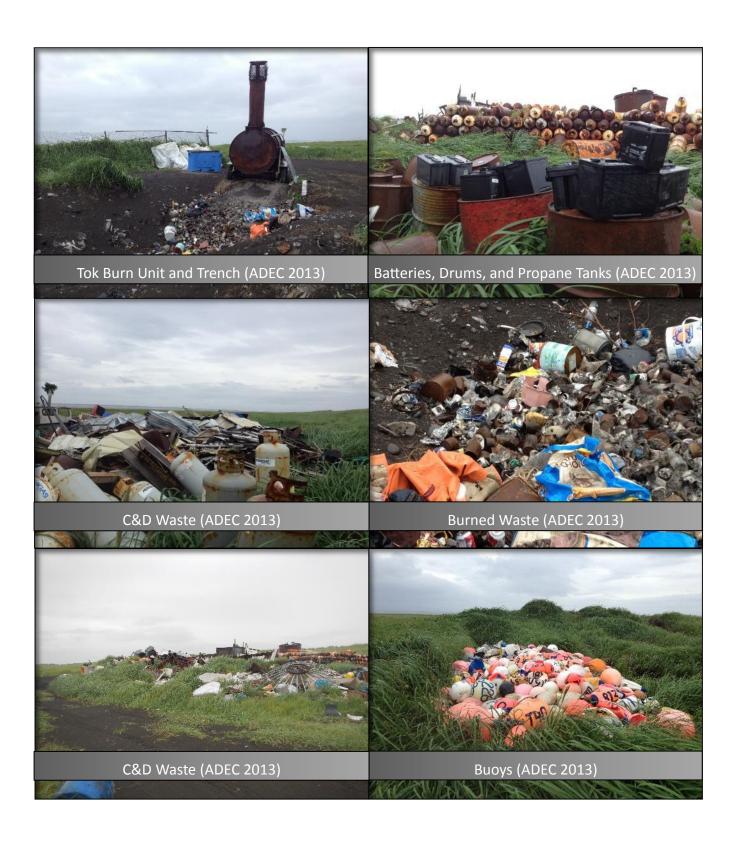
There were no signs of stressed vegetation. The landfill is 80 feet from a subsistence area and a critical habitat area for the Steller's eider.

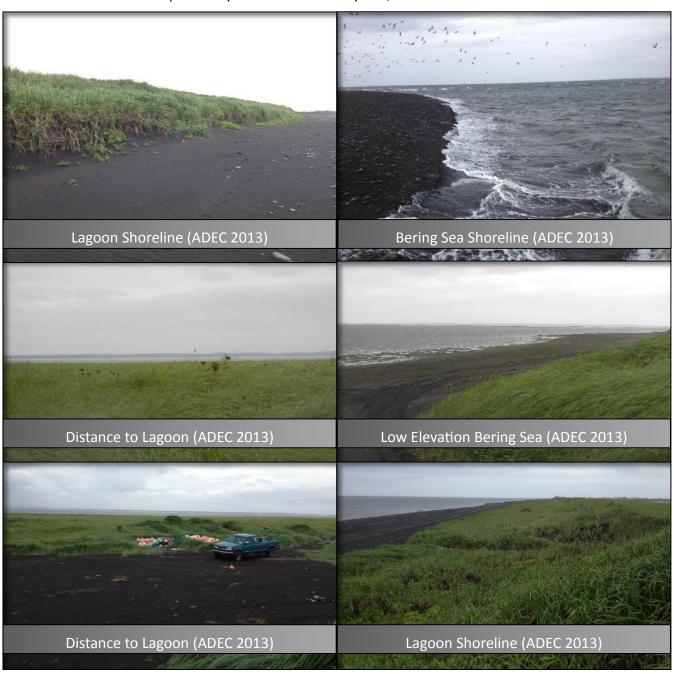
The Nelson Lagoon landfill is susceptible to erosion on both the Bering Sea and Nelson Lagoon sides of the sand spit. The US Army Corps of Engineers 2009 study, *Alaska Baseline Erosion Assessment* (BEA), lists an estimated erosion rate for this area of 5 feet per year. During the 2013 site inspection, the landfill was approximately 80 feet from the Bering Sea. According to the BEA, factors causing and contributing to erosion at the site include high tides and storm surges. There is a constant prevailing wind of 20 to 25 miles per hour, which combined with wave action also contributes to erosion. The soil structure is primarily sand which is more susceptible to erosion than larger-grained soil types like gravel.

This site is estimated to be impacted by erosion within 16 years, or around 2029.
