DETAILED ACTION PLAN

OSCARVILLE SCHOOL TANK FARM

WASTE EROSION ASSESSMENT & REVIEW (WEAR)

MAY 2015

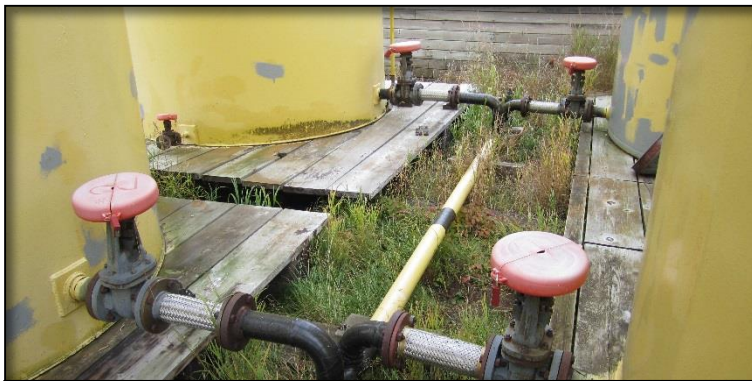
Vegetation Growing in Tank Farm (ADEC 2012)

The presence or absence of a liner beneath the tank farm should be confirmed either by reviewing the design documents or by careful excavation within the diked area. If present, an effective liner must be intact and impermeable with no vegetation or soil present on the liner. If a liner is not present, one should be installed as a code-compliant liner system is necessary to protect the soil and nearby drinking water well. The school's drinking water well should continue to be monitored for VOCs in accordance with the Drinking Water Program's requirements.

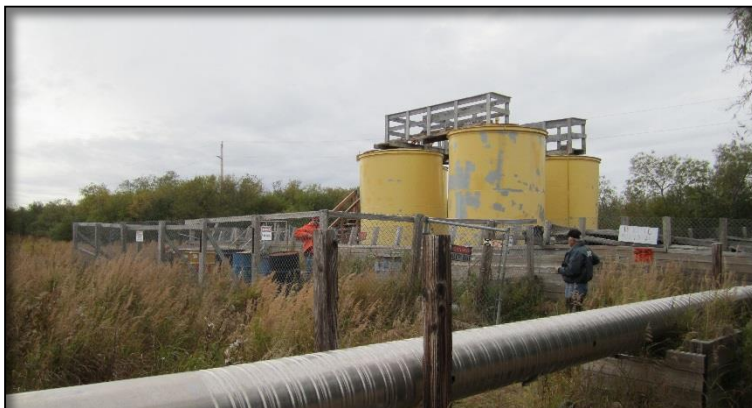
School Tank Farm (ADEC 2012)

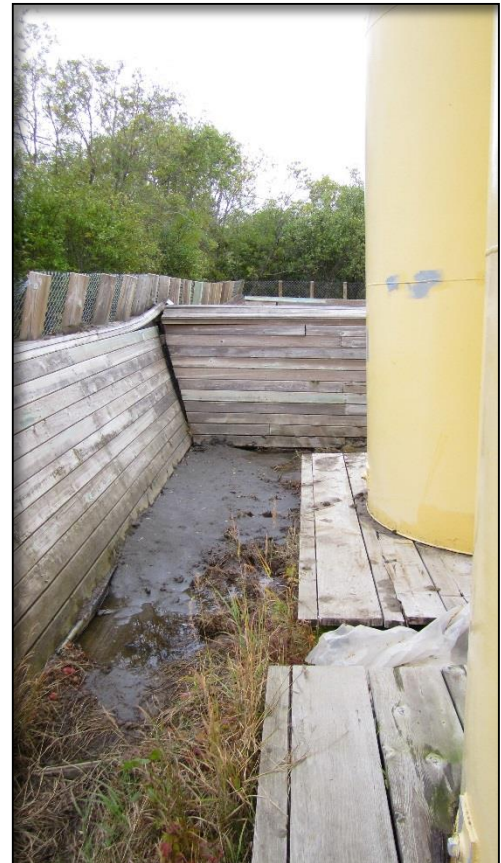
Wooden Fence and Vegetation (ADEC 2012)

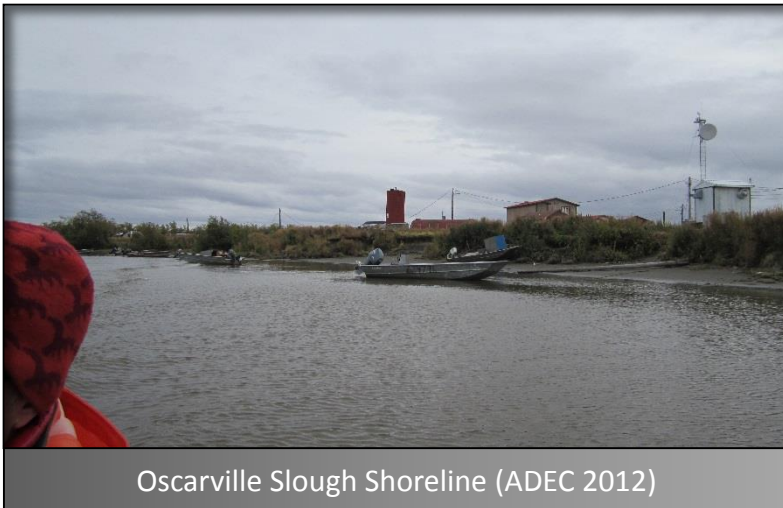
The school tank farm is located 145 feet from the Oscarville Slough that connects to the Kuskokwim River. Community residents report an erosion rate of 3 feet per year. Erosion is primarily caused by river currents and ice jams, with other factors including boat wakes and pedestrian and off-road vehicle traffic on the riverbank. The last known large flood impacting the site was the flood of 1989 that produced state and federal disaster declarations and resulted in the Army Corps of Engineers placing a high water mark on the school to document the event. The riverbanks are comprised of silt, which is more easily eroded than granular soil types such as gravel.

Oscarville Slough Shoreline (ADEC 2012)

Although the school tank farm is not likely to be impacted by erosion in the immediate future, erosion control measures should be investigated for Oscarville Slough. Erosion mitigation may benefit the community, school, and main infrastructure in addition to the tank farm. The slough should also be monitored and yearly erosion rates documented, as storm and flooding events can cause these rates to change.

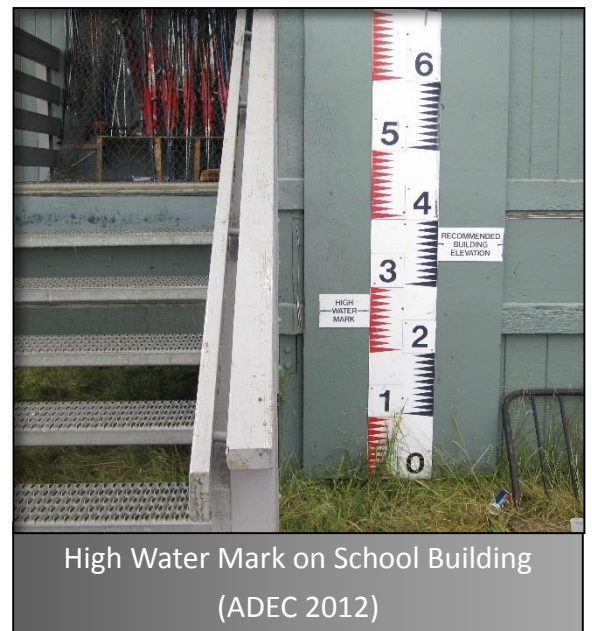
High Water Mark on School Building
(ADEC 2012)

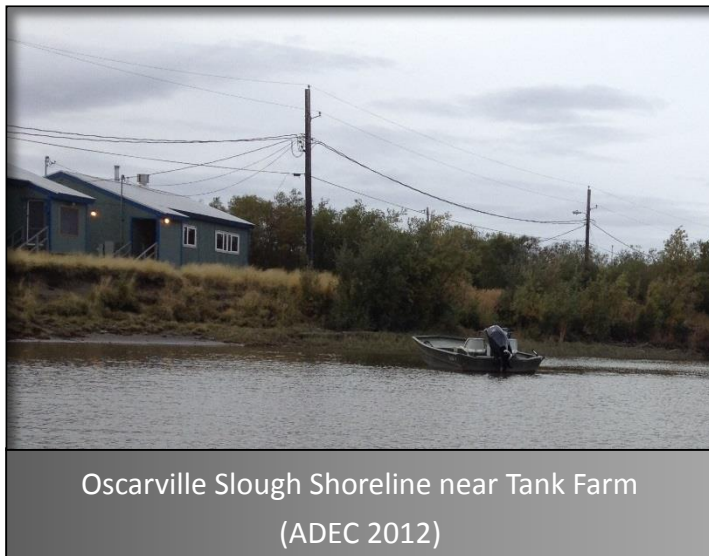
At current erosion rates, the site will be impacted around 2055.

Oscarville Slough Shoreline near Tank Farm
(ADEC 2012)
