**ALASKA DEPARTMENT OF ENVIRONMENTAL CONSERVATION**  
**Division of Spill Prevention and Response**  
**Prevention Preparedness and Response Program**  
***SITUATION REPORT (SITREP)***

## **Bloom Enterprises Fire**

**SITREP #:** 2 and Final

**SPILL #:** 17309912901

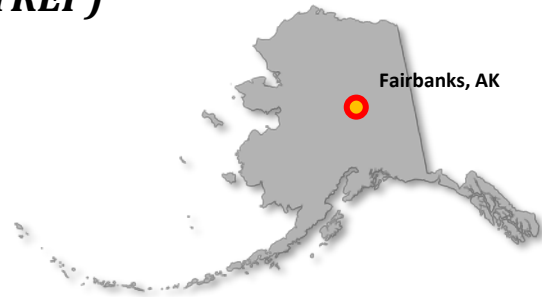
**RESPONSE ACTION:** Initial response actions following source control was conducted by FNSB HAZMAT team and ADEC. Responders recovered pooled product along the side of the 2448 Arvilla Street property using absorbent material, a rope mop skimmer, and a vacuum truck. The vacuum truck was used to remove floating pooled product from standing water and contaminated gravel along the edge of the property. **The majority of the spilled product was pooled adjacent to Arvilla Street, and rope mop skimmers were used to collect the oily mixture. Recovered liquids were stored in a 10,000 gallon storage tank on site for future treatment and disposal.**
