**CONTAMINATION INVESTIGATION REPORT**  
**Fairbanks Townsite, Block 2**

September 13, 2002

**RE: Contamination Investigation Report  
City of Fairbanks Townsite, Block 2**

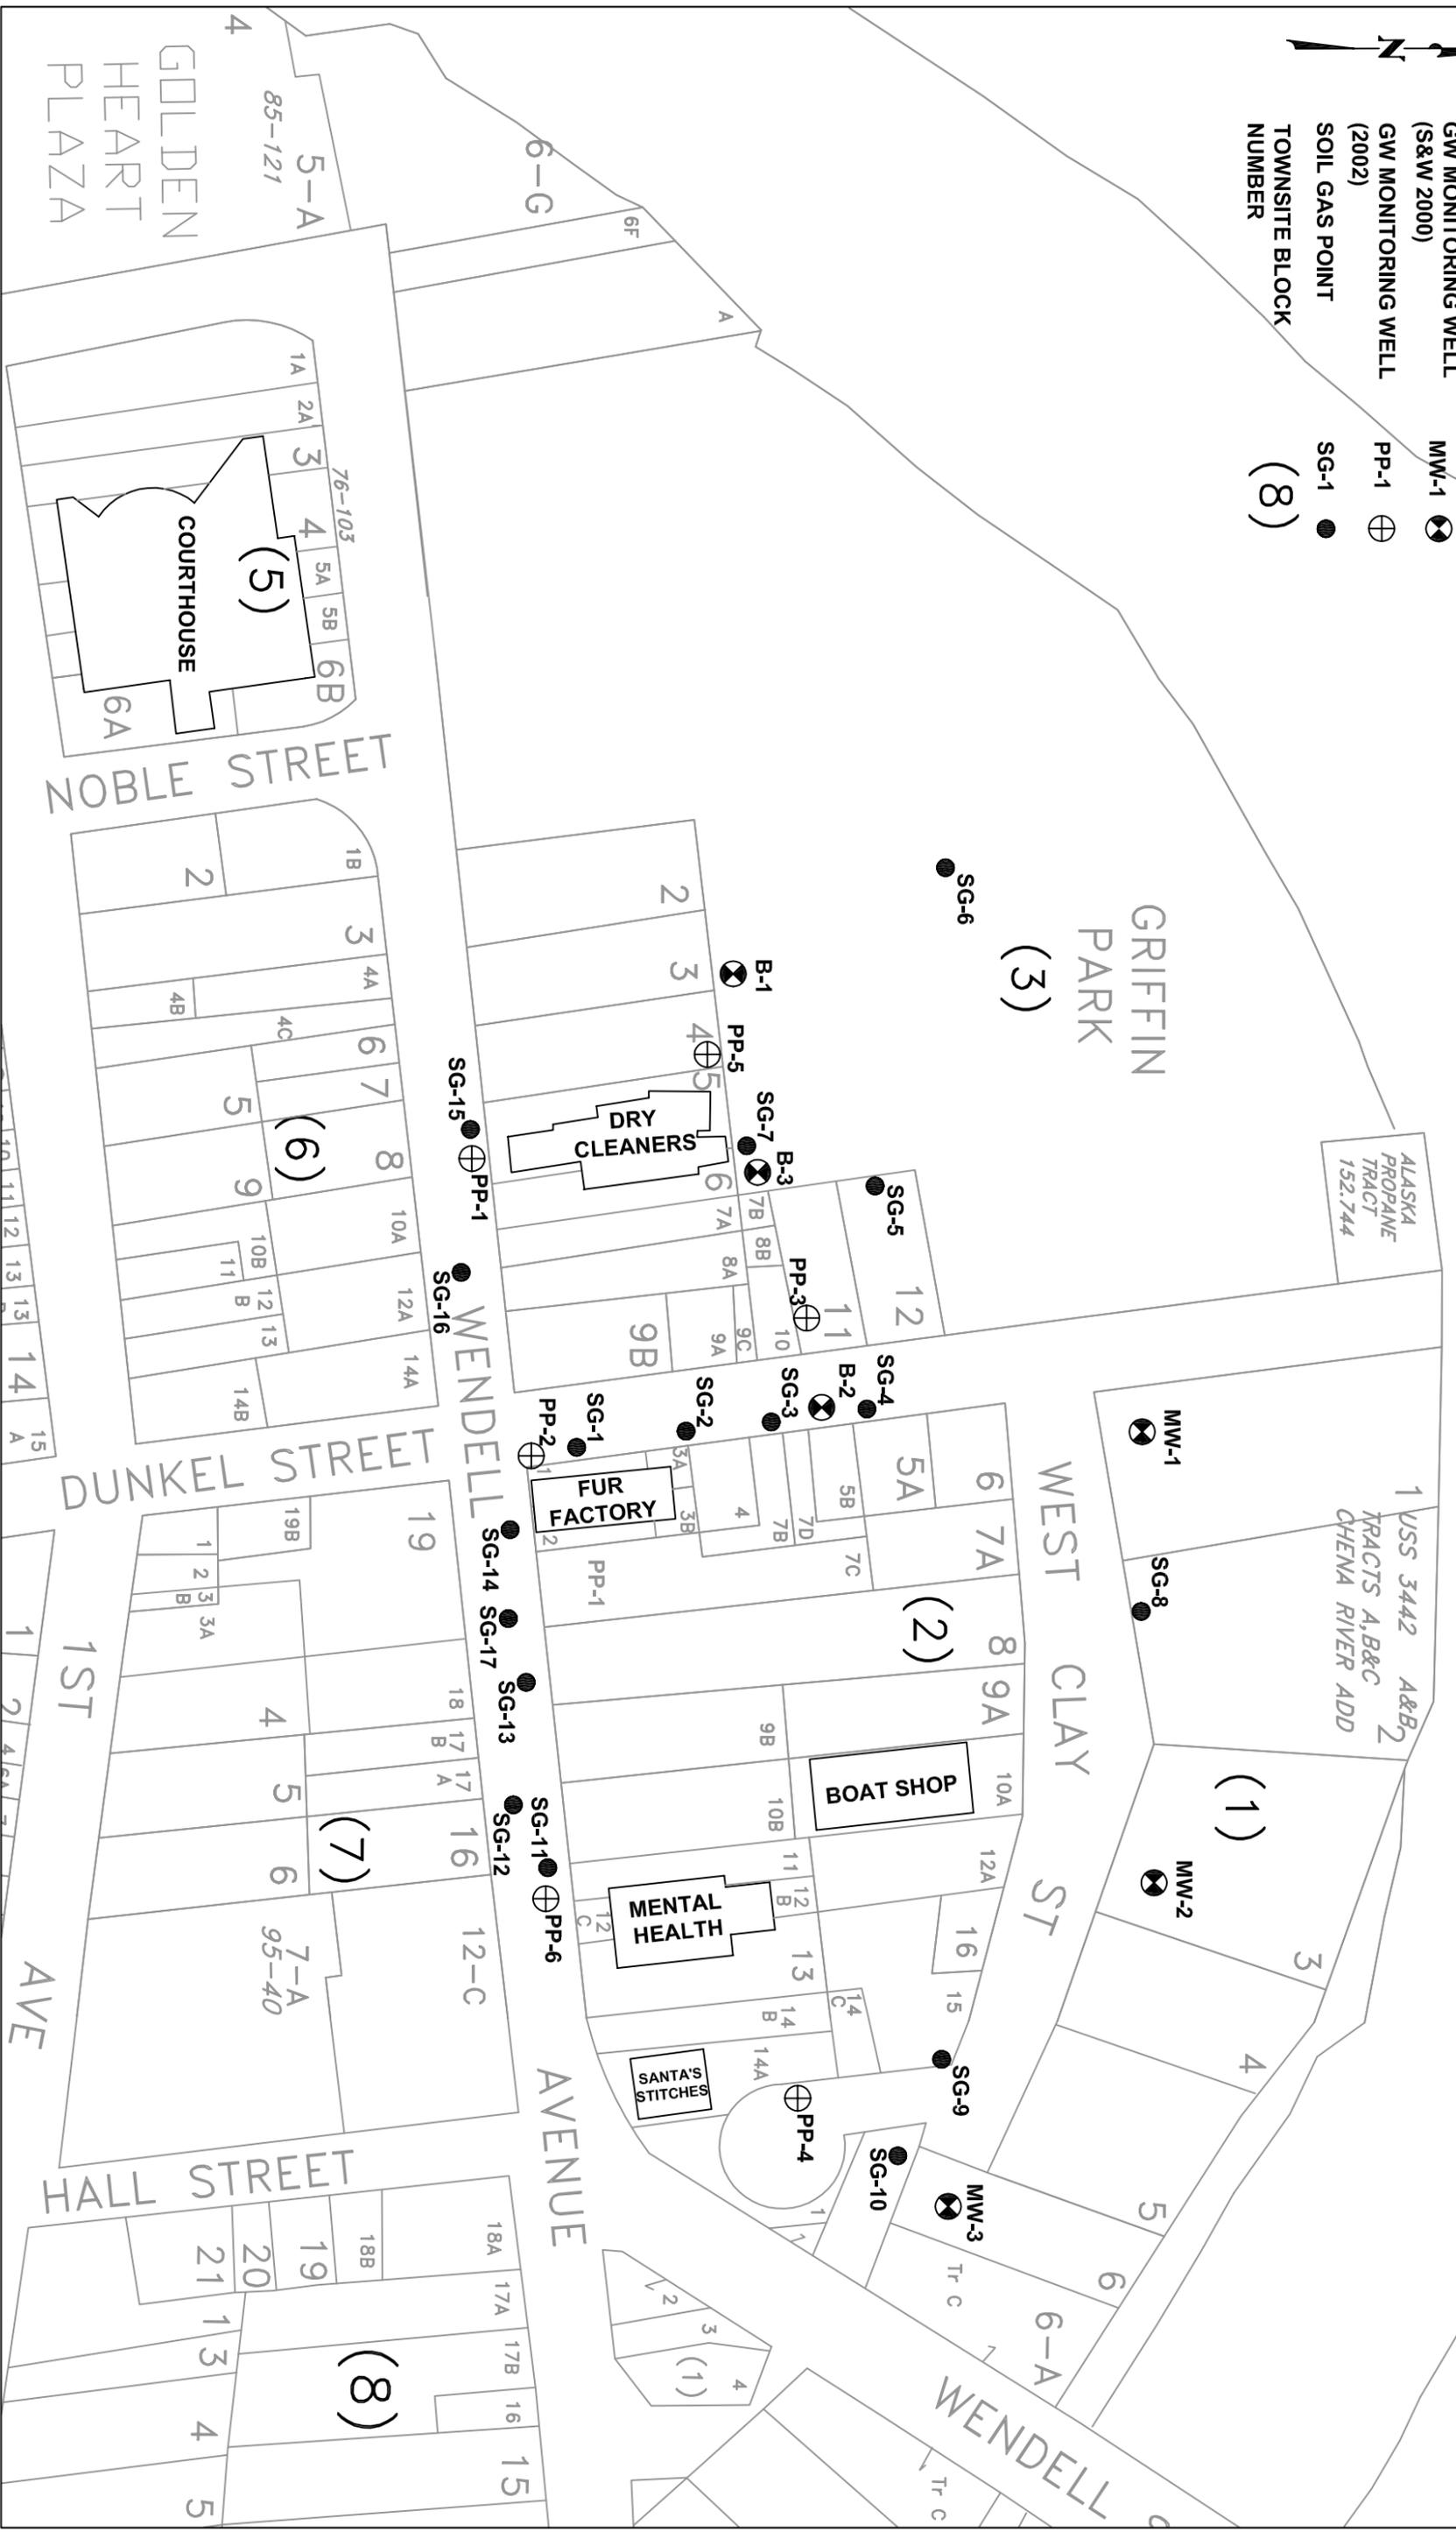
**FIGURE**  
2

Soil-gas results from SG-11, SG-15, SG-16 and SG-17, and groundwater results from monitoring wells PP-1, PP-2 and PP-6 substantiate our suspicion about the underground wood-stave, sewer mainline along Wendell Avenue having carried chemical contaminants. There is good correlation between the field soil-gas data and soil-gas analytical results, and between soil-gas and groundwater analytical results. The seven soil-gas points driven in this street were staggered on both sides of the sewer pipeline in an attempt to assess the sewer line as a potential migration pathway for VOC leakage to groundwater. Of the four samples submitted for VOC analysis from beneath Wendell Avenue, a consistent, descending trend in the magnitudes of PCE, TCE and cDCE is noted as the well locations move eastward from SG-15 to SG-11. SG-15 was located quite near the junction of the sewer service connection to the MC Commercial dry cleaners (Block 3, Lot 5 & 6; in Figure 2). This is in the same proximity as groundwater monitoring well PP-1, where significant concentrations of PCE, TCE, cDCE and VC (vinyl chloride) were detected in groundwater in excess of the ADEC 18 AAC 75.345 GW cleanup levels. For comparison, the magnitude of PCE in groundwater at monitoring well PP-2, located about 175 feet up-gradient of PP-1, was 35 times less. PCE and TCE contamination in groundwater at monitoring well PP-5 (Block 3, Lot 4; in Figure 2) is similarly an order of magnitude less than that encountered in monitoring well PP-1.

ADEC is investigating VOC groundwater contamination in the area. We recommend sharing findings in this report with ADEC in support of its efforts to delineate local groundwater contamination.

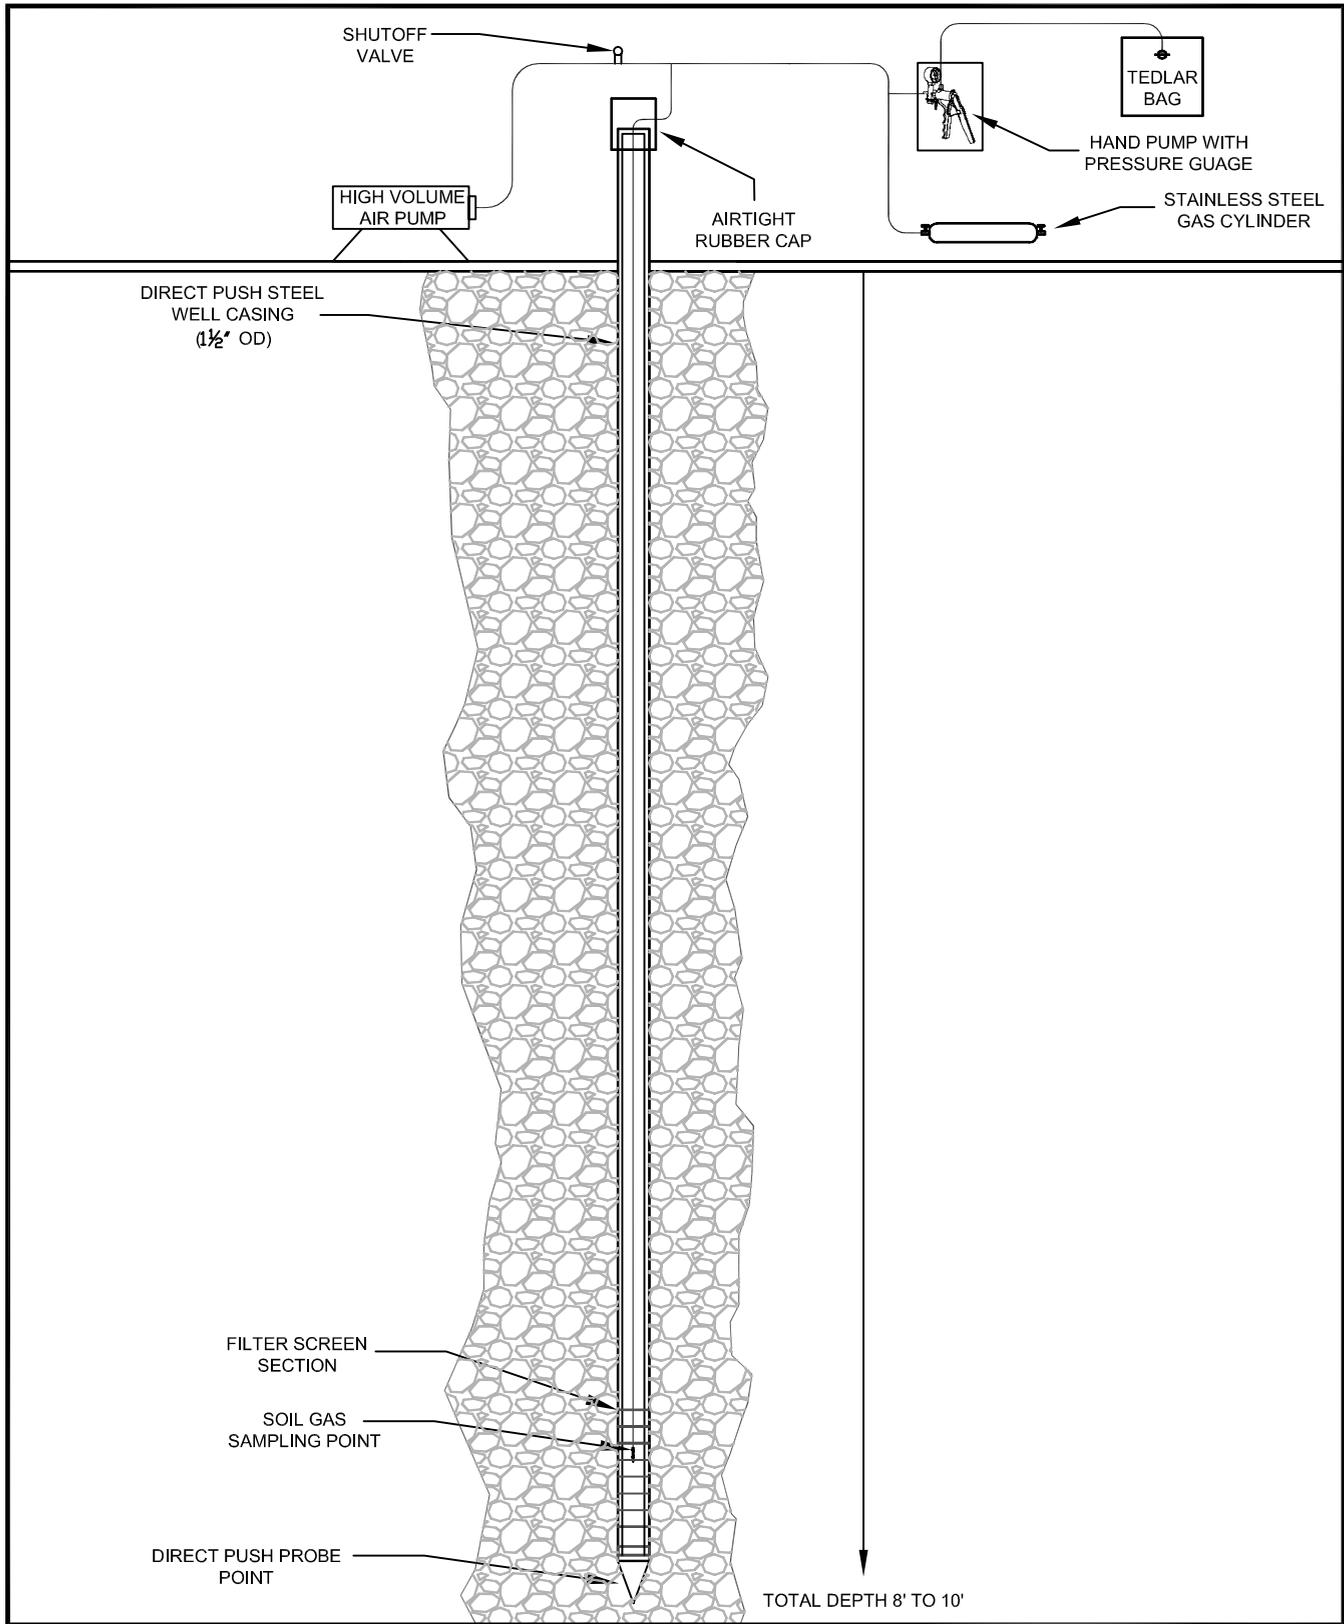
FIGURE  
3

Figure 3 illustrates the soil-gas sampling methodology. The above-ground piping stick-up of the temporary soil-gas points was retrofitted with a rubber seal configured with poly-tube insert for vacuuming and sampling. After the sampling tube is sealed, a vacuum pump applied to the well created negative pressure inside the well. This procedure removed stagnant air inside the well chamber, allowing it to refill with soil gas from the screened interval depth. At the sampling port, a hand pump and Tedlar® bag were used to collect a field-screening sample. An RAE PGM-7240 ppb-VOC gas monitor was used to measure total volatile organics in the field-screened soil gas samples. For analytical samples, silicon tubing was connected to one side of a stainless steel gas cylinder and the vacuum pump to the other side for drawing soil gas into the cylinder from a well. The gas cylinders were sealed with stop-cock valves at both ends; labels were attached for sample identification and logging. Soil-gas samples were listed on a Chain-of-Custody form and routed through CT&E Environmental Services, Inc (CT&E) to Air Toxics, Limited (AT), a certified NELAP (National Environmental Laboratory Accreditation Program) laboratory in Folsom, California.

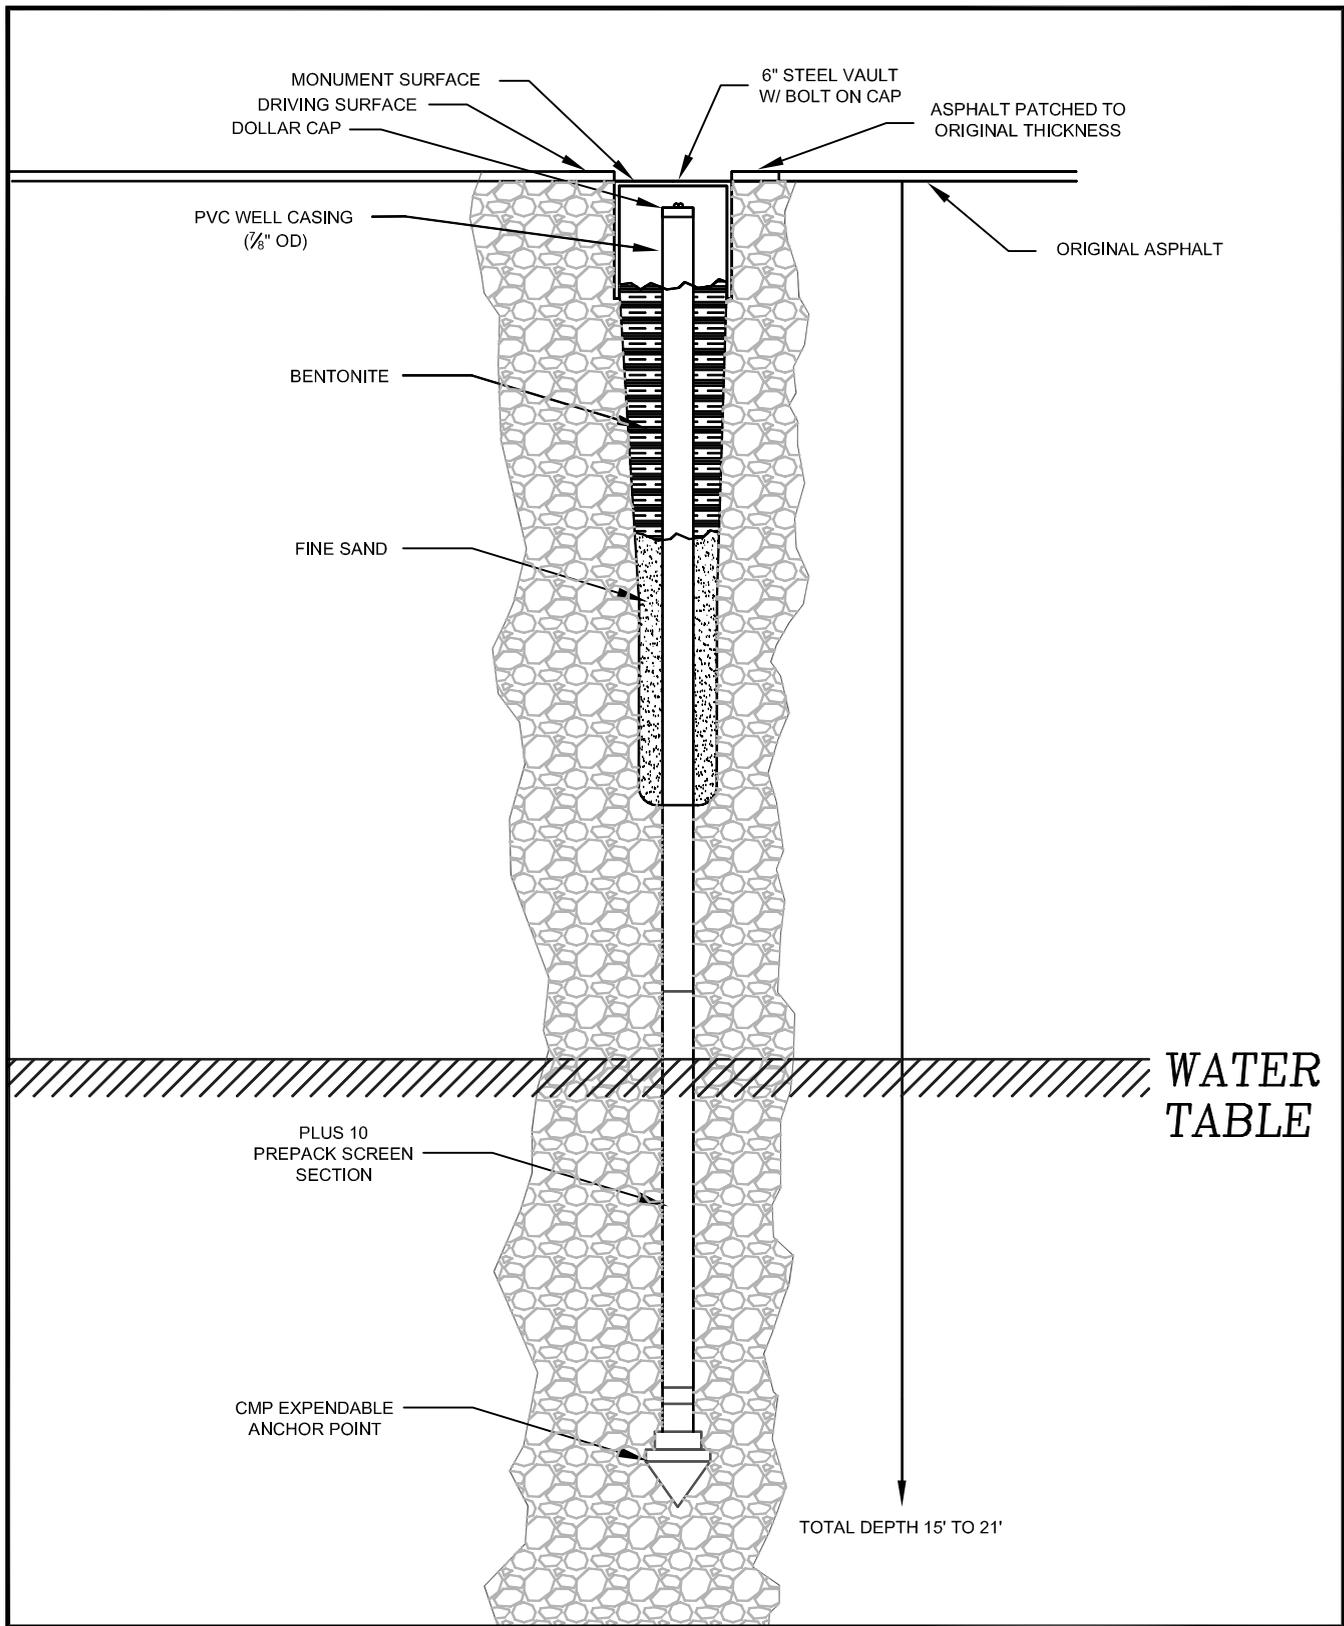
FIGURE  
4

Each of the six groundwater monitoring wells were constructed with a 7/8-inch PVC casing above a screened interval; wells PP-1 through PP-4 each have a 5-foot screened interval and wells PP-5 and PP-6 have 10-foot screened intervals. Well depths are ±15 feet and ±20 feet below grade. Figure 4 illustrates the typical direct-push, flush-mount monitoring well construction. The annular space above a prepack well screen was backfilled with fine sand beneath a bentonite plug. Five of the wells were completed as flush-mount installations, complete with a well monument and a locking cap. The well monuments are recessed below grade about ½-inch. Monitoring well PP-5, located inside fenced property, was completed with a 3-foot stick-up monument for easy location despite snow cover buildup. The wells were purged and developed to remove silt and other debris shortly after installation. Approximately 20 gallons of purge water was captured in a drum for treatment through our dual-phase extraction unit with air-stripper, and subsequent disposal at Golden Hearts Utilities.

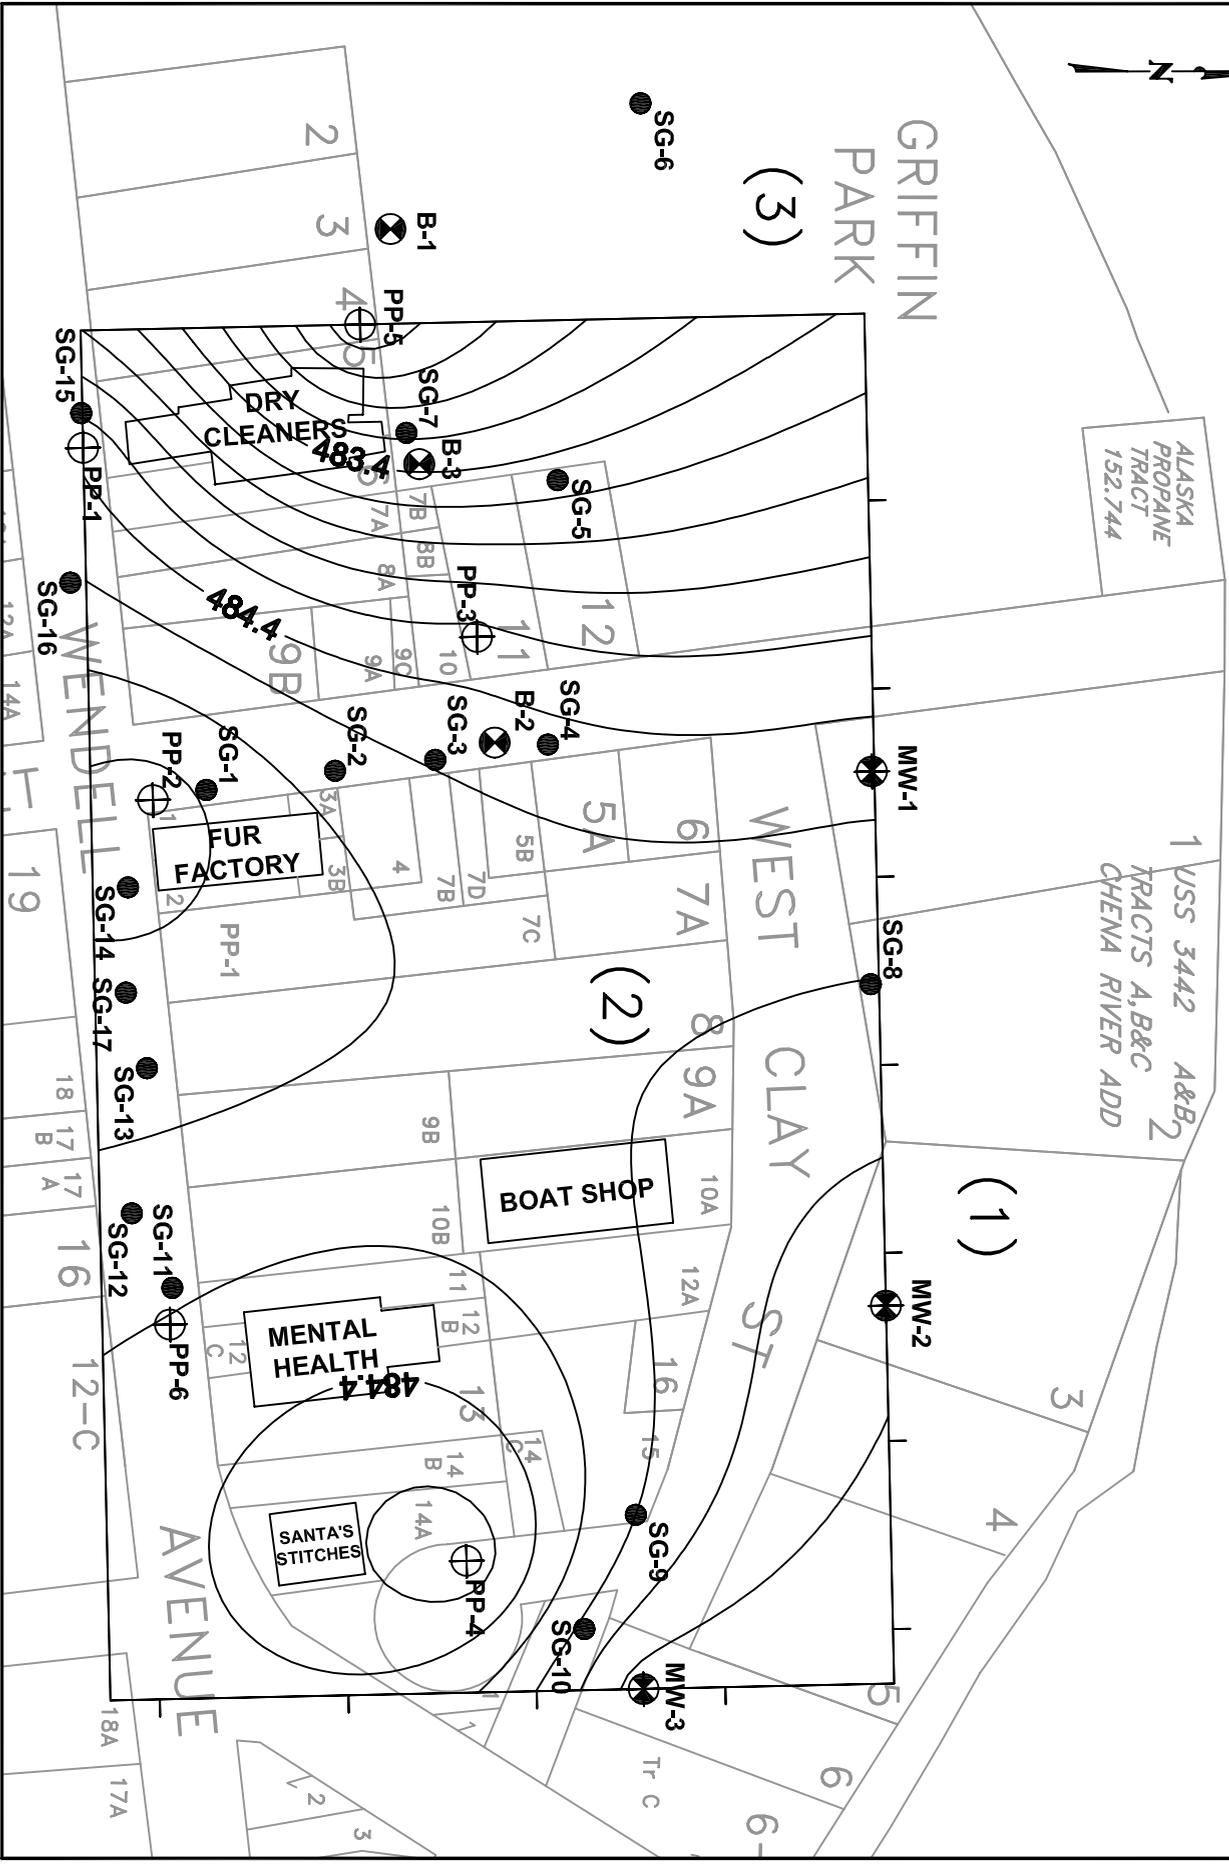
GROUNDWATER CONTOURS  
 CONTAMINATION INVESTIGATION  
 BLOCK 2, FAIRBANKS TOWNSITE

In the presence of a small or shallow groundwater gradient (or for low-rate groundwater movement) over time, the highest PCE concentrations in groundwater can be expected beneath a source, with depth. Lateral migration in groundwater would generally be down-gradient. However, groundwater reversals (consequence of flooding, ice jamming, or local dewatering events) or transport through a wood-stave sewer pipeline in this case, can lead to PCE detection in groundwater up-gradient of a source. In our opinion, the collective soil gas and groundwater results support the hypothesis that the MC Commercial sewer outfall has been a likely source for VOC contamination of the local groundwater. We have used the words "has been" because the clear presence of PCE daughter products and their reported concentrations in groundwater suggests old or weathered PCE contamination. This does not preclude VOC saturation of the wood-stave pipeline and gradual release of new contamination. Regardless, the ultimate source of the encountered VOC contamination in groundwater is apparently off-site and west (down-gradient) of Block 2.
