APPENDIX A

Aircraft Arresting System (Site ID AAS3)

Preliminary Assessment Report
Former Galena Forward Operating Location, Alaska

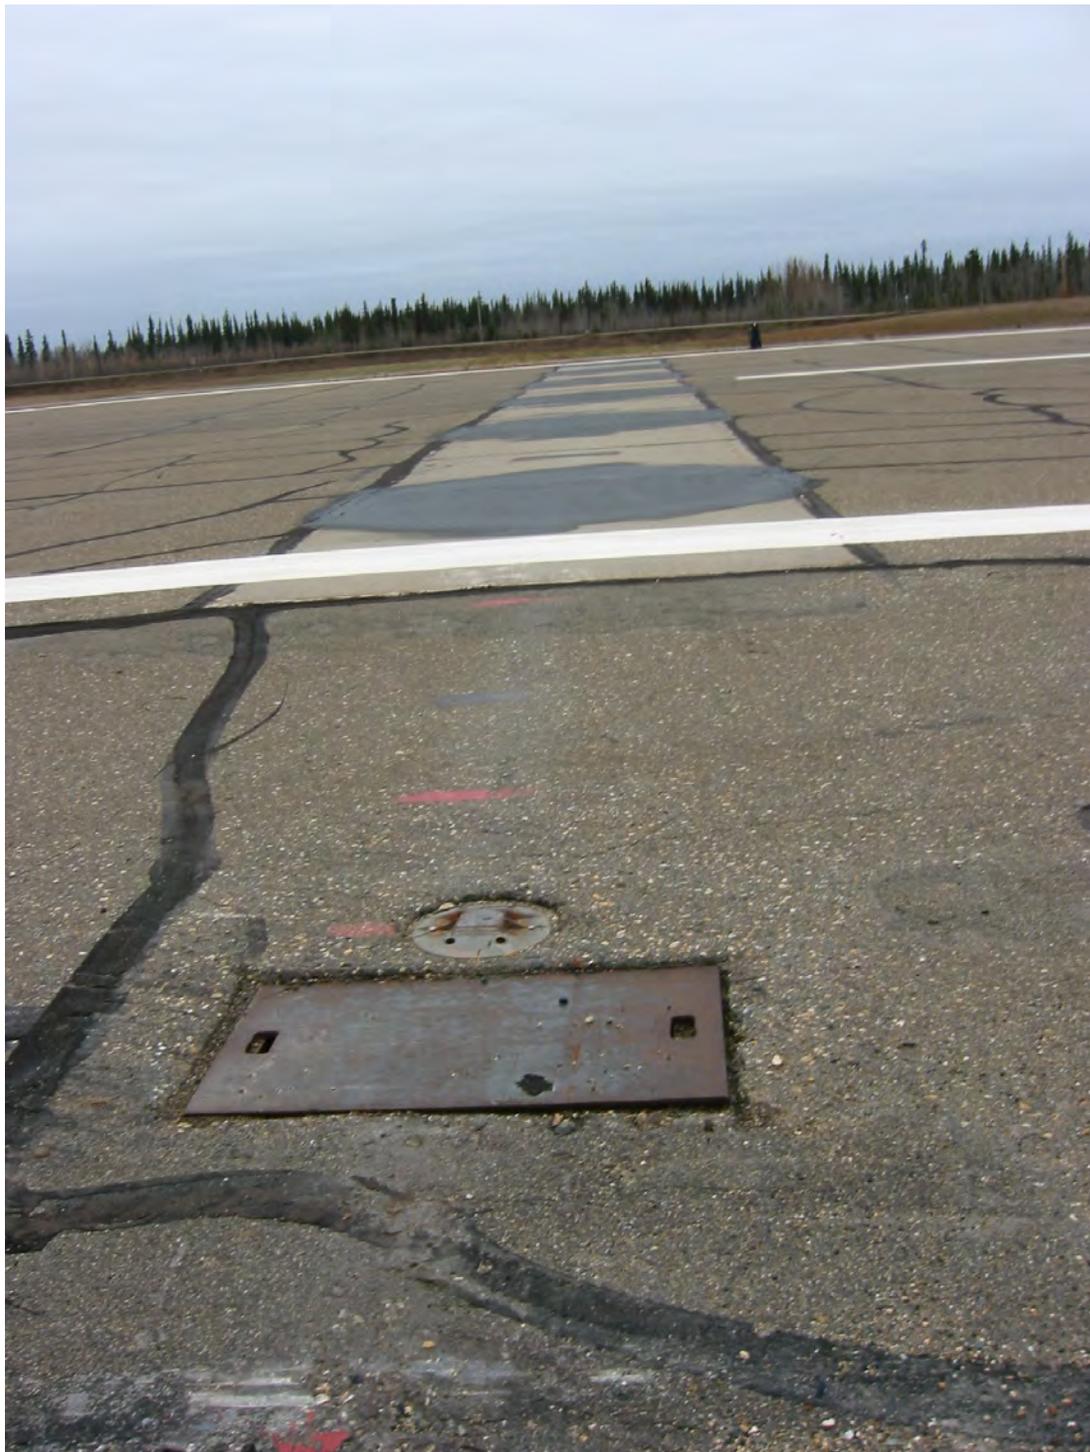
The AAS was removed in 2007. USAF personnel who removed the AAS stated that the vaults where the main equipment was housed were demolished by breaking up the concrete in the vaults and filling them in with clean soil. Associated small vaults that allowed access to the electrical lines that provided power for the AAS equipment are still intact, located adjacent to the runway markings that indicated the location of the AAS. The patched runway following the removal of the AAS is shown in Figure A4-AAS3.

An inspection of Site AAS3 was conducted in October 2009. Black patched circles were observed on the tarmac where the AAS wire used to go. Two sets of small vaults were observed on each end of the runway and electrical wires were observed inside the vaults. No evidence was found that would indicate a potential release from Site AAS3.

FIGURE A4-AAS3
Patched Runway Following the Removal of the Aircraft Arresting System and Concrete Vault, October 2009

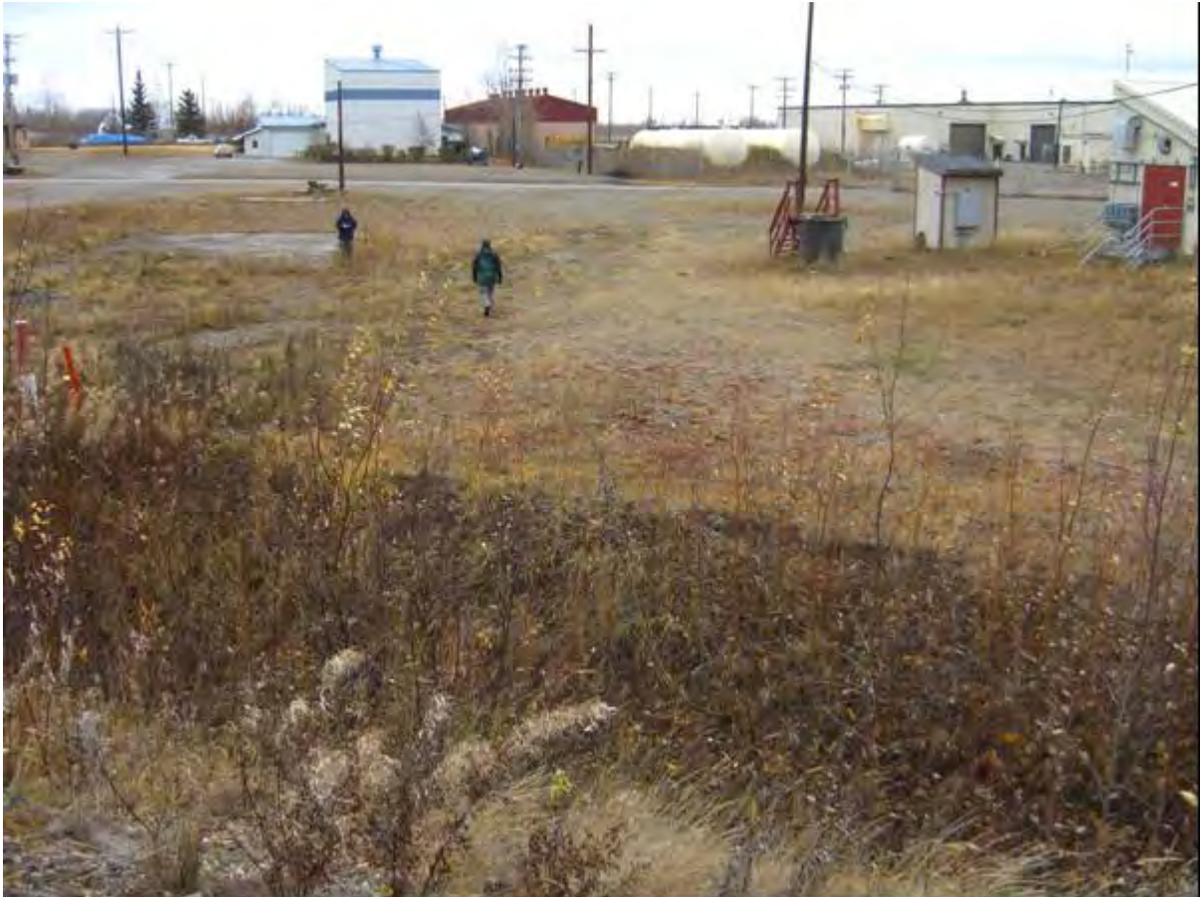
An inspection of Site AOC023 was conducted in October 2009. A photograph of the site in October 2009 is provided in Figure A4-AOC023. The surface of the site was observed to be pavement and gravel. No observations regarding odors or staining were recorded. No viable ecological habitat exists at the site.

FIGURE A4-AOC023
Site AOC023, October 2009

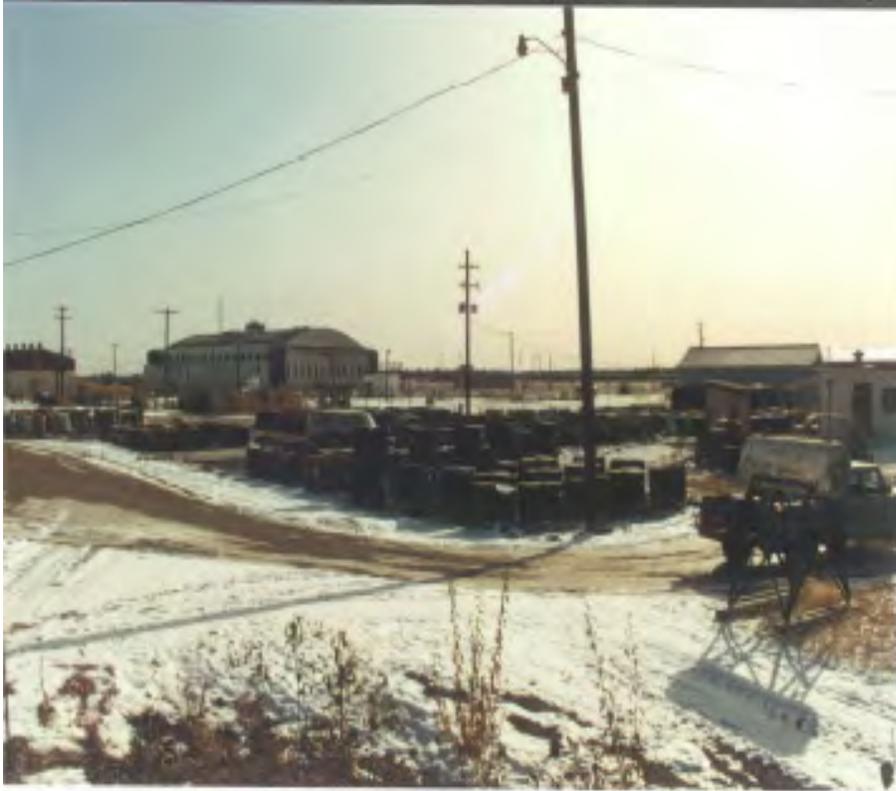
Figure 1. Waste Accumulation Area, looking southeast. (Sept. 24, 1992). AST can be seen at the right side of photo. (Source: Woodward-Clyde Consultants, July 1993)

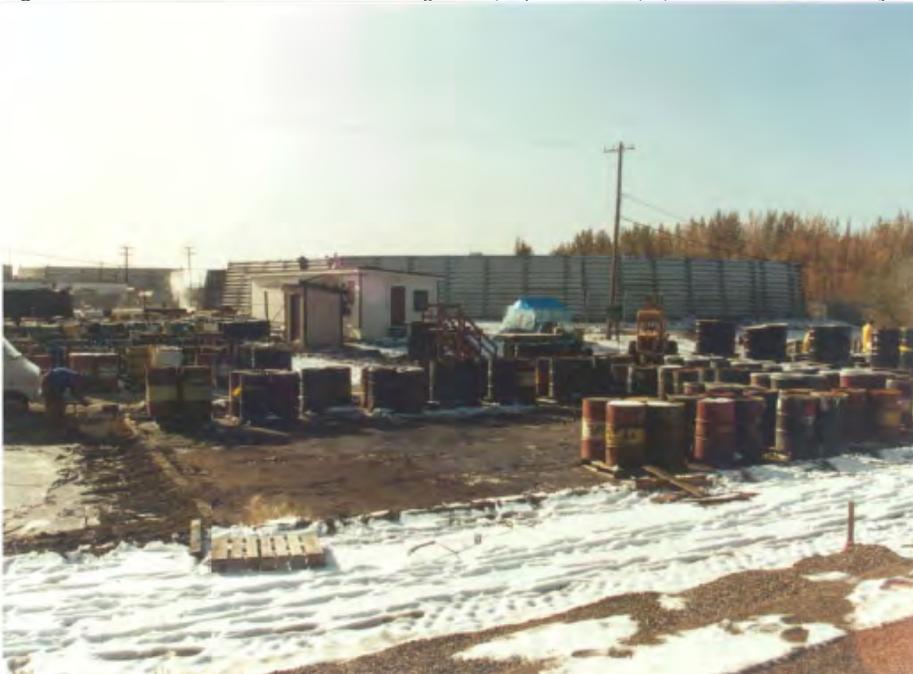
Figure 4. Waste Accumulation Area, looking southwest (Sept. 24, 1992). Concrete pad can be seen in the front portion of the photo. (Source: Woodward-Clyde Consultants, July 1993)

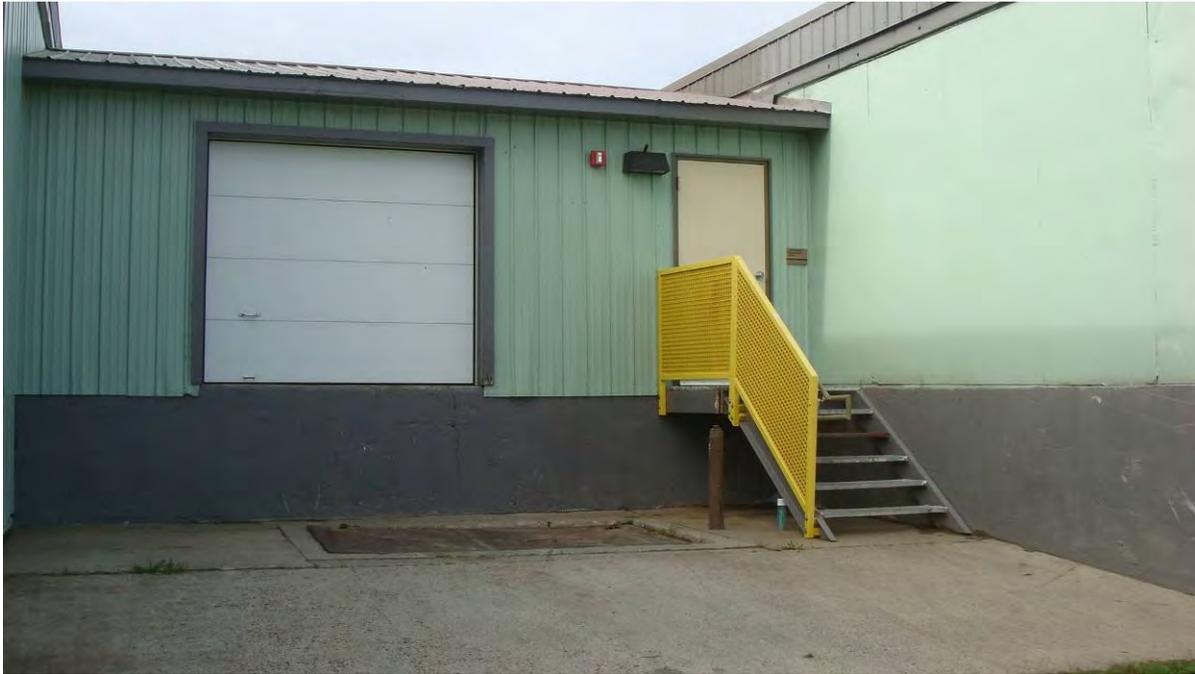
FIGURE A3-B1859 GREASE TRAP
Site B1859 Grease Trap Facing Southwest, July 2011

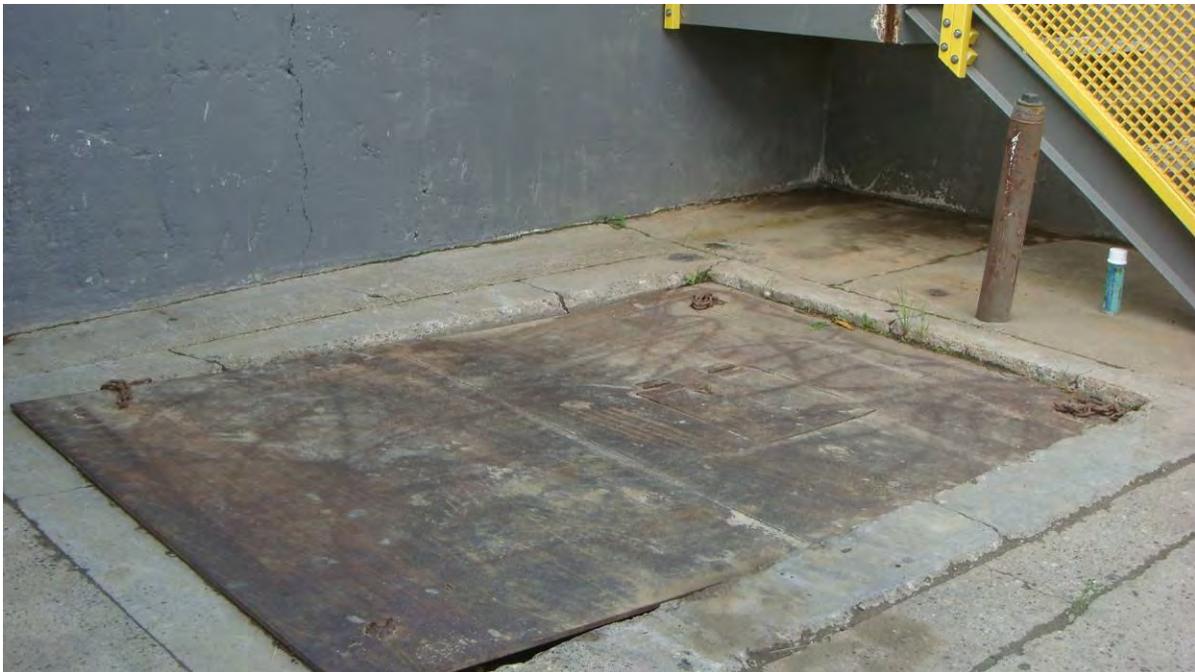
FIGURE A4-B1859 GREASE TRAP
Site B1859 Grease Trap Close Up, July 2011

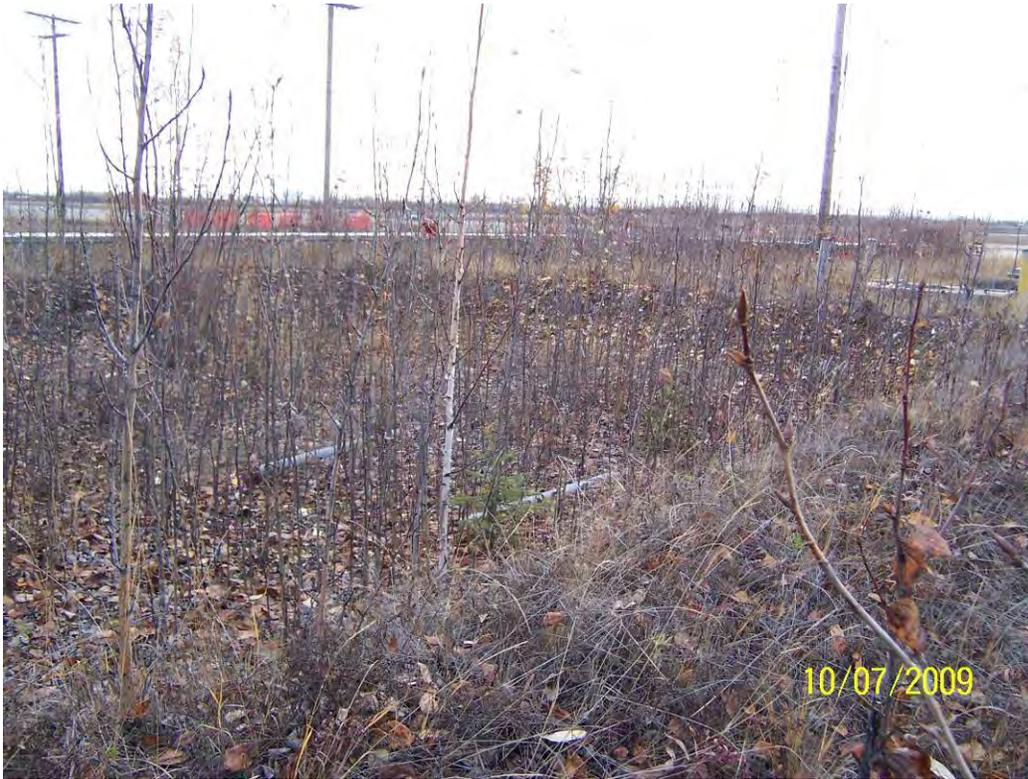
FIGURE A3-BERM

An inspection of Site BERM was conducted in October 2009. The ground surface near Site BERM was observed to consist of saplings (such as balsam poplar) and grass surrounded by pavement and gravel (see Figure A3-BERM). A utility vault was observed approximately 50 feet south of the berm. No surface staining or petroleum odors or visual signs of ecological impact or acute toxicity were observed. No evidence was found that would indicate a potential release for an aboveground diesel tank.

Soil Berm, North of Former Birchwood Hangar Building 1551, October 2009

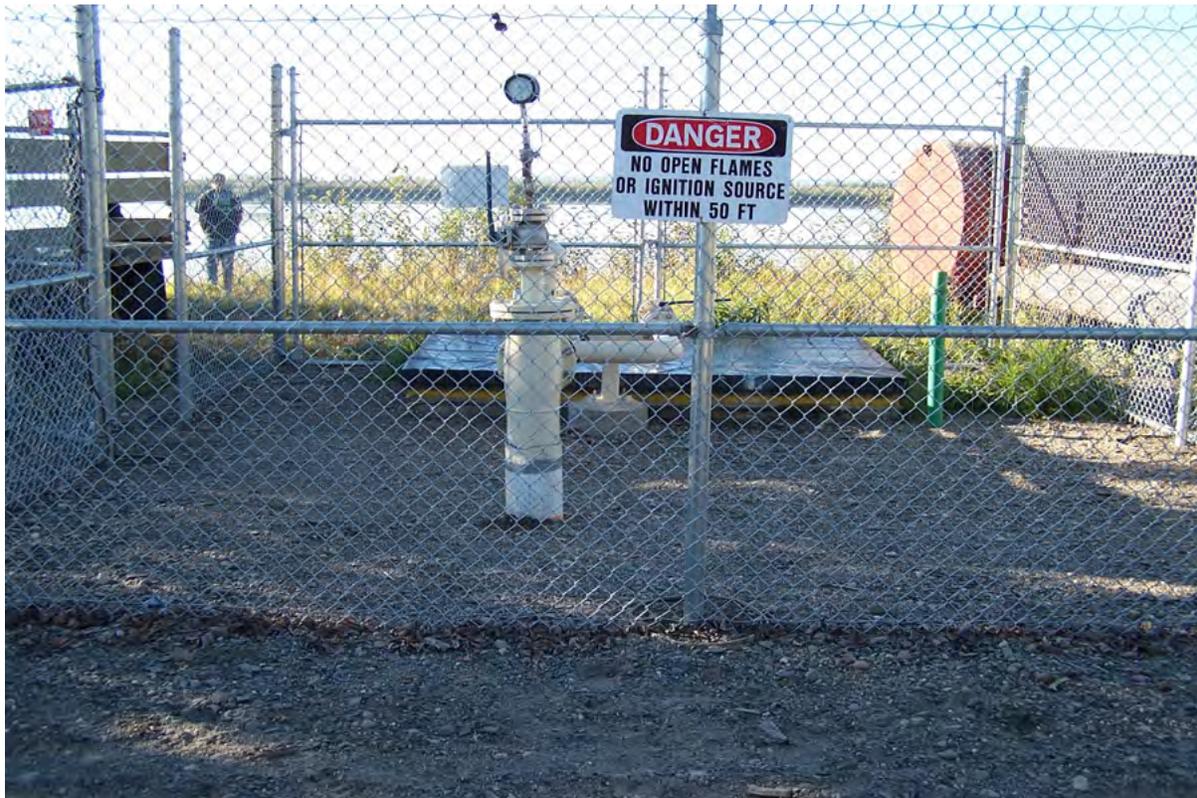
FIGURE A3-BLA
Fenced Barge Landing Area Looking Southwest
Source: USAF, May 2008, Photo 97
