ADOT&PF SOLDOTNA MAINTENANCE STATION

[View detailed information from the database on this site.](#)
Database Name: ADOT&PF Soldotna Maintenance Station

Status: Cleanup Complete

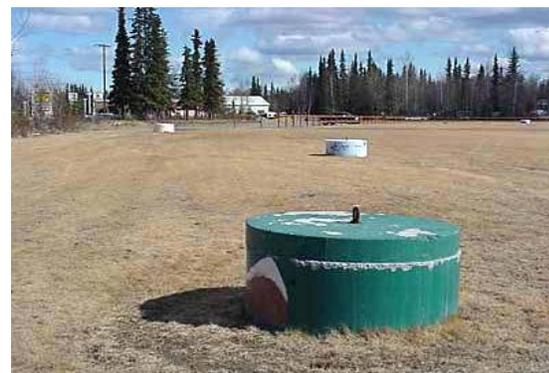
The former ADOT&PF maintenance yard is now a grassy park. Painted cement cylinders covering monitoring wells also provide seating for park users. (DEC photo, 4/03)

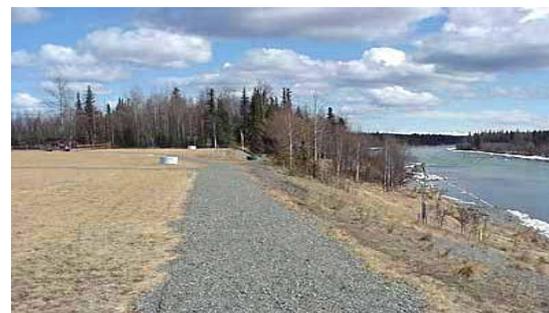
Pathway in the park skirts the edge of the bank above the Kenai River. Additional monitoring wells are visible in the distance. (DEC photo, 4/03)
