**Greater Kuparuk Area (GKA)
Alpine Field
Corrosion Programs Overview**

April 1, 2004

Commitment to Corrosion Monitoring
4th Annual Report to the Alaska Department of Environmental Conservation

**Prepared by
ConocoPhillips Corrosion Team**

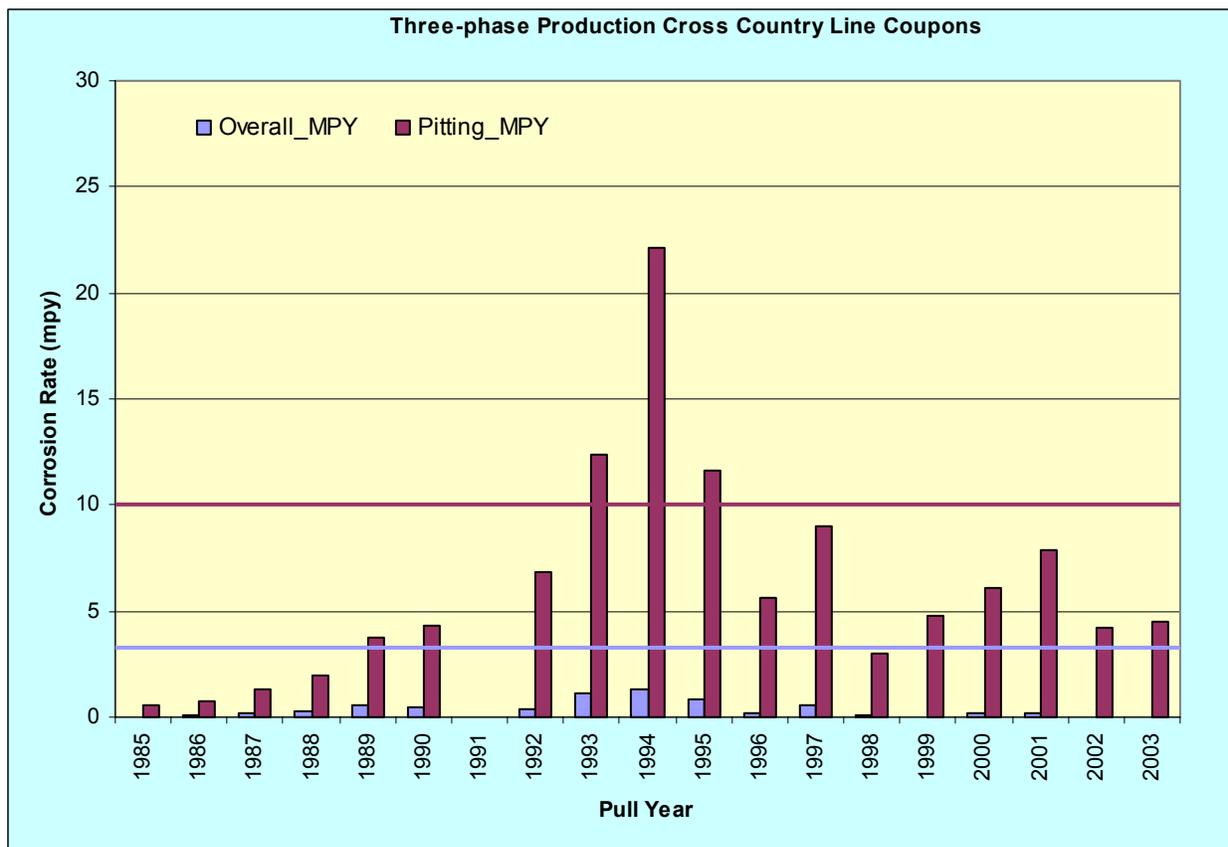
Figure 1. Three-phase Production Cross-Country Line Coupons – general and pitting corrosion rates as a function of time.

Three-phase Production Cross-Country Lines: The monitoring data summarized in Kugaruk Tables 1 and 2 and presented in Figure 1 suggest that general corrosion is under control. The data presented in the Tables 1 and 2 and in Figure 1 include corrosion coupon data from the wet oil lines starting at CPF3 and going to CPF1 and CPF2.

Recurring CRM inspections also support the conclusion that corrosion is under control in the three-phase production cross-country lines. In 2003, 584 corrosion-rate monitoring (CRM) inspections were conducted, with five minor increases found (i.e. less than 1% of total CRM inspections resulted in an increase). Other internal inspection data also support the CRM data conclusions and are discussed in section 3.1.c, below.

In 2003, the 16-inch CPF3-to-CPF1 Wet Oil Line showed coupon pitting corrosion rates above the threshold of 10 mpy; actual inhibitor concentration was verified and adjusted based on coupon results. Additionally, later in the year this line experienced a lower water cut and the corrosion inhibitor concentration was adjusted.

Where corrosion rates exceeded targets, corrosion inhibitor concentrations were increased and/or the amount of inspection was increased. In 2003, coupon or probe corrosion rates exceeded targets on 17 lines and action was taken on all 17 of these lines. In 2003, inspection results indicated minor corrosion had occurred on five lines; corrosion inhibitor concentrations were increased in all five of these lines. A complete listing of the 22 lines with coupon/probe corrosion rates that exceeded targets or where inspection indicated increased damage, is given Table A1 of Appendix A.

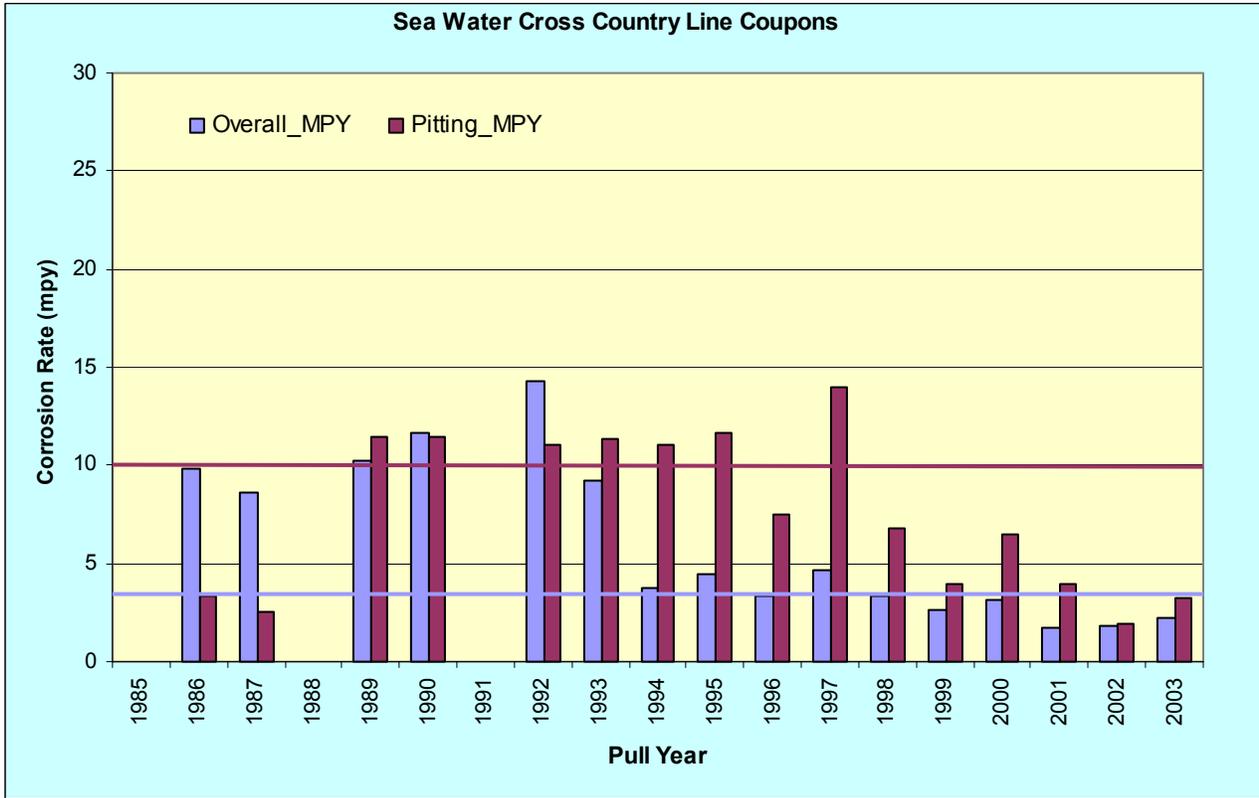
Figure 2. Seawater Cross-Country Line Coupons – general and pitting corrosion rates as a function of time.

Sea Water Cross-Country Lines: The monitoring data summarized in Kuparuk Tables 1 and 2 and presented in Figure 2 above, shows the average corrosion rates for the sea water cross-country line coupons remained under thresholds in 2003. The coupon location on the 30" STP discharge line showed general corrosion rates above threshold in 2003. This is likely due to short term increased dissolved oxygen levels, the origin of which is under investigation.

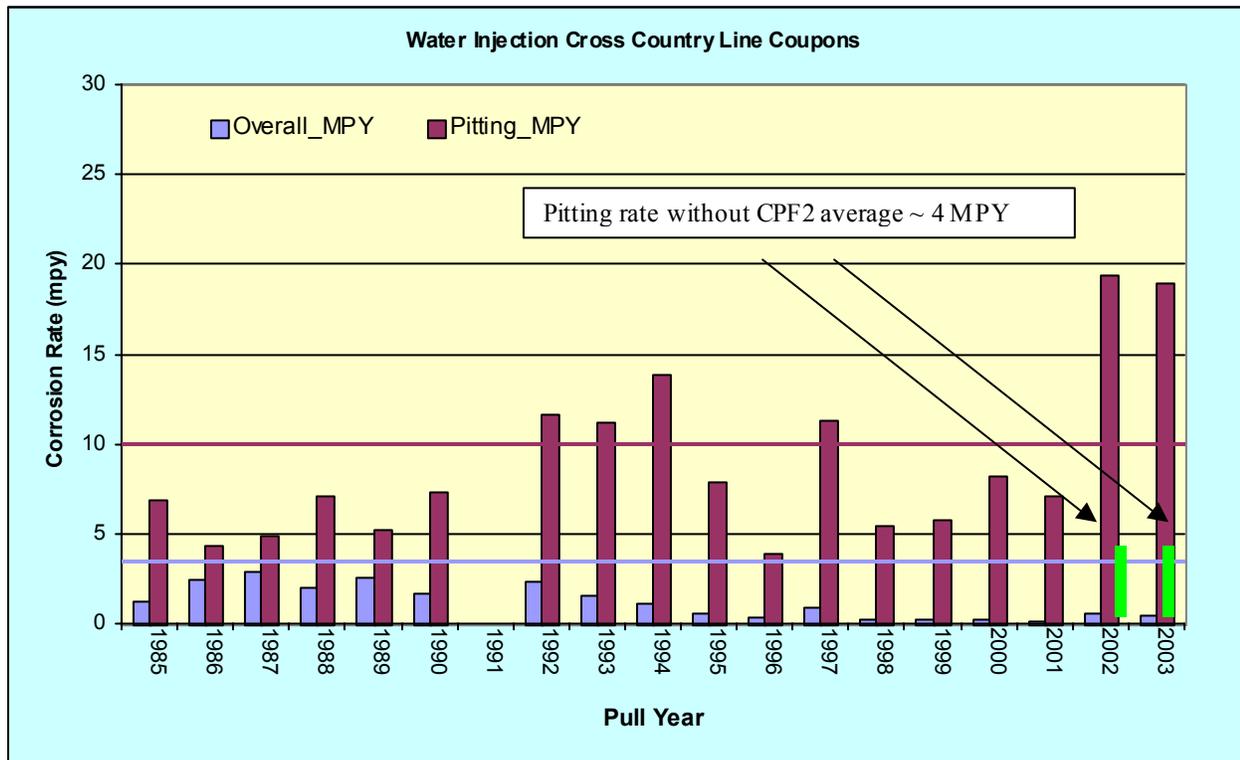
Figure 3. Water Injection Cross-Country Line Coupons – general and pitting corrosion rates as a function of time.

Mixed Water Injection Cross-Country Lines: The monitoring data summarized in Kugaruk Tables 1 and 2 and presented in Figure 3 show that average general corrosion rates are below the threshold, but that pitting rates for the field are above the threshold. Closer analysis of the data shows that the average pitting rate excluding CPF2 locations is well under the threshold. Recent inspection data from the CPF2 lines show some damage on three lines. This information, along with coupon results, was used to prioritize 2003 inspection efforts. RTR inspection performed in 2003 included 23,099 feet on 28 cross-country water injection lines. A review of the CPF biocide programs has been conducted and new treatment procedures are in place.

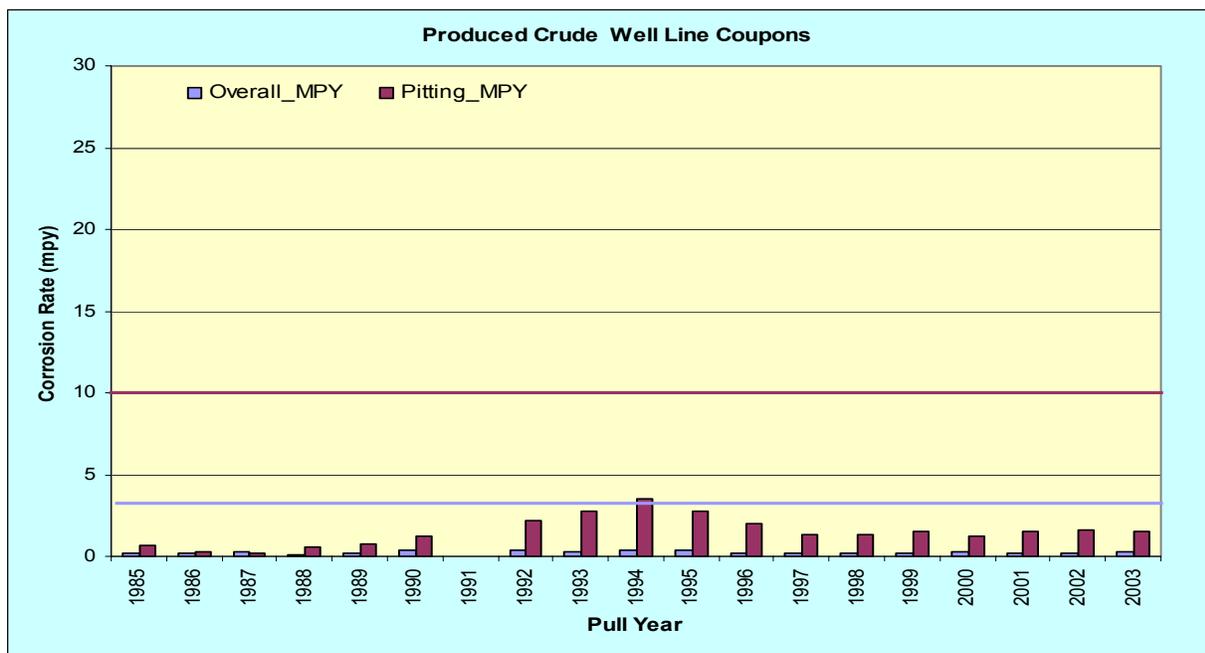
Figure 4. Three-phase Production Well Line Coupons – general and pitting corrosion rates as a function of time.

Three-phase Production Well Flow Lines: While the monitoring data summarized in Kugaruk Tables 1 and 2 and presented in Figures 4 and 5 suggest that corrosion rates are below targets, inspection data indicate that higher corrosion rates have been experienced historically. The well line inspection data are discussed in section 3.1.b below, and are a good example of why monitoring data alone cannot be relied upon to characterize corrosion in a given system. For three-phase production, coupons monitor free flowing fluid and have not shown the predominant, under-deposit corrosion mechanism.

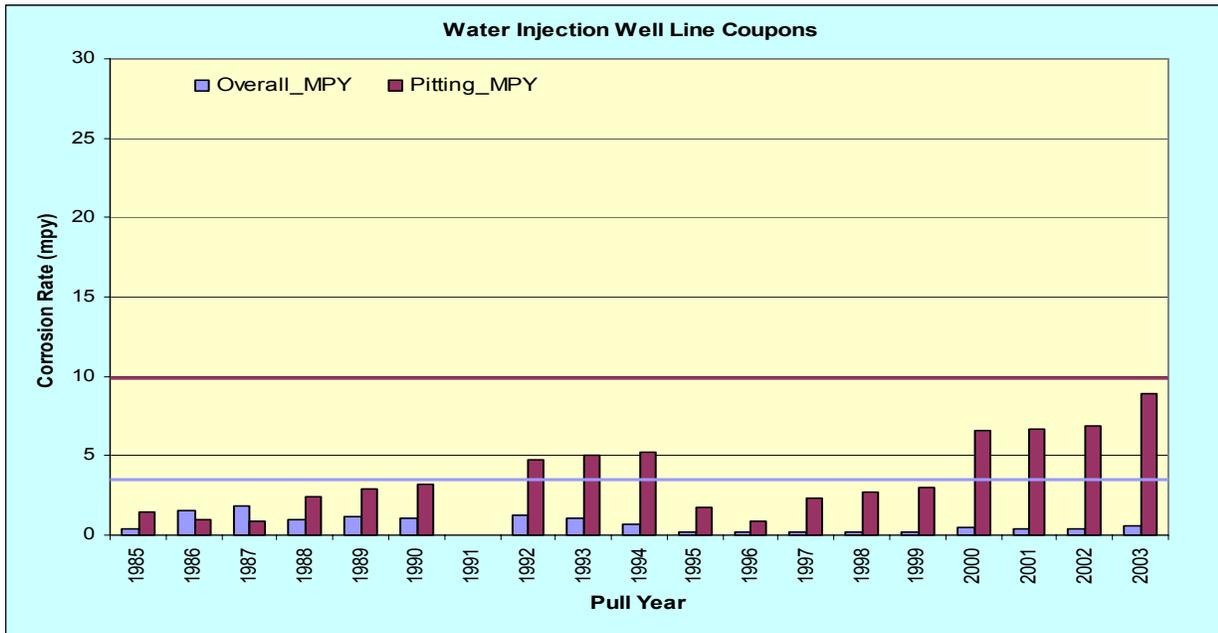
Figure 5. Water Injection Well Line Coupons – general and pitting corrosion rates as a function of time.

Water Injection Well Flow Lines: There is an increasing trend in the coupon pitting rates. As discussed in section 3.1.b below, the well line inspection data on water injectors show that there are a significant (22) and an increasing number of corrosion related repairs.

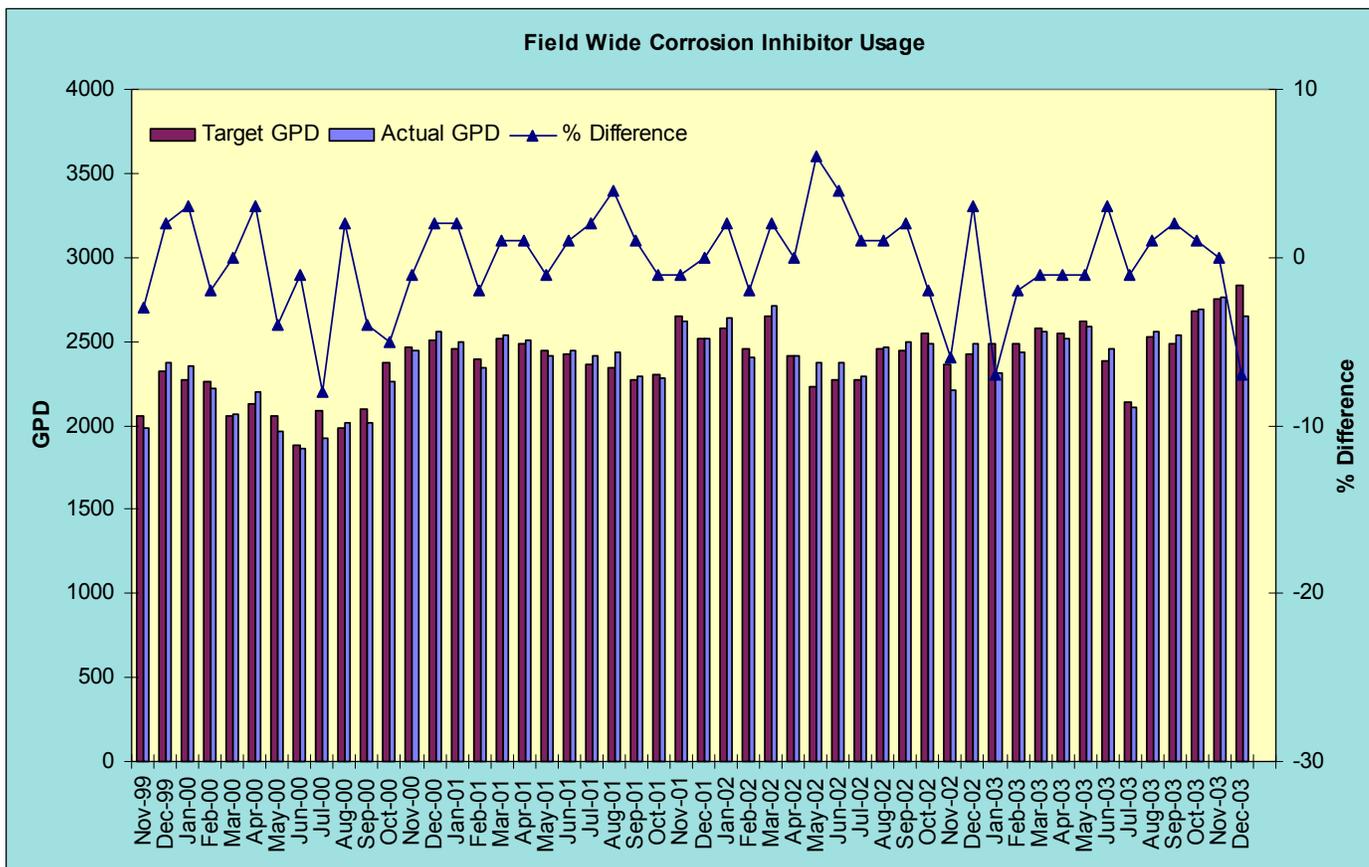
Figure 6. Field-wide Corrosion Inhibitor Use.

For the Kuparuk field, Figure 6 shows the actual number of gallons of corrosion inhibitor pumped per day, the recommended number of gallons of corrosion inhibitor per day, and the percent difference between the two. The difference fluctuated around zero percent deviation from the recommended amount of corrosion inhibitor; the average deviation for the year was -1.0% . The larger variation seen in the December 2003 data was caused by the extreme weather that caused delays in routine pump rate checks and refilling of chemical tanks.

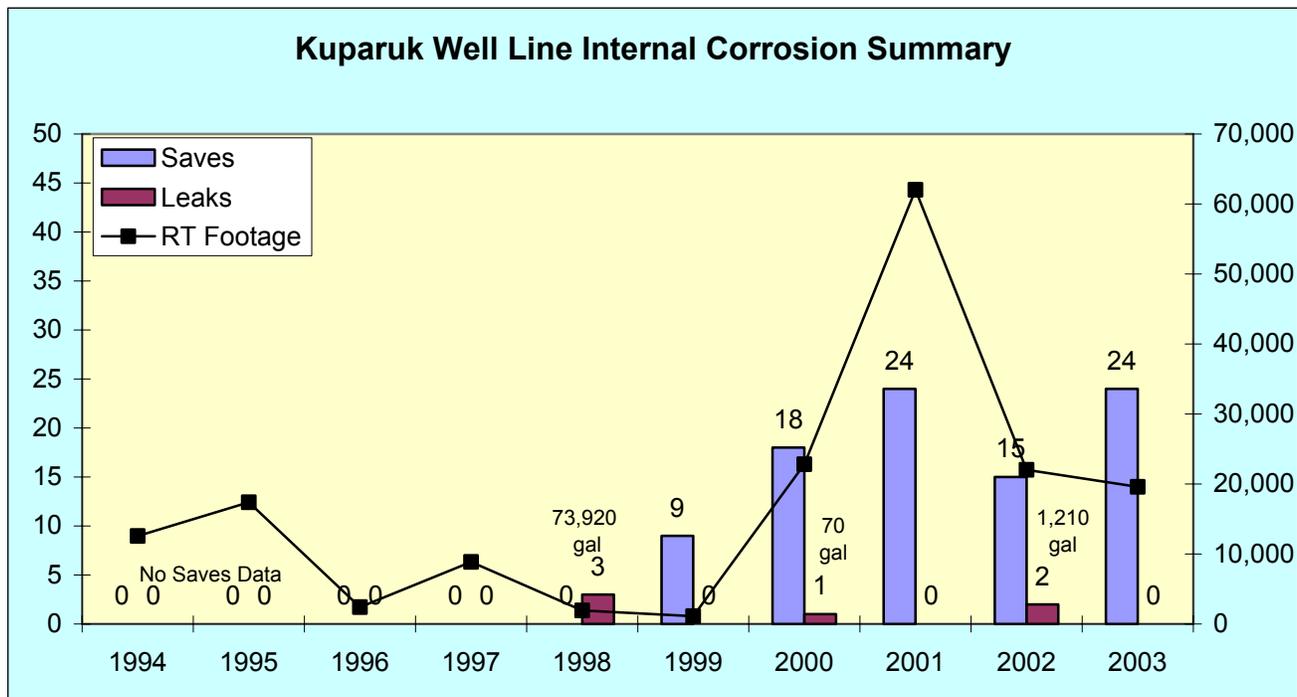
As indicated in Figure 8 below, repair recommendations were initiated on 24 lines (22 injection, 2 production) in 2003 because of internal corrosion damage. Repairs typically consist of either installing a sleeve or replacing the de-rated section of line. We met our primary 2003 goal of completing the inspection of all well lines requiring baseline inspection.

Figure 8. Summary of Well Line Internal Corrosion Inspections – RT footage, leaks, and saves as a function of time.

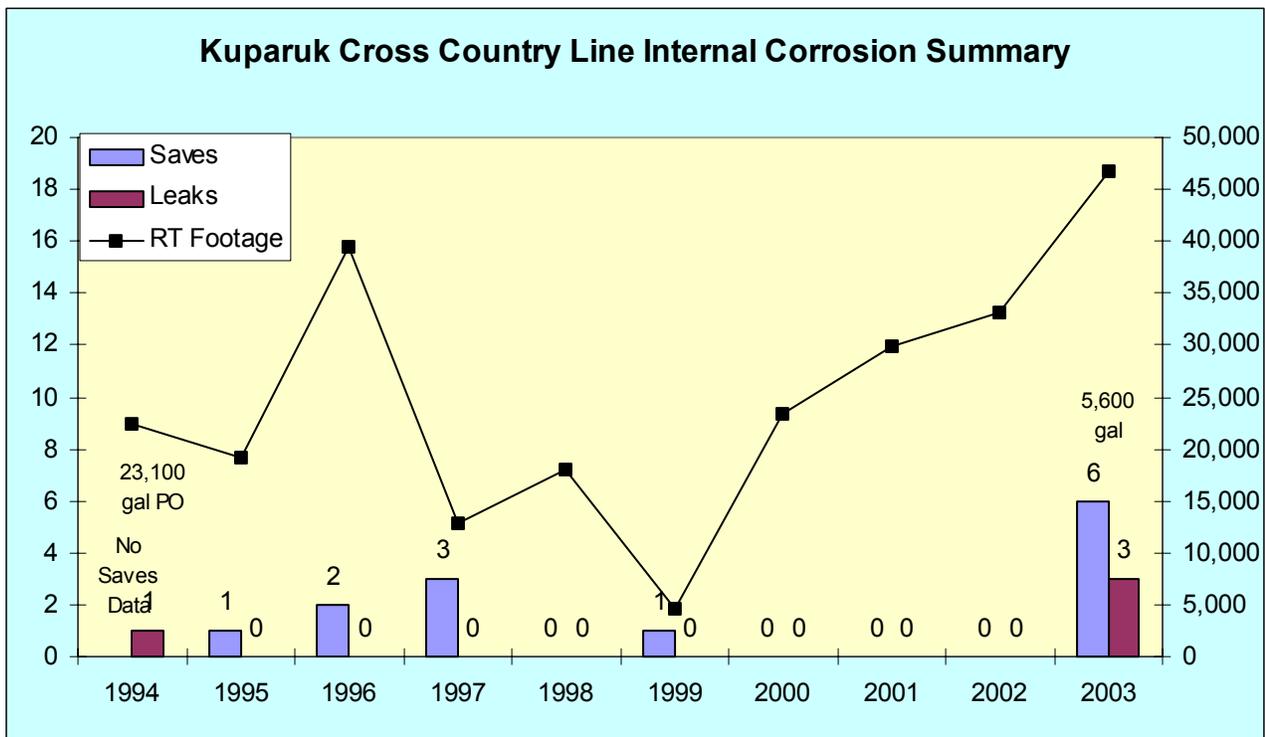
As indicated in Figure 9, nine repair recommendations were initiated on cross-country lines because of internal corrosion damage in 2003. The corrosion mechanisms were deadleg corrosion (five repairs), under deposit corrosion (three repairs) and weld attack on a flowing line (one repair). Because of large increase in repairs we will increase our inspection effort on deadlegs in 2004.

Figure 9. Summary of Cross-Country Line Internal Corrosion Inspections – RT footage, leaks, and saves as a function of time.

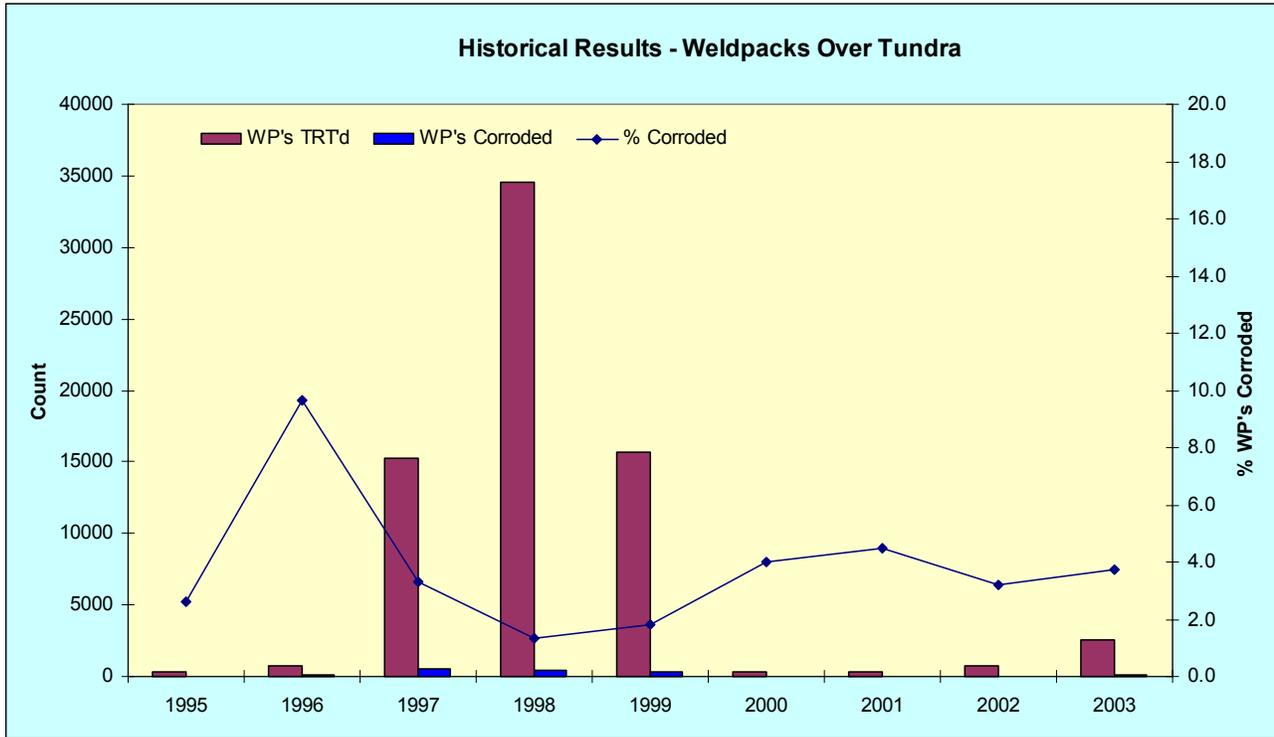
Figure 10. Summary of Weld Packs on Cross-Country Lines over Tundra (off-pad).

Figure 10 illustrates the most-complete external corrosion inspection program of the three external corrosion programs. 2002 and 2003 values include re-inspections and clean-up of locations missed or not properly documented during the original base line effort.

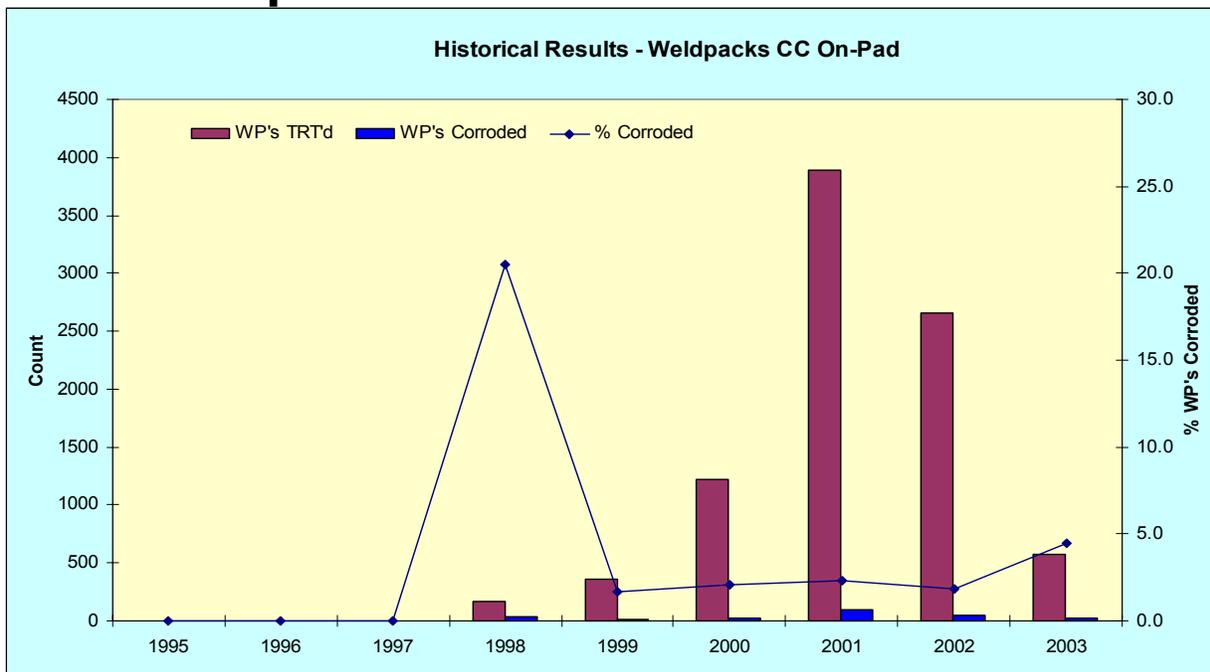
Figure 11. Summary of Weld Packs on Cross-Country Lines on Pads.

Figures 11 and 12 depict the results of the major focus of the external weld pack inspection program in 2003. The cross-country on-pad program is nearing completion and all baseline inspections should be complete by year-end 2004. The well line weld-packs were inspected using a prioritization scheme that examined the oldest, the hottest, and the thinnest-walled lines first. As of year-end 2003, 96% of the cross-country on-pad weld-packs and 91% of the well line weld-packs have received their baseline TRT inspections.

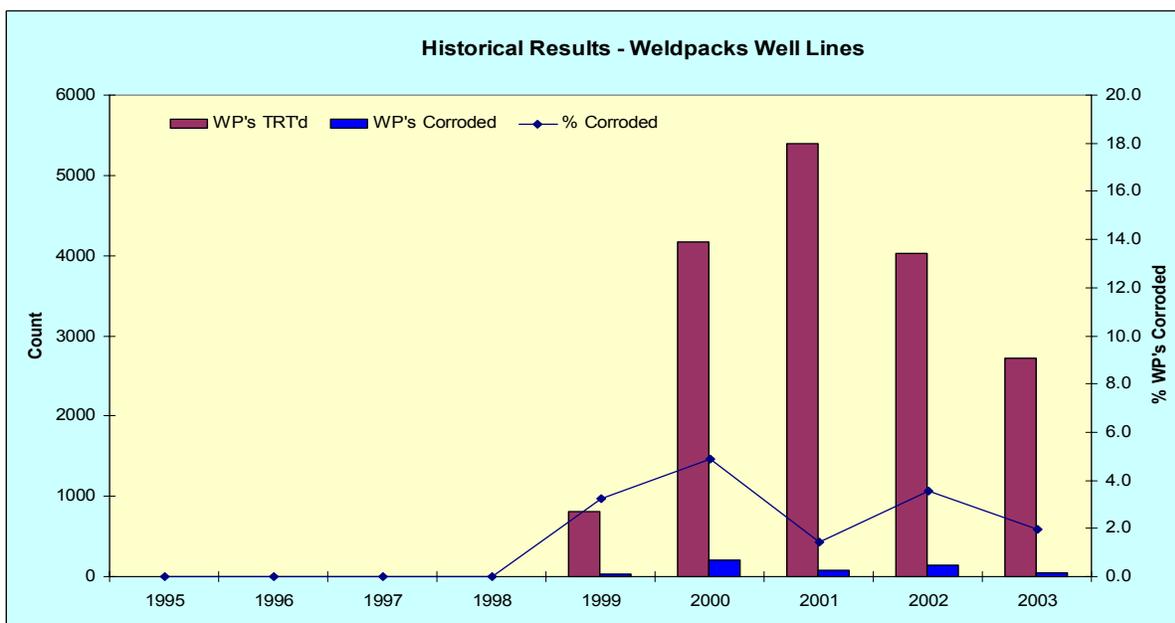
Figure 12. Summary of Weld Packs on Well Lines.

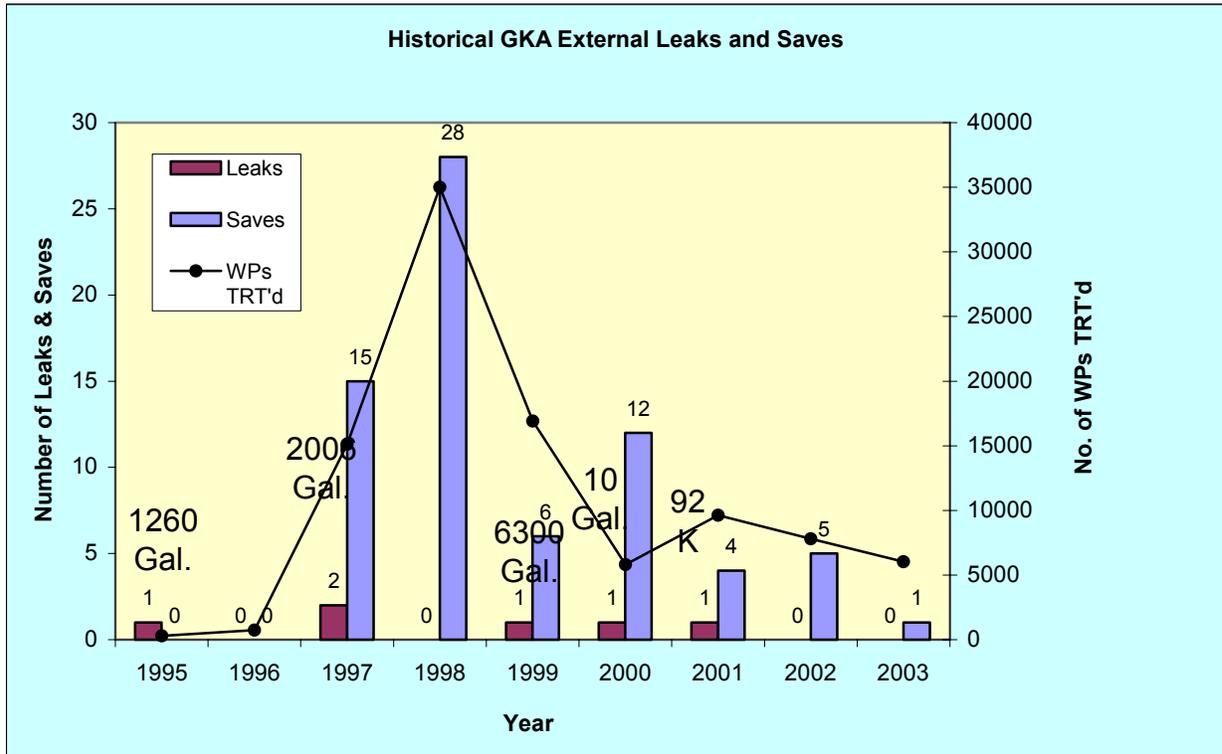
Figure A1. Leaks, saves, number of weld packs inspected with TRT, and volumes of leaks as a function of time.

Note: The leak in 2001 due to external corrosion was located in a weld pack in a below-grade piping segment, and as such, would not have been detected by the TRT inspection program. The location had not yet received PTI/TWI inspection.
