**Greater Kuparuk Area (GKA)
Western North Slope (WNS)
Corrosion Programs Overview**

March 31, 2005

Commitment to Corrosion Monitoring
5th Annual Report to the Alaska Department of Environmental Conservation

Prepared by
ConocoPhillips Corrosion Team

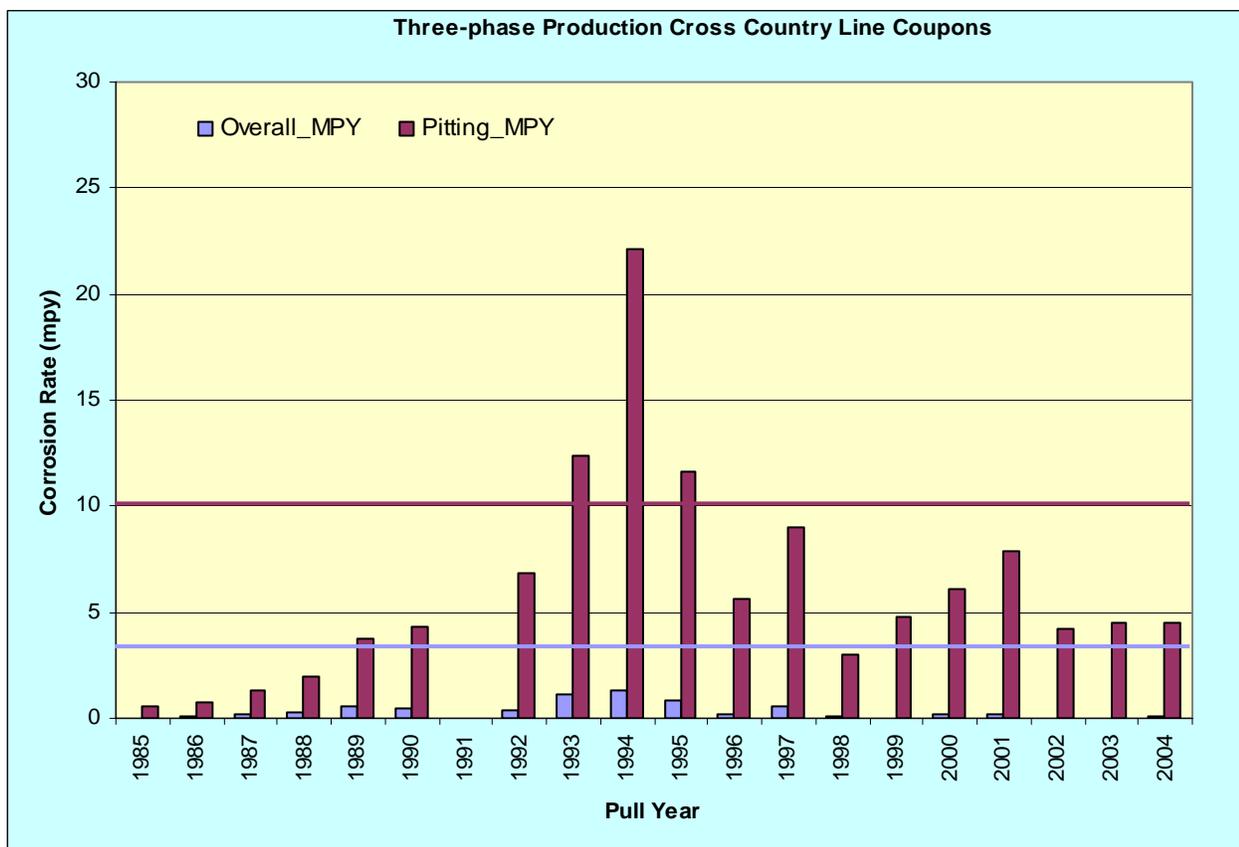
Figure 1. Three-phase Production Cross-Country Line Coupons – general and pitting corrosion rates as a function of time.

Three-phase Production Cross-Country Lines: The monitoring data summarized in Kuparuk Tables 1 and 2 and presented in Figure 1 suggest that general corrosion is under control. The data presented in the Tables 1 and 2 and in Figure 1 include corrosion coupon data from the wet oil lines starting at CPF3 and going to CPF1 and CPF2.

Recurring CRM inspections also support the conclusion that corrosion is under control in the three-phase production cross-country lines. In 2004, 587 corrosion-rate monitoring (CRM) inspections were conducted, with two minor increases found. Other internal inspection data also support the CRM data conclusions and are discussed in section 3.1.c, below.

Where corrosion rates exceeded targets, corrosion inhibitor concentrations were increased and/or the amount of inspection was increased excluding: one corrosion inhibitor test location (2WUVPO); and one location that had increased inspection damage over a 12-month period and that had its corrosion inhibitor concentration increased at the end of 2003 (1L10PO). In 2004, coupon or probe corrosion rates exceeded targets on fifteen lines and action was taken on all fifteen of these lines. In 2004, inspection results indicated minor corrosion had occurred on six lines; corrosion inhibitor concentrations were increased in four of these lines. A complete listing of the lines with coupon/probe corrosion rates that exceeded targets and/or where inspection indicated increased damage is given in Table 3.

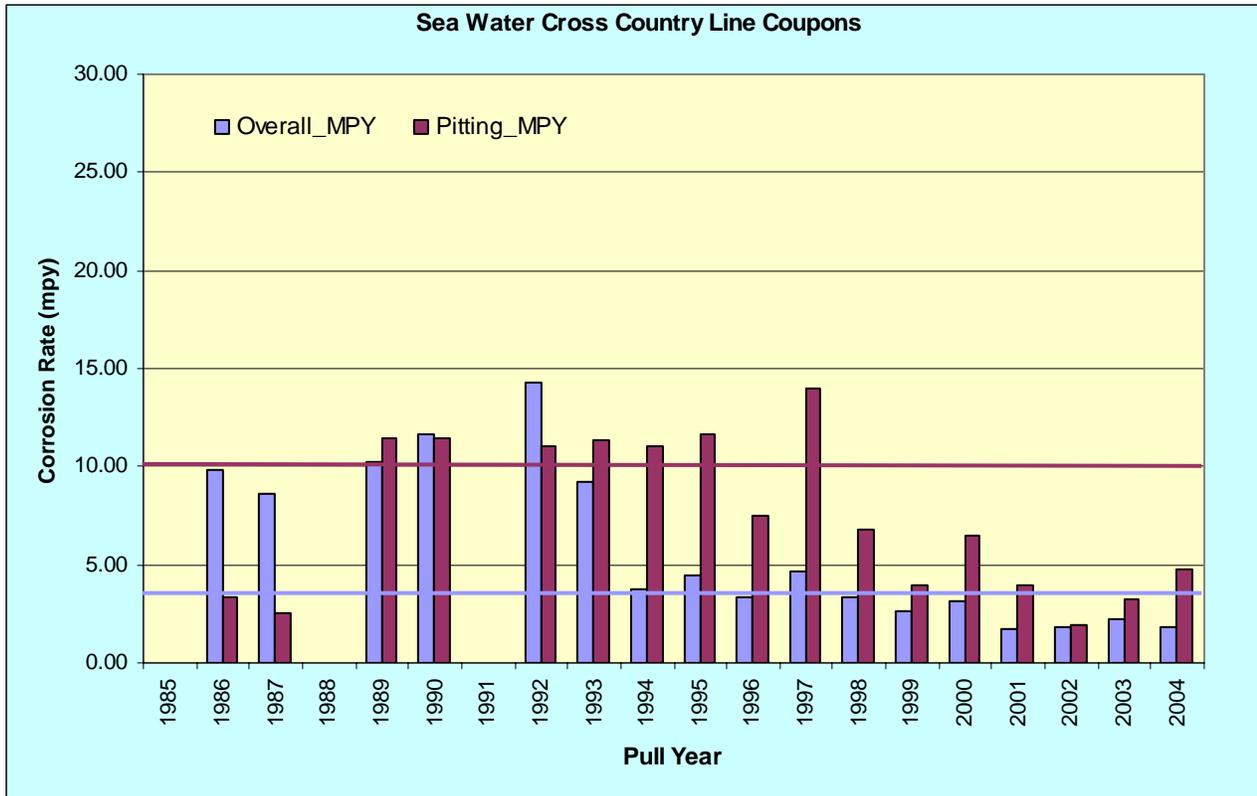
Figure 2. Seawater Cross-Country Line Coupons – general and pitting corrosion rates as a function of time.

Sea Water Cross-Country Lines: The monitoring data summarized in Kuparuk Tables 1 and 2 and presented in Figure 2 above, shows the average corrosion rates for the sea water cross-country line coupons remained under thresholds in 2004.

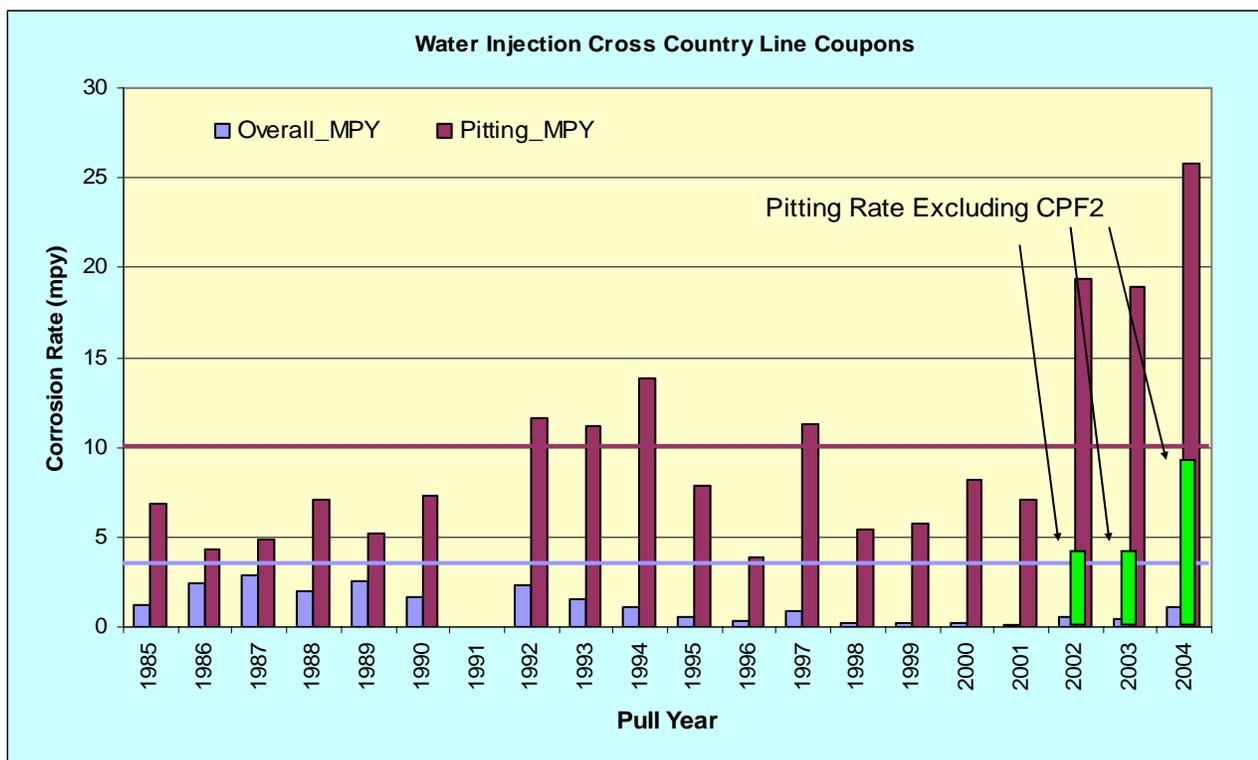
Figure 3. Water Injection Cross-Country Line Coupons – general and pitting corrosion rates as a function of time.

Mixed Water Injection Cross-Country Lines: The monitoring data summarized in Kuparuk Tables 1 and 2 and presented in Figure 3 show that average general corrosion rates are below the threshold, but that pitting rates for the field are above the threshold. Closer analysis of the data shows that the average pitting rate excluding CPF2 locations is under the threshold. Coupon results are used to prioritize inspection efforts. During the second half of 2004, equipment was installed and procedures were implemented to provide enhanced biocide treatments at CPF2. The first quarter 2005 coupon pulls from CPF2 show that pitting rates are lower than the 2004 average, but are still above threshold. In addition to the biocide treatment enhancements, an additional 80K BWPD of SW has been added to CPF2. This will increase line velocities and is anticipated to help reduce the under-deposit corrosion seen on many of these coupons.

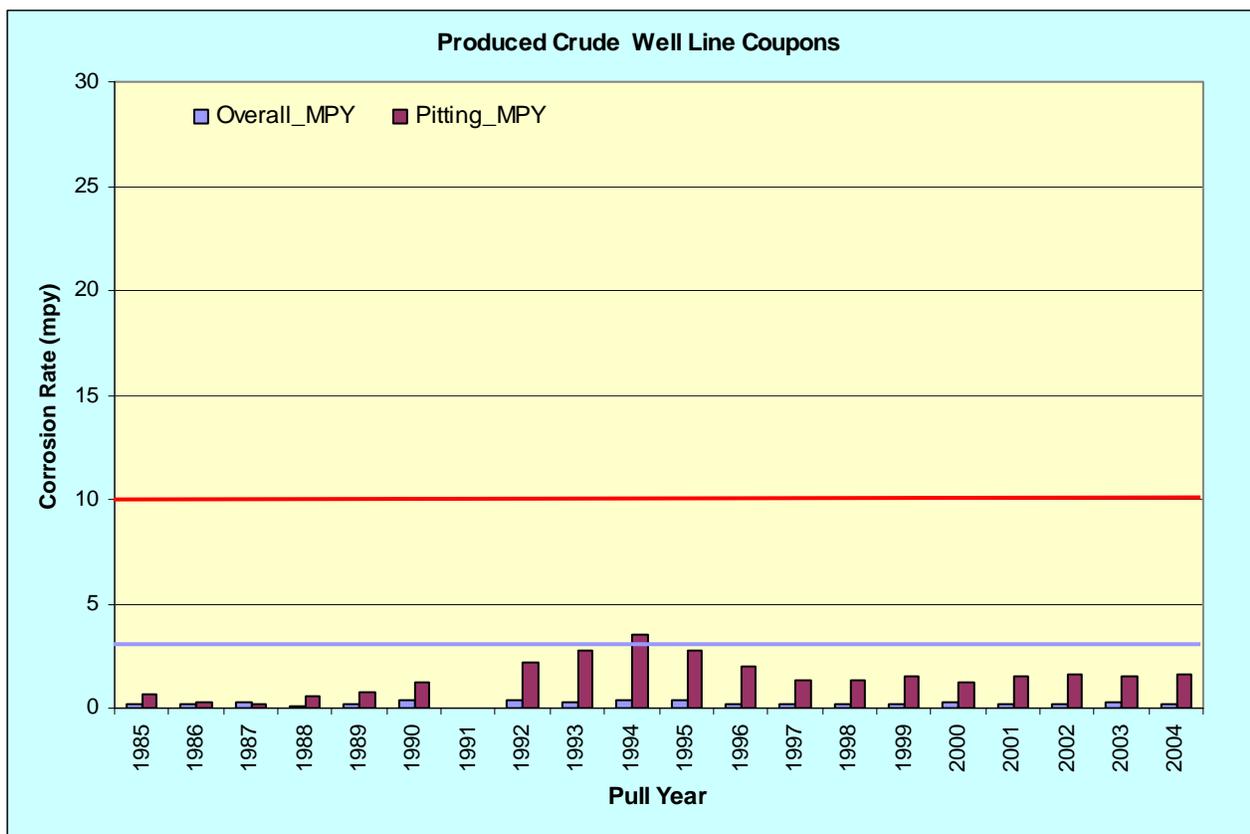
Figure 4. Three-phase Production Well Line Coupons – general and pitting corrosion rates as a function of time.

Three-phase Production Well Flow Lines: While the monitoring data summarized in Kuparuk Tables 1 and 2 and presented in Figures 4 and 5 suggest that corrosion rates are below targets, inspection data indicate that higher corrosion rates have been experienced historically. The well line inspection data are discussed in section 3.1.b below, and are a good example of why monitoring data alone cannot be relied upon to characterize corrosion in a given system. For three-phase production, coupons monitor free flowing fluid and have not shown the predominant, under-deposit corrosion mechanism.

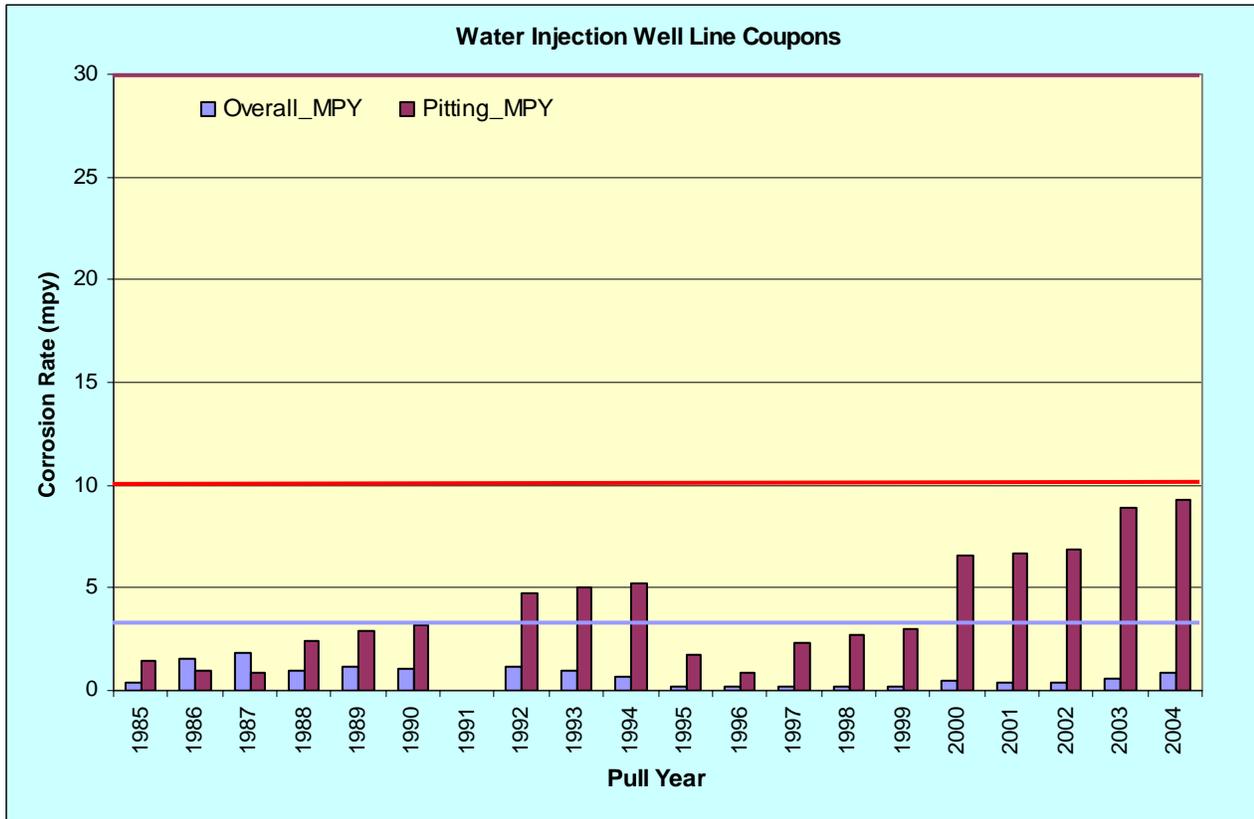
Figure 5. Water Injection Well Line Coupons – general and pitting corrosion rates as a function of time.

Water Injection Well Flow Lines: As discussed in section 3.1.b below, the well line inspection data on water injectors show that there are a significant number of corrosion related repairs. The water feeding this system is treated at the facilities with biocide and is discussed under Figure 3 - Water Injection Cross-Country Line Coupons.

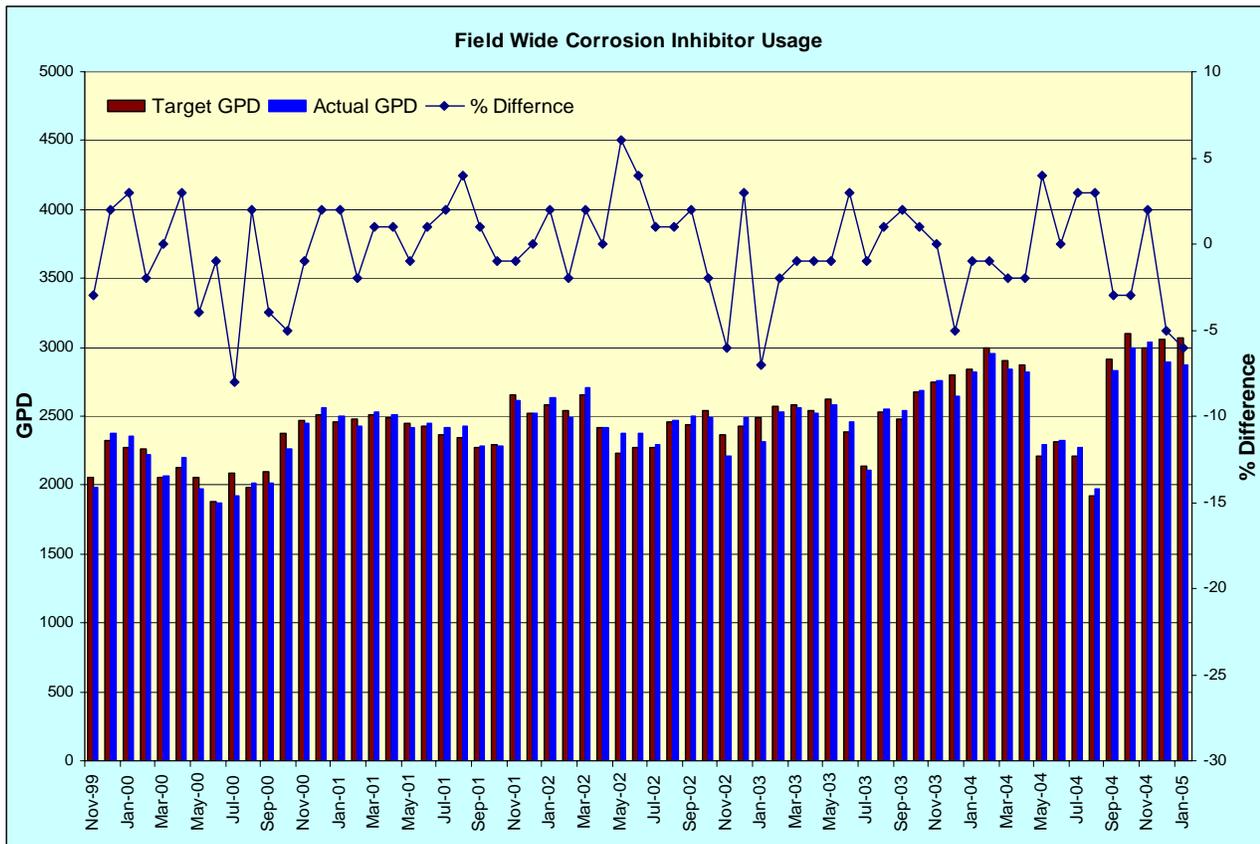
Figure 6. Field-wide Corrosion Inhibitor Use.

For the Kuparuk field, Figure 6 shows the actual number of gallons of corrosion inhibitor pumped per day, the recommended number of gallons of corrosion inhibitor per day, and the percent difference between the two. The average deviation for the year was -0.85% . The larger variation seen in the November and December 2004 data was caused by the extreme weather. The lower usage seen in May through August was due to pumping a more concentrated blend of the same field-wide corrosion inhibitor (the concentration of active components in both blends is the same).

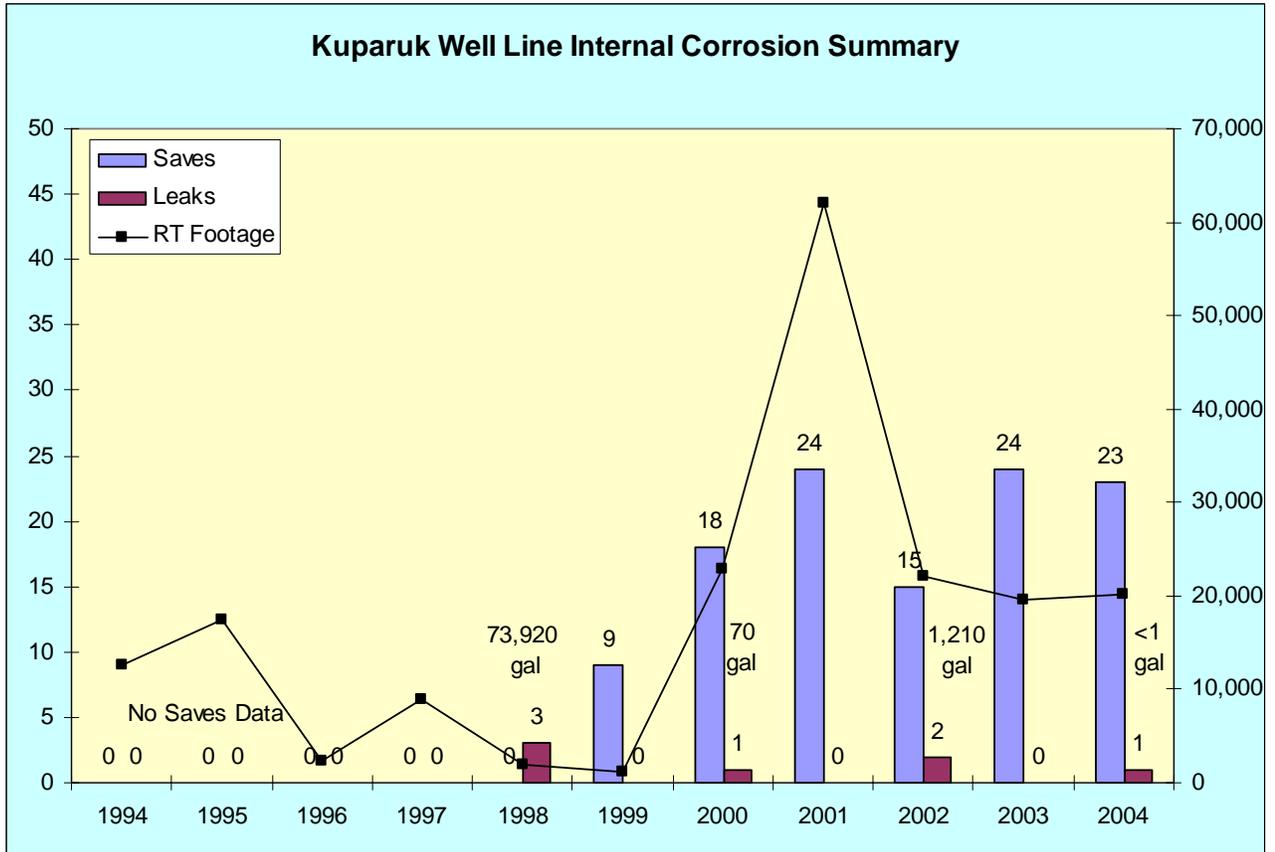
As indicated in Figure 8 below, repair recommendations were initiated on 24 lines (16 water injection, 8 production) in 2004 because of internal corrosion damage. Except for the leak, the corrosion mechanisms were all underdeposit corrosion. The leak, determined not to be an ADEC-reportable spill, was in a water injection line and was caused by erosion associated with a straightening vane pack. More information on the leak can be found in section 3.1.g.

Figure 8. Summary of Well Line Internal Corrosion Inspections – RT footage, leaks, and saves as a function of time.

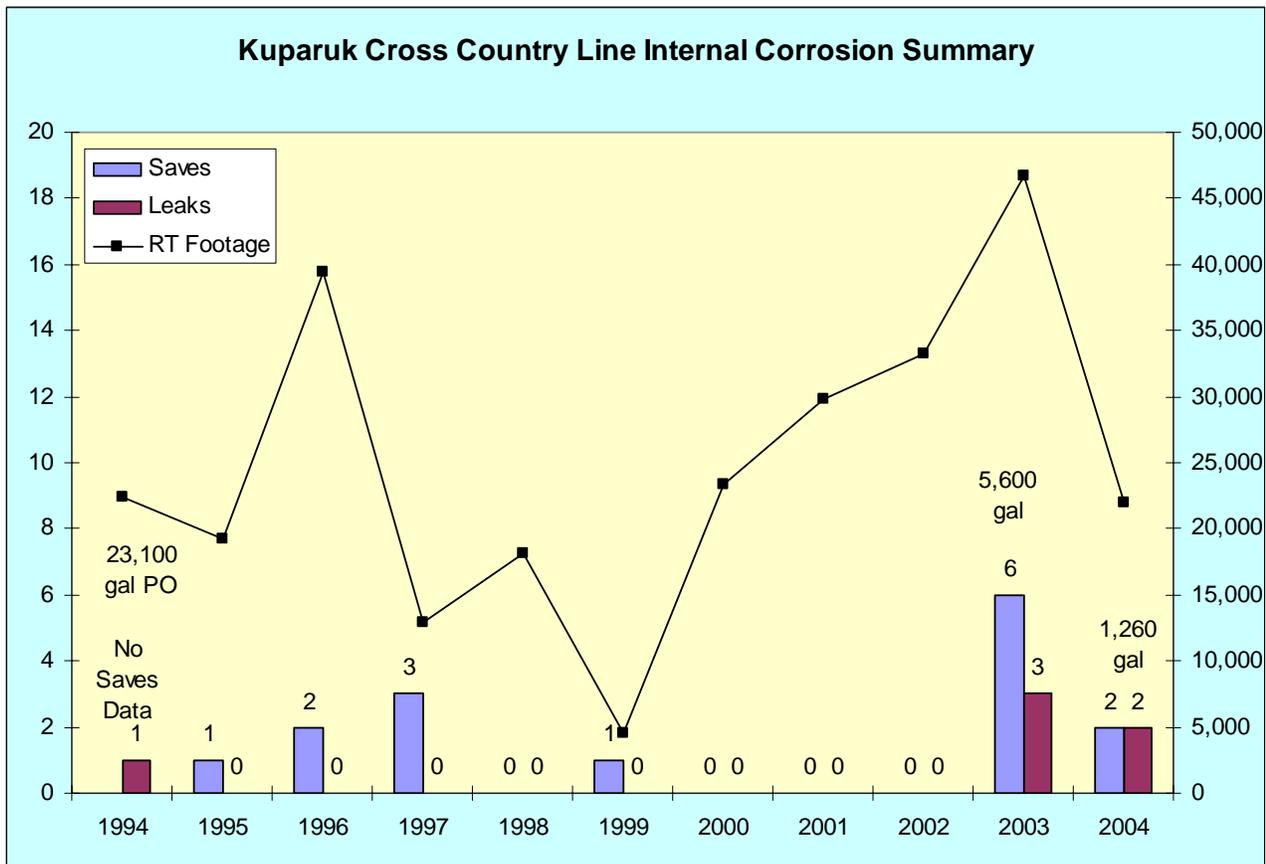
As indicated in Figure 9, four repair recommendations were initiated on cross-country lines (1 seawater injection, 3 production) because of internal corrosion damage in 2004. The corrosion mechanism for the three production lines was deadleg corrosion. The corrosion mechanism for the seawater injection line leak, determined not to be an ADEC-reportable spill, was microbiologically induced corrosion. More information on the leak can be found in section 3.1.g.

Figure 9. Summary of Cross-Country Line Internal Corrosion Inspections – RT footage, leaks, and saves as a function of time.

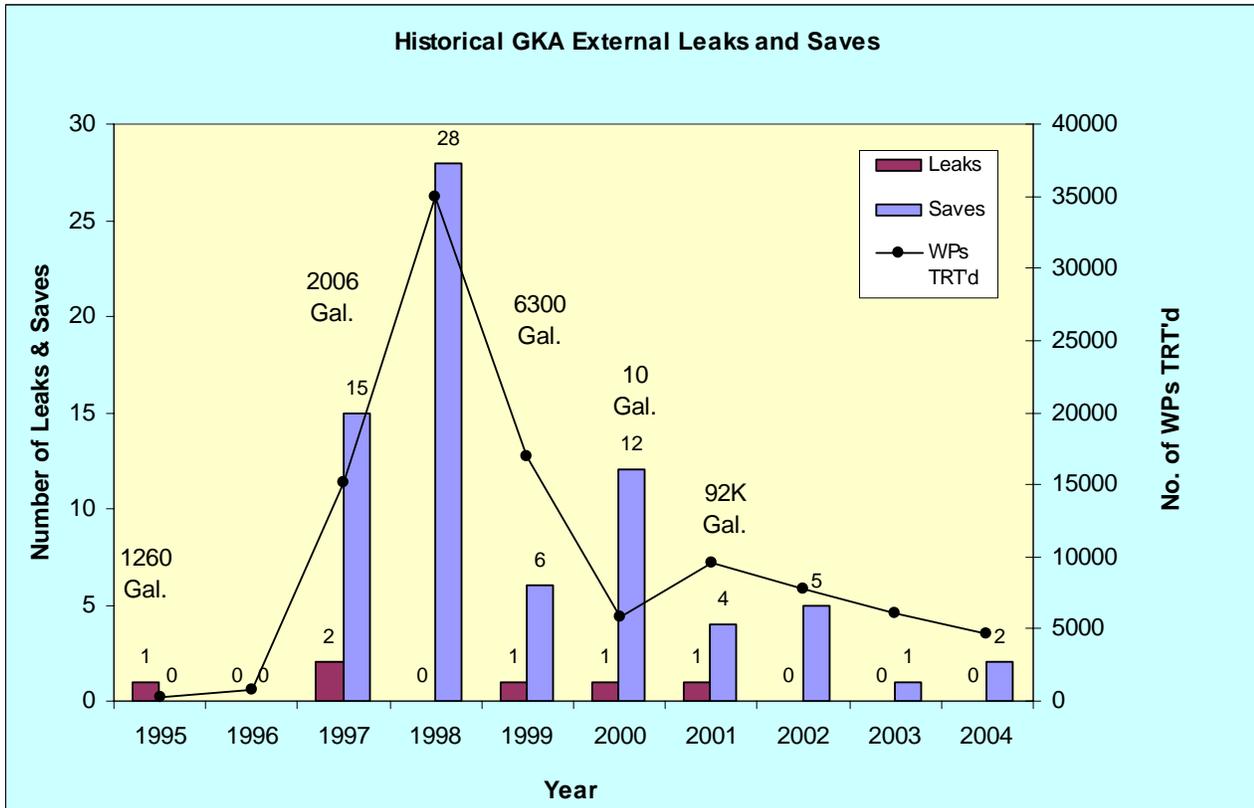
Figure 10. Leaks, saves, number of weld packs inspected with TRT, and volumes of leaks as a function of time.

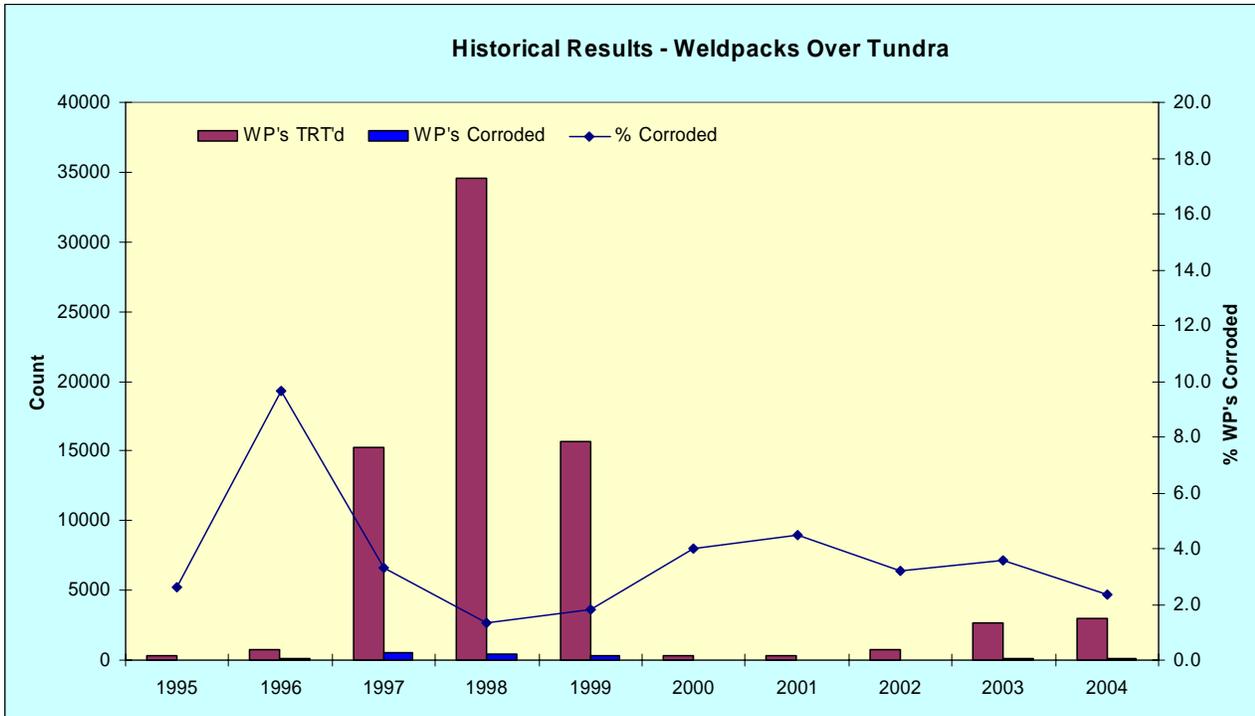
Figure 11. Summary of Weld Packs on Cross-Country Lines over Tundra (off-pad).

Figure 11 illustrates the most-complete external corrosion inspection program of the three external corrosion programs. 2002, 2003, and 2004 values include re-inspections and clean-up of locations missed or not properly documented during the original base line effort.

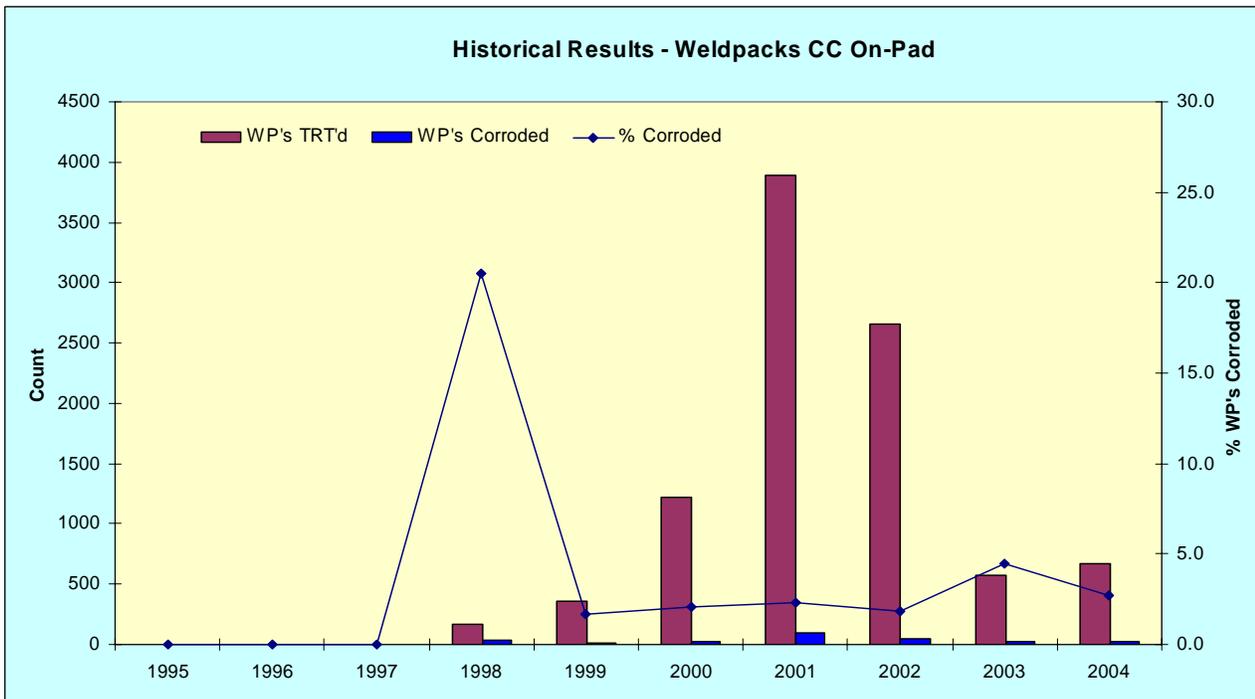
Figure 12. Summary of Weld Packs on Cross-Country Lines on Pads.

Figures 12 and 13 depict the results of the major focus of the external weld pack inspection program in 2004. The cross-country program and the well line weld pack program met milestones in 2004 by completing all of the baseline TRT inspections of all weld packs in their respective areas.

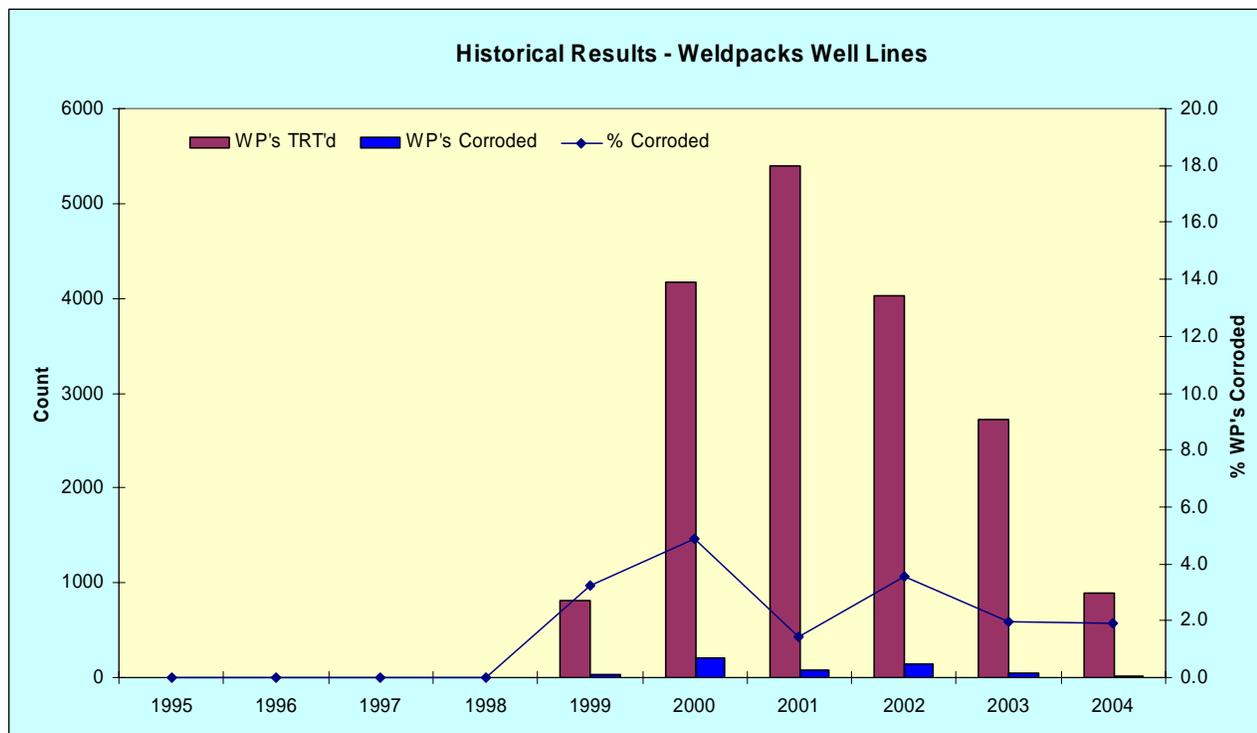
Figure 13. Summary of Weld Packs on Well Lines.
