**Greater Kuparuk Area (GKA)
Western North Slope (WNS)
Corrosion Programs Overview**

Commitment to Corrosion Monitoring
8th Annual Report to the Alaska Department of Environmental Conservation

**Prepared by
ConocoPhillips Corrosion Team**

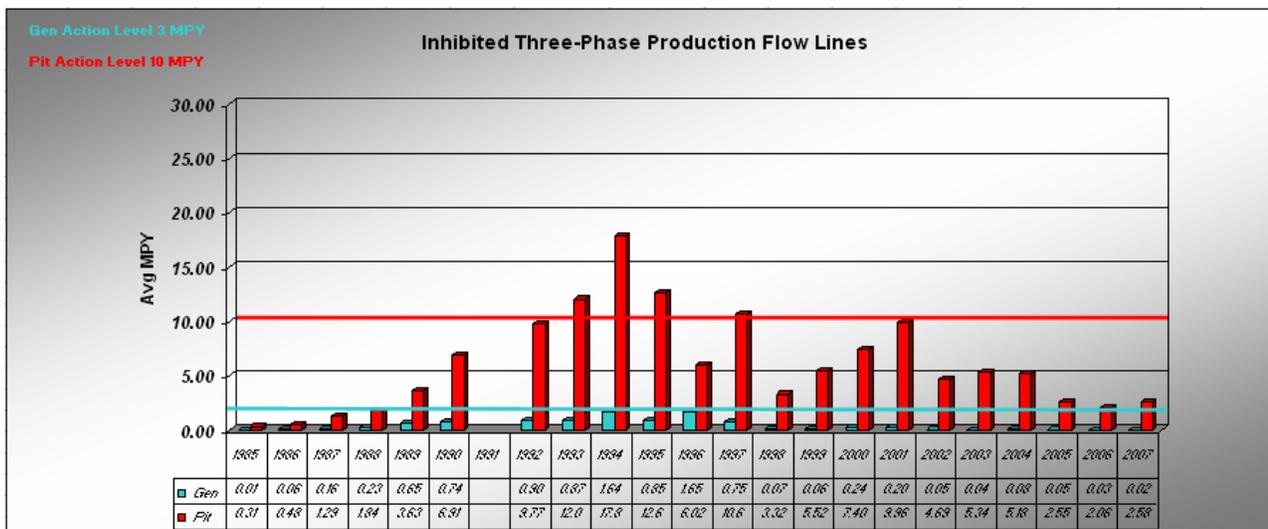
Figure 1. Inhibited Three-Phase Production Flow Line Coupons – general and pitting corrosion rates by year.

Three-phase Production Flow Lines: The monitoring data summarized in Kuparuk Tables 1 and 2 and presented in Figure 1 suggest that general corrosion is under control. The data presented in Tables 1 and 2 and in Figure 1 include corrosion coupon data from the wet oil lines starting at CPF3 and going to CPF1 and CPF2.

Recurring corrosion-rate monitoring (CRM) inspections also support the conclusion that corrosion is under control in the three-phase production flow lines. In 2007, 861 CRM inspections were conducted, with 30 increases found. Other internal inspection data supporting the CRM data are discussed in section B.1.b, below.

Where corrosion rates exceeded targets, corrosion inhibitor concentrations were increased and the amount of inspection was increased. In 2007, coupon, probe or inspection-based corrosion rates exceeded targets or revealed increased damage on 21 lines. In 2007, inspection results indicated minor corrosion had occurred in 13 lines. A complete listing of the lines with coupon/probe corrosion rates that exceeded targets and/or where inspection indicated increased damage is given in Table 3.

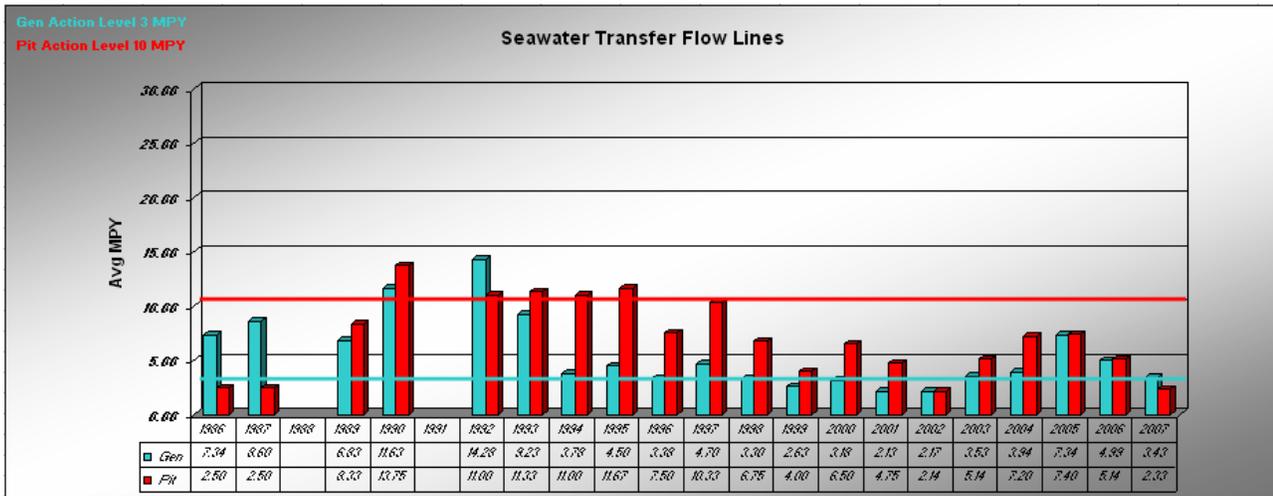
Figure 2. Seawater Transfer Flow Line Coupons – general and pitting corrosion rates by year.

Seawater Transfer Flow Lines: The monitoring data summarized in Tables 1 and 2 and presented in Figure 2 above, show the average corrosion rates for the sea water flow line coupons. Average general corrosion rates are above the threshold and pitting rates for the field are below the threshold. Biocide concentration is currently at 1000 ppm with weekly maintenance pigging.

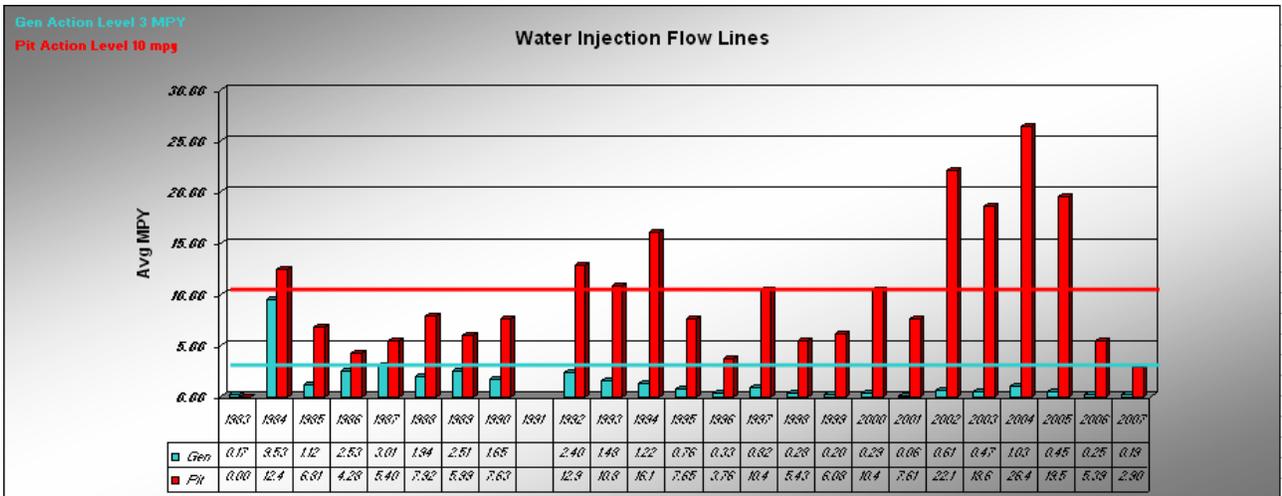
Figure 3. Water Injection Flow Line Coupons – general and pitting corrosion rates by year.

Water Injection Flow lines: The monitoring data summarized in Tables 1 and 2 are presented in Figure 3. Increased pigging and biocide have brought the WI flow lines coupon pitting rates under control. Since seawater and produced water commingling were suspended at CPF2 in 2005, pitting rates have been reduced markedly. Coupon results are used to prioritize inspection efforts. Additional chemical injection systems are being installed at all three CPF's to allow for chemical treatment of individual lines. Cleaning pig technology is continually being tested. New cleaning pig styles have been field proven and another pigging technology is under evaluation with promising results.

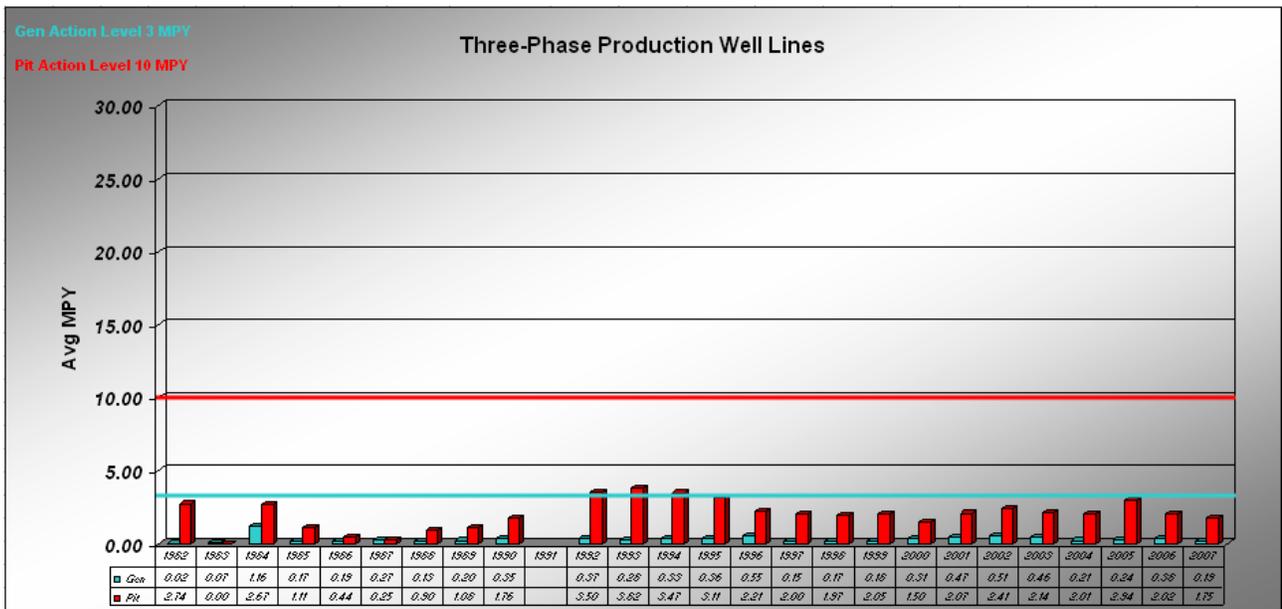
Figure 4. Three-Phase Production Well Line Coupons – general and pitting corrosion rates by year.

Three-phase Production Well Lines: While the monitoring data summarized in Tables 1 and 2 and presented in Figures 4 and 5 suggest that corrosion rates are below targets, inspection data indicate that higher corrosion rates have been experienced historically. The well line inspection data are discussed in section B.1.a, below, and are a good example of why monitoring data alone cannot be relied upon to characterize corrosion in a given system. For three-phase production, coupons monitor free flowing fluid and have not shown the predominant, under-deposit corrosion mechanism.

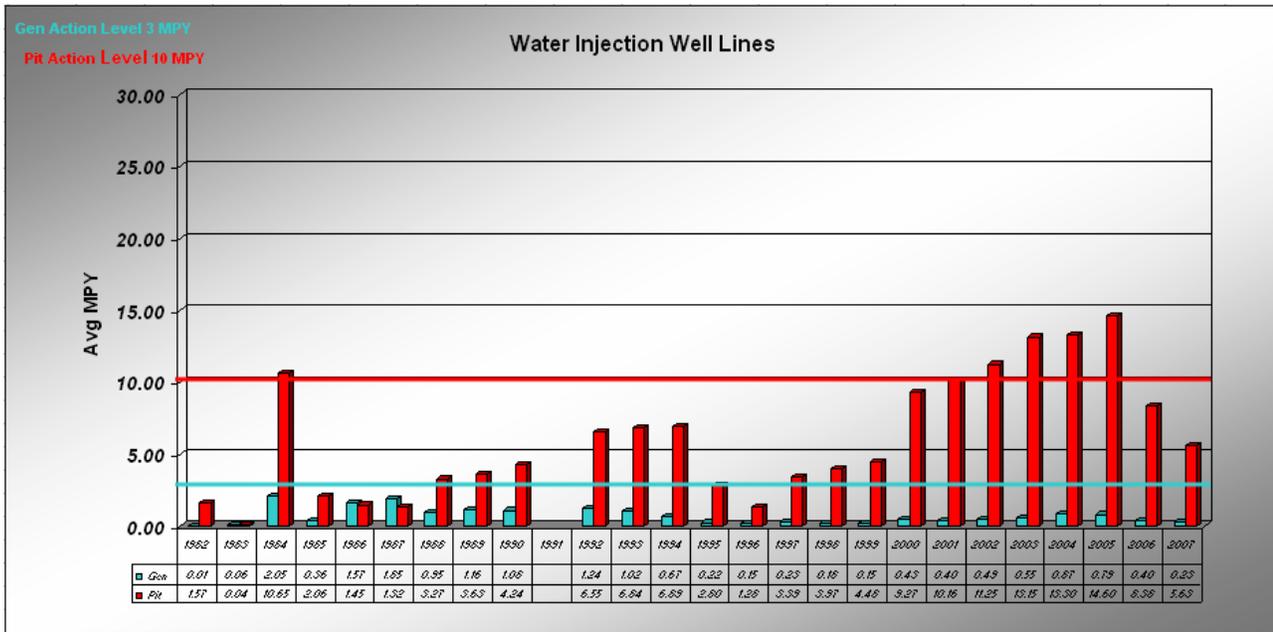
Figure 5. Water Injection Well Line Coupons – general and pitting corrosion rates by year.

Water Injection Well Lines: As discussed in section B.1.a, below, the well line inspection data on water injectors show that there are a significant number of corrosion related repairs. The water feeding this system is treated at the facilities with biocide and is discussed under Figure 3 - Water Injection Flow Line Coupons. We believe that corrosion in the water injection well lines is exacerbated by additional solids accumulating in the well lines because of low flow rates and improved pigging upstream of the well lines.

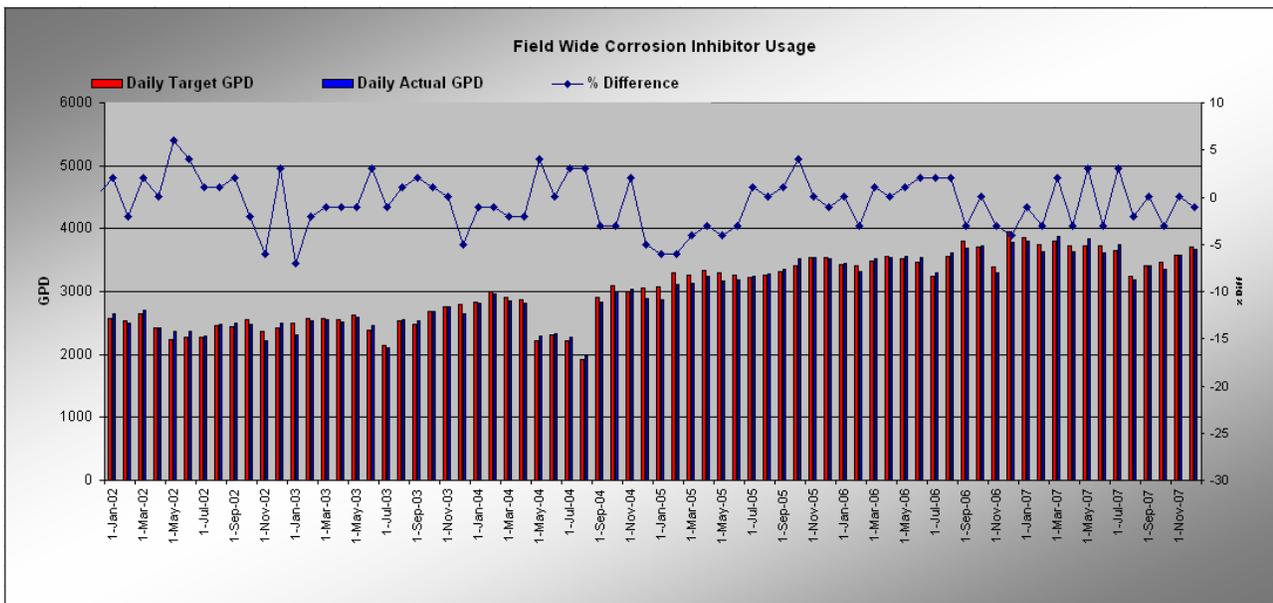
Figure 6. Field-wide Corrosion Inhibitor Use.

For the Kuparuk field, Figure 6 shows the actual number of gallons of corrosion inhibitor pumped per day, the recommended (target) number of gallons of corrosion inhibitor per day and the percent difference between the two. The average deviation for the year was -0.67%. Corrosion inhibitor use has increased since 2003 mainly because of field-wide water rate increases and increased corrosion rates caused by water and solids handling.

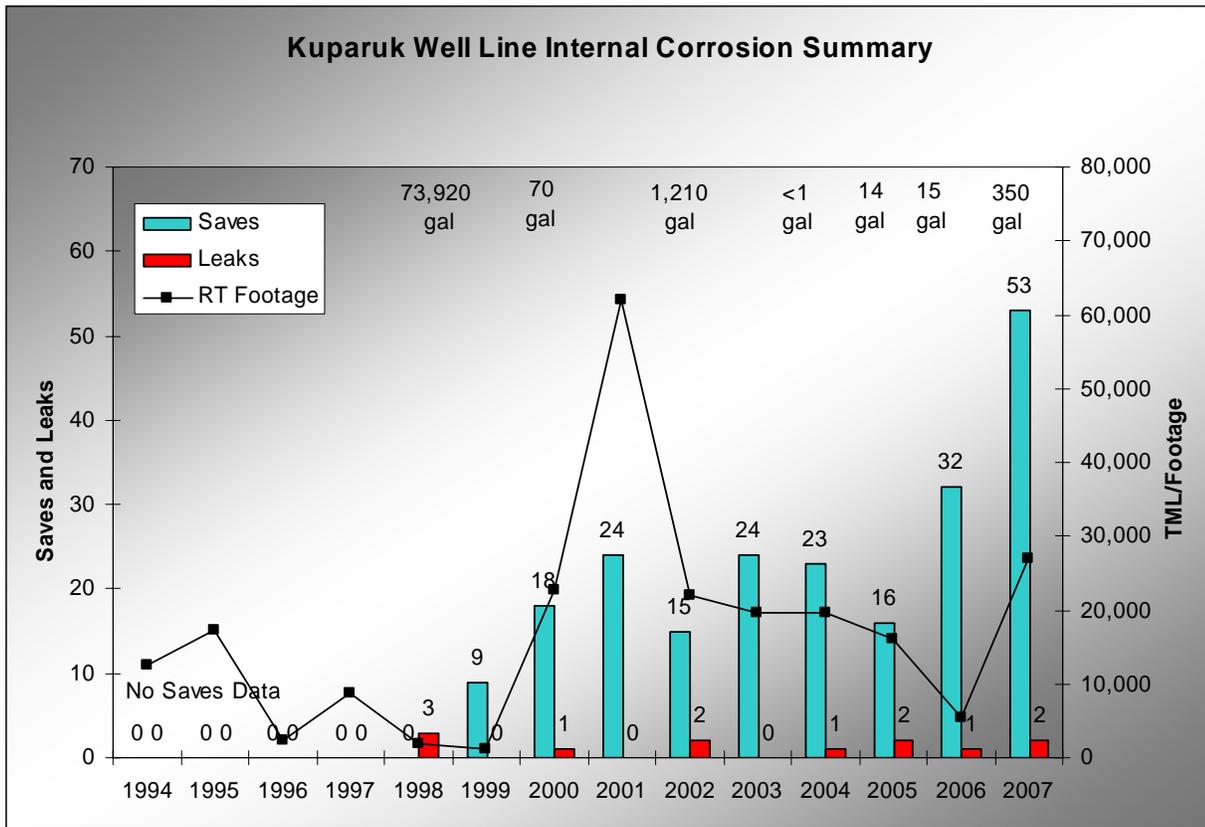
As indicated in Figure 8, below, repair recommendations were initiated on 55 well lines (41 water injection and 14 production) in 2007 because of internal corrosion or a combination of internal and external corrosion damage. The predominant corrosion mechanism was associated with solids (under-deposit corrosion or erosion). More information on the two leaks can be found in section C.

Figure 8. Summary of WI and Three-Phase Production Well Line Internal Corrosion Inspections – RT footage, leaks, and saves by year.

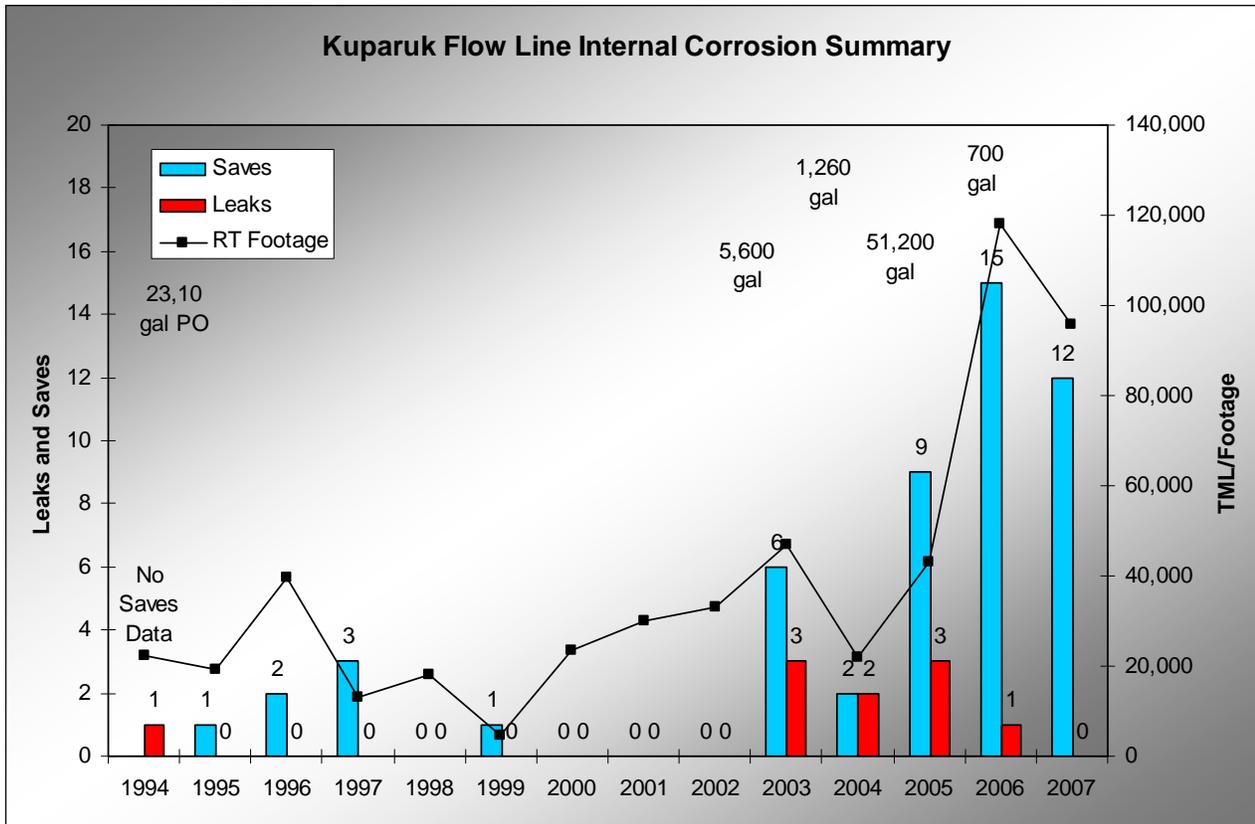
As indicated in Figure 9 below, 12 repair recommendations were initiated on flow lines (5 water injection and 7 production) in 2007 because of internal corrosion damage. The corrosion mechanism for all repair recommendations was deadleg or solids-related corrosion. There were no leaks in flow lines caused by internal corrosion in 2007.

Figure 9. Summary of WI and Three-Phase Production Flow Line Internal Corrosion Inspections – RT footage, leaks, and saves by year.

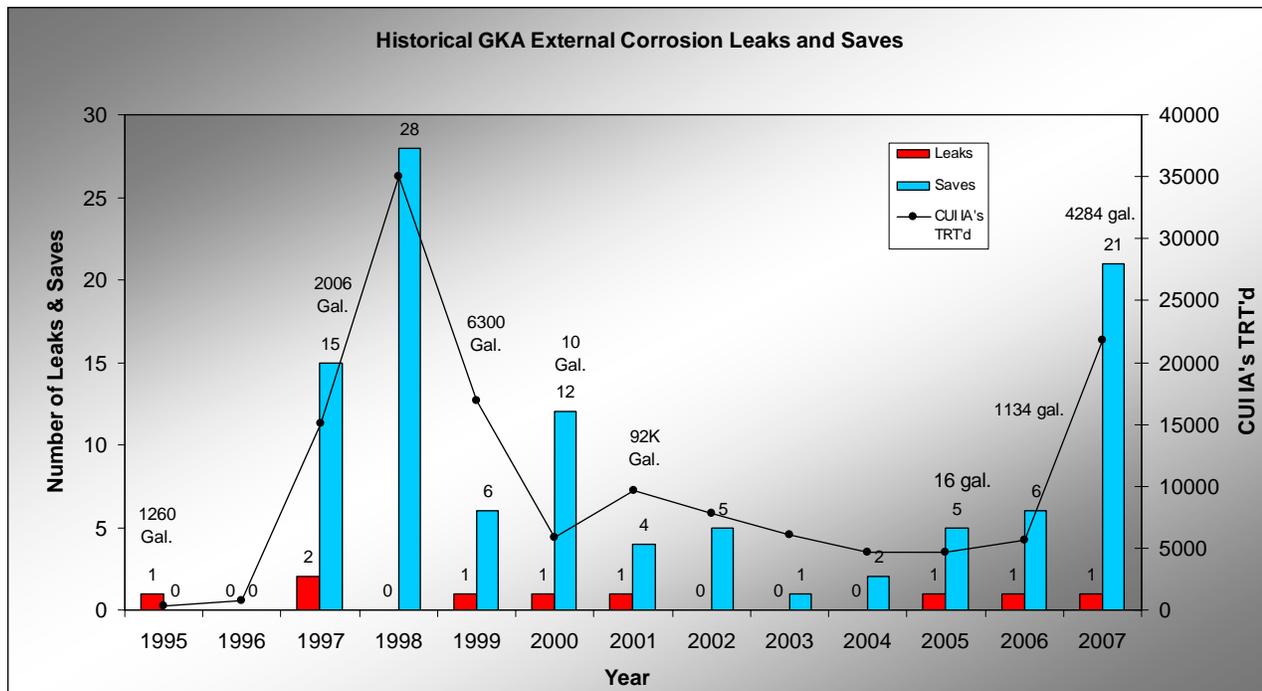
Figure 10. Leaks, saves, number of CUI IA's inspected with TRT, and volumes of leaks by year.

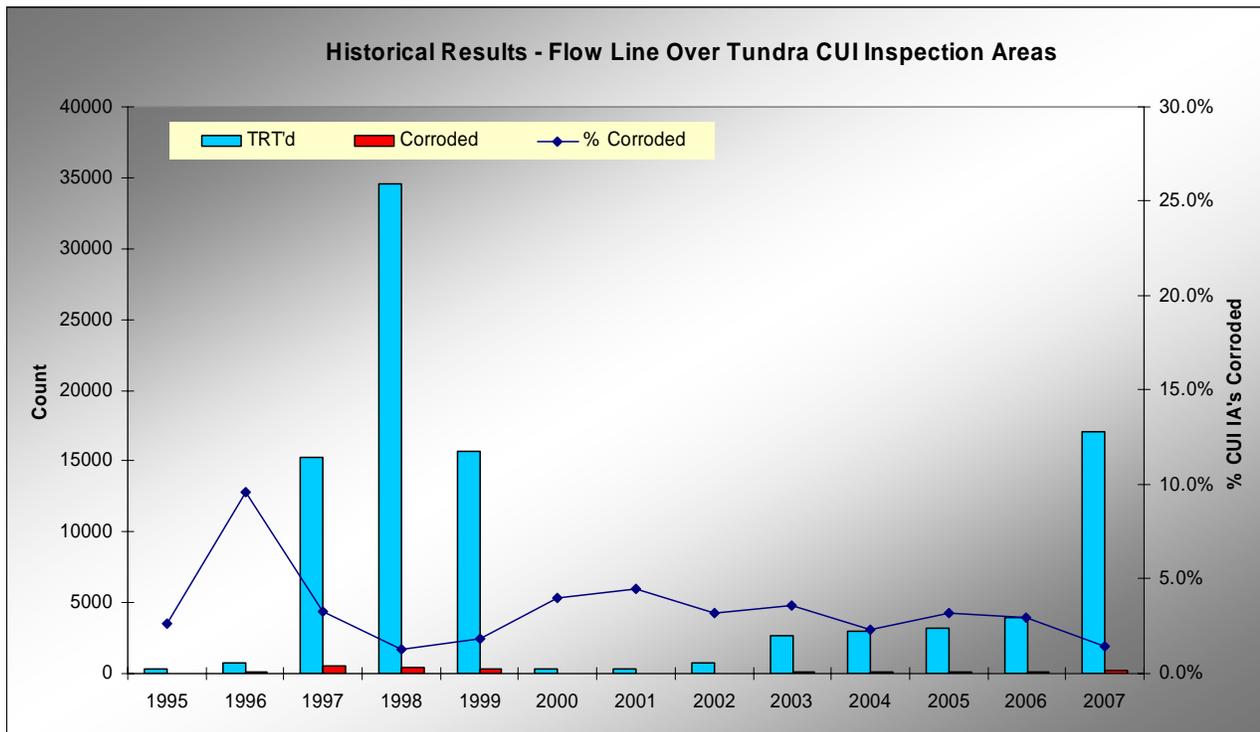
Figure 11. Summary of Flow Line Over-Tundra (off-pad) CUI Inspection Areas.

Figure 11 illustrates the latest results from the external corrosion inspection program. 2002 through 2006 values include recur follow-up inspections and clean-up of locations missed or not properly documented during the original base line effort. The increased inspection effort in 2007 is representative of our field-wide recur inspection to re-evaluate all locations on a 5 year inspection interval.

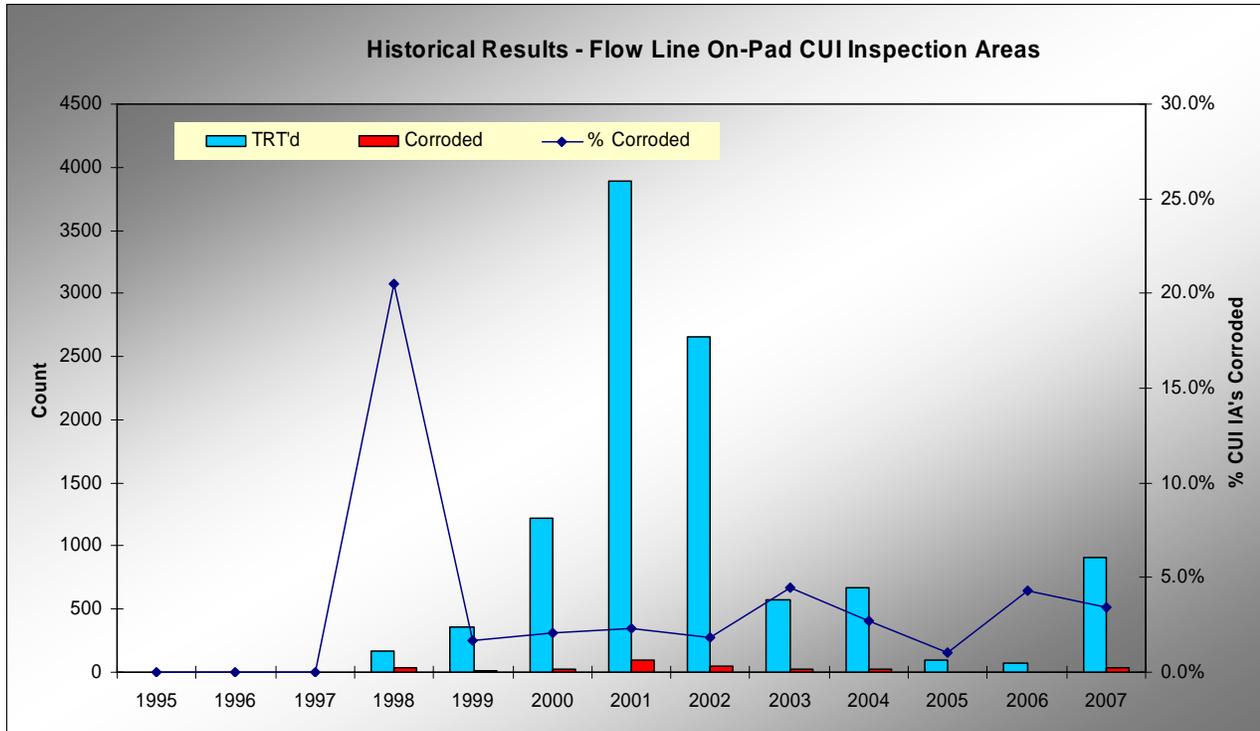
Figure 12. Summary of Flow Line On-Pad CUI Inspection Areas.

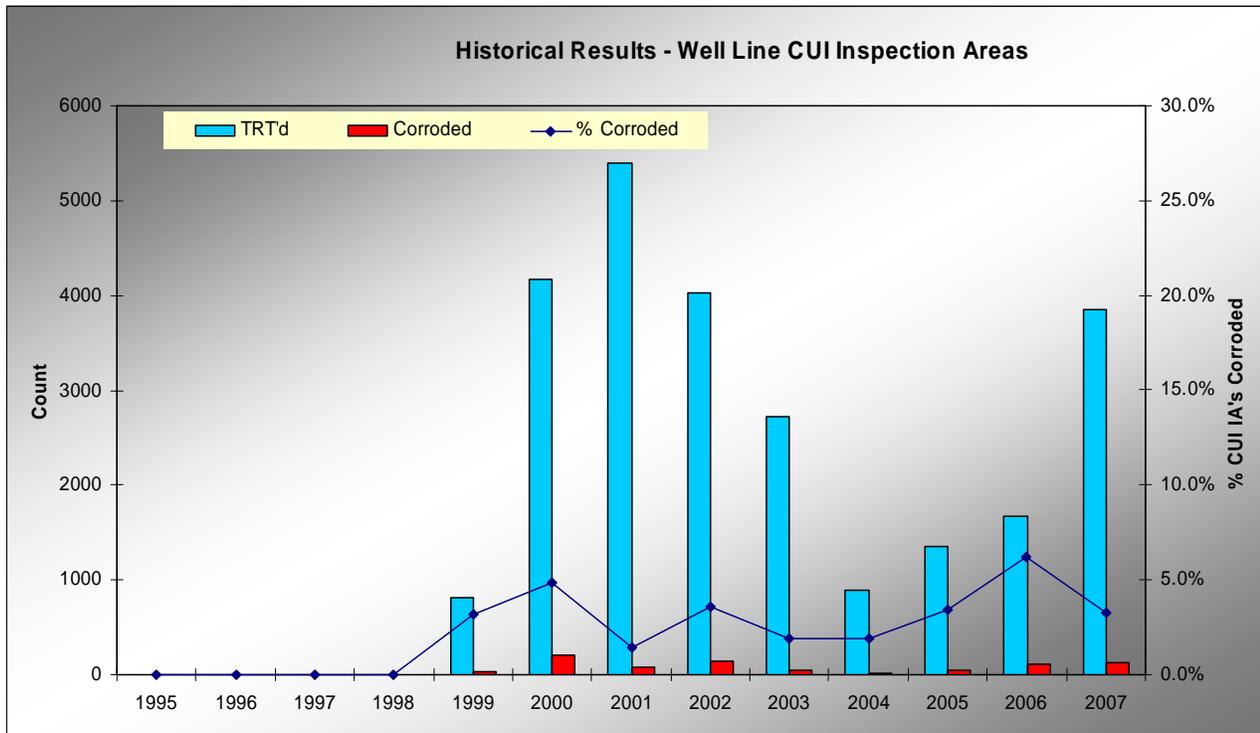
Figure 13. Summary of Well Line CUI Inspection Areas.

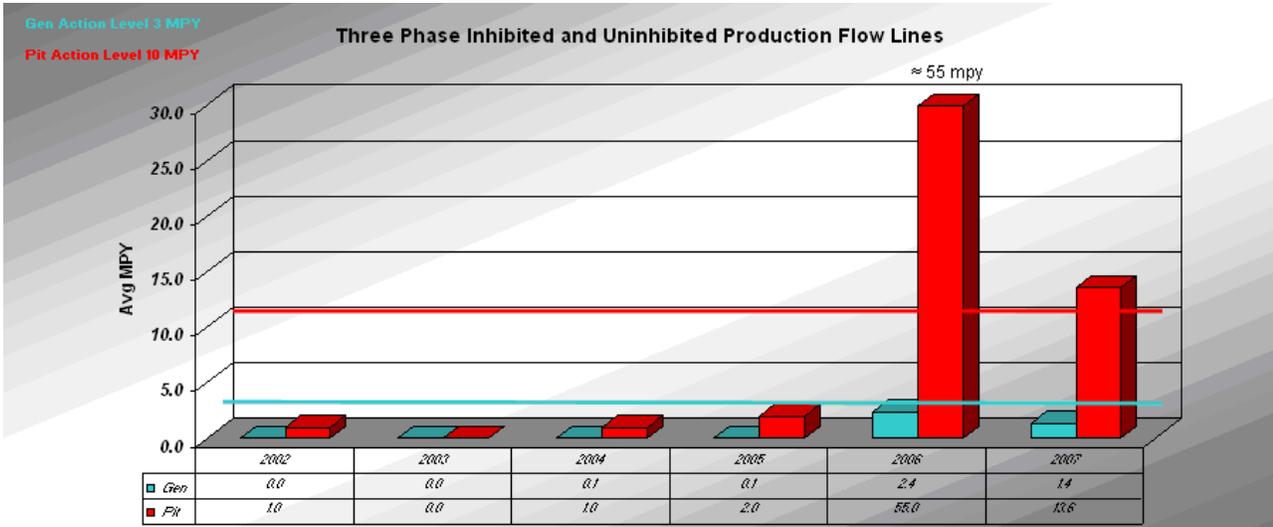
Figure 14. WNS Three-phase Production Flow Line Coupons – general and pitting corrosion rates by year.

Three-phase Production Flow Lines: The monitoring data summarized in Tables 7 and 8 and presented in Figures 14 show that pitting corrosion rates in 2007 exceeded the action level. In response to the coupon and probe corrosion rates, a new corrosion inhibitor formulation was selected for use at Alpine in the first quarter of 2007. In addition, a new corrosion inhibition formulation was tested in 2007. Inspection data, discussed in section B.1.b, indicate that significant corrosion damage has not taken place in these lines.

Corrosion inhibitor injection facilities were upgraded at CD1 to handle rising water production. At CD2, the installation of corrosion inhibitor injection facilities was accelerated because water production significantly outpaced the forecasted water rate. The subsequent coupon pull showed improvement.

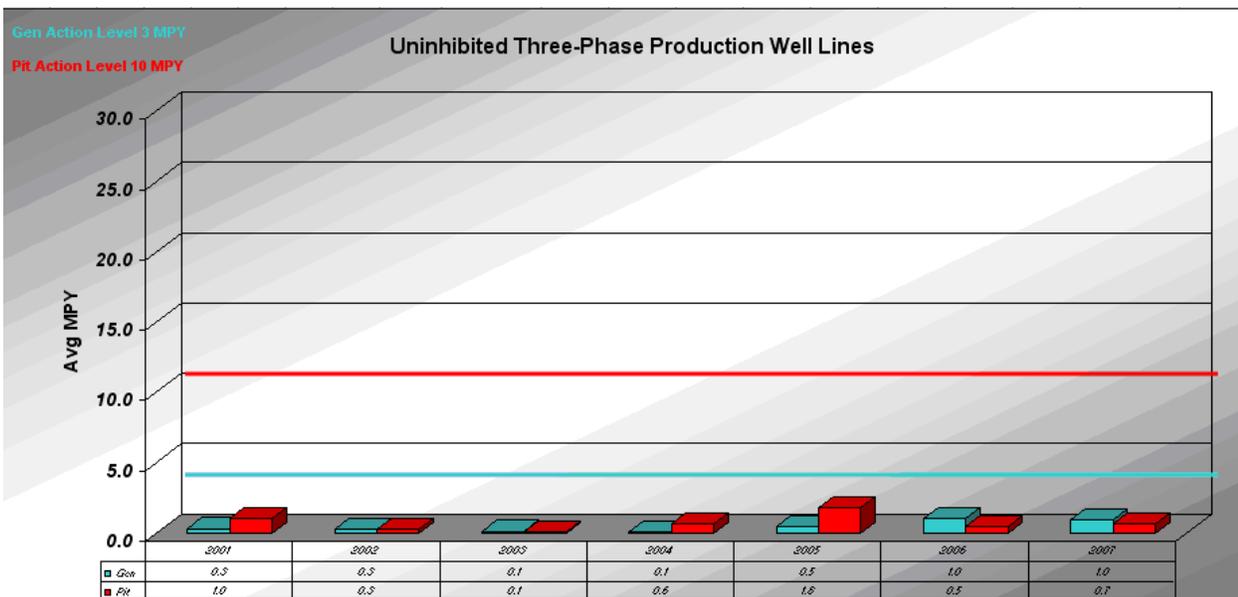
Figure 15. WNS Three-phase Production Well Line Coupons – general and pitting corrosion rates by year.

Three-phase Production Well Lines: The monitoring data summarized in Tables 7 and 8 and presented in Figures 15 show that corrosion rates have not approached action levels in the well lines. Inspection data, discussed in section B.1.a, indicate that significant corrosion damage has not taken place in these lines.

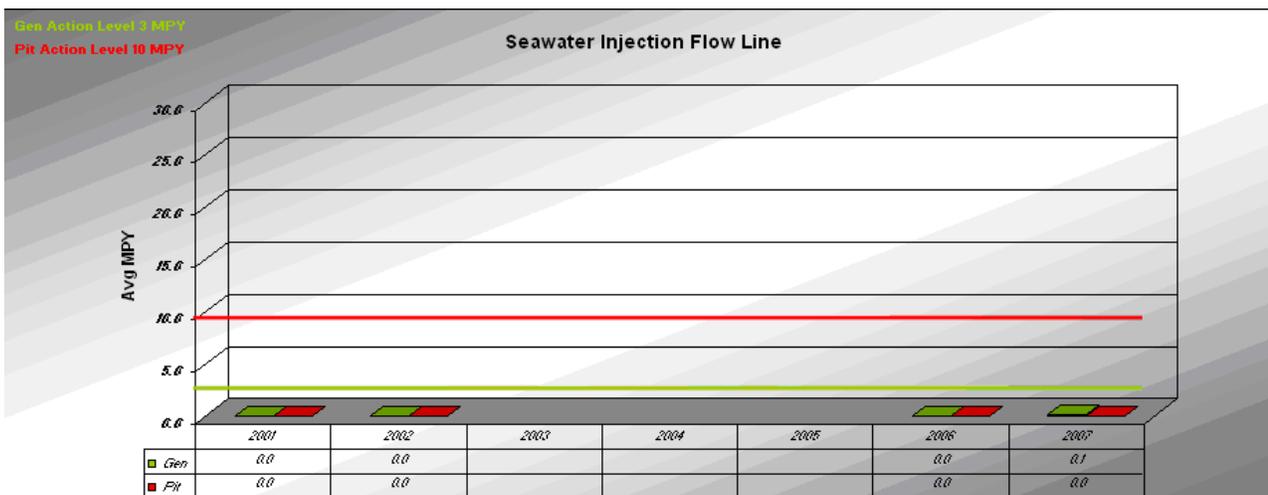
Figure 16. WNS Sea Water Flow Line Coupons – general and pitting corrosion rates by year.

Sea Water Flow Line from Kuparuk to Alpine: The monitoring data summarized in Tables 7 and 8, and presented in Figure 16 above, show the average corrosion rates for the sea water flow line coupons. Data collection resumed in 2006 when a coupon fitting was installed to replace the previous location which was obstructed by piping reconfiguration. Average general and pitting corrosion rates for this line are minimal. The biocide treatment at STP is currently at 1000 ppm with weekly maintenance pigging.

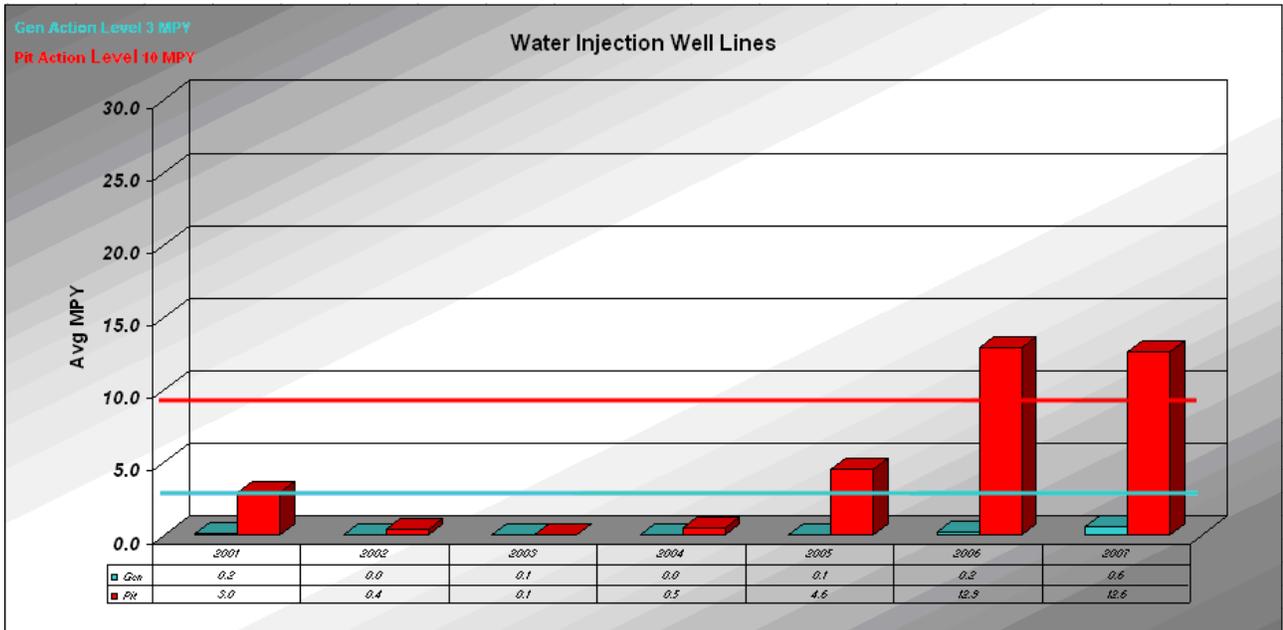
Figure 17. WNS Water Injection Well Line Coupons – general and pitting corrosion rates by year.

Water Injection Well Lines: The monitoring data summarized in Tables 7 and 8 and presented in Figure 17 show that pitting corrosion rates exceeded the action level. Inspection data presented in section B.1.a do not indicate damage in these lines, but given Kuparuk’s experience with corrosion-related repairs, WNS inspection programs will continue to look for damage in the injectors.
