ENVIRONMENTAL MANAGEMENT PLAN

Tanana Airport Facility and Community

Tanana, Alaska

By:
SLR International Corp
June 2009
(rev. April 2010)

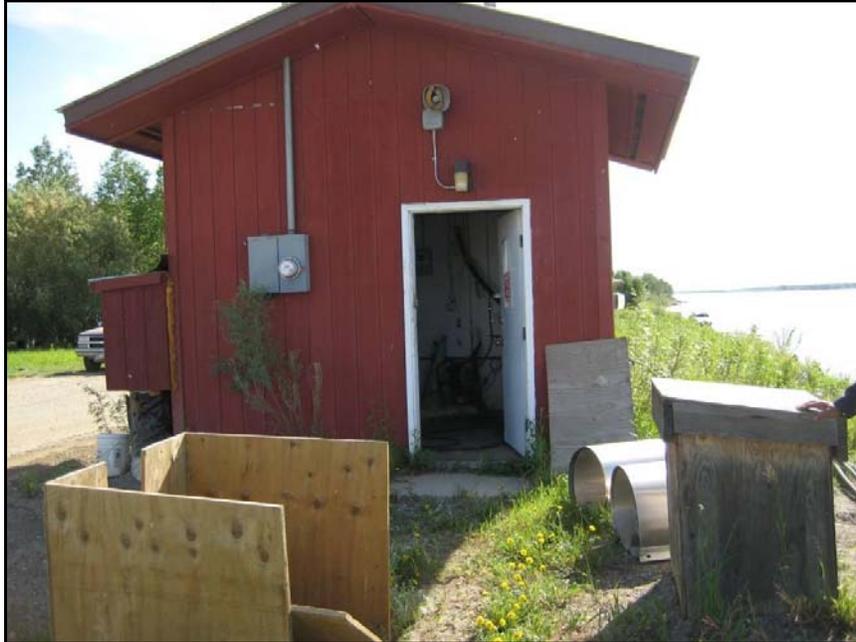
Photograph 1: The red well house in the picture is the location of the Tanana City Drinking Water Well site. The new Toogha well (Well #3), the current drinking water source, is located in the box in the lower right hand corner of the photograph.

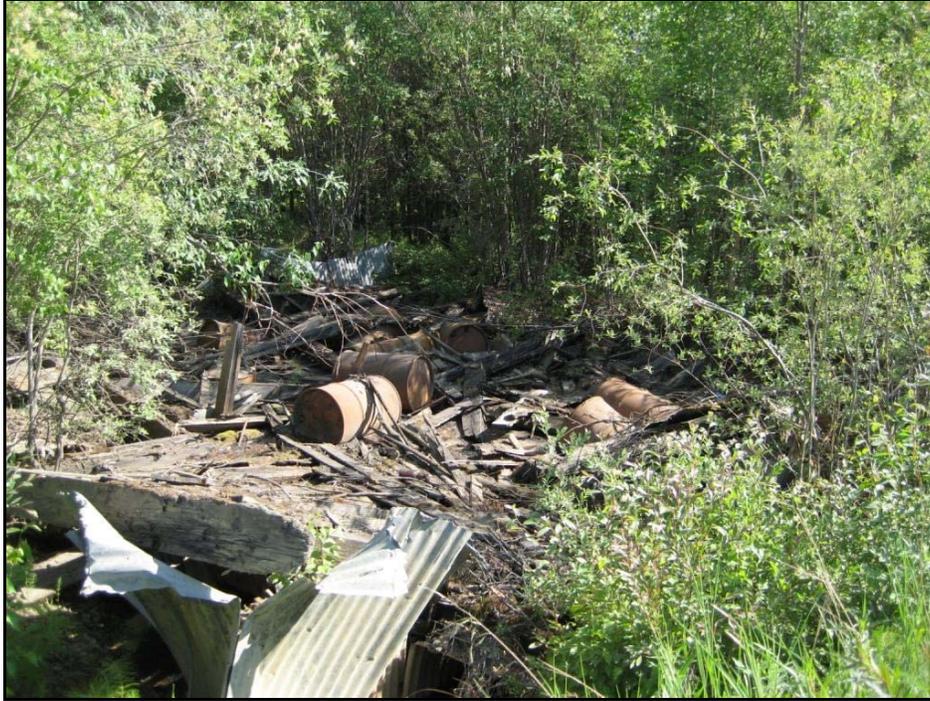
A large drum dump was observed during the site visit. Ten to 15 drums were present in this location. All of the drums observed during the June 2009 site visit were in poor condition, and the drums were corroded such that a release of any contents may be imminent. The site area is shown in photograph 5 in Appendix B.

Photograph 5: Drums and Debris in Swale site of environmental concern. This site is adjacent to the former Fort Gibbon Tank Farm and former Front Street Drum Storage Area.

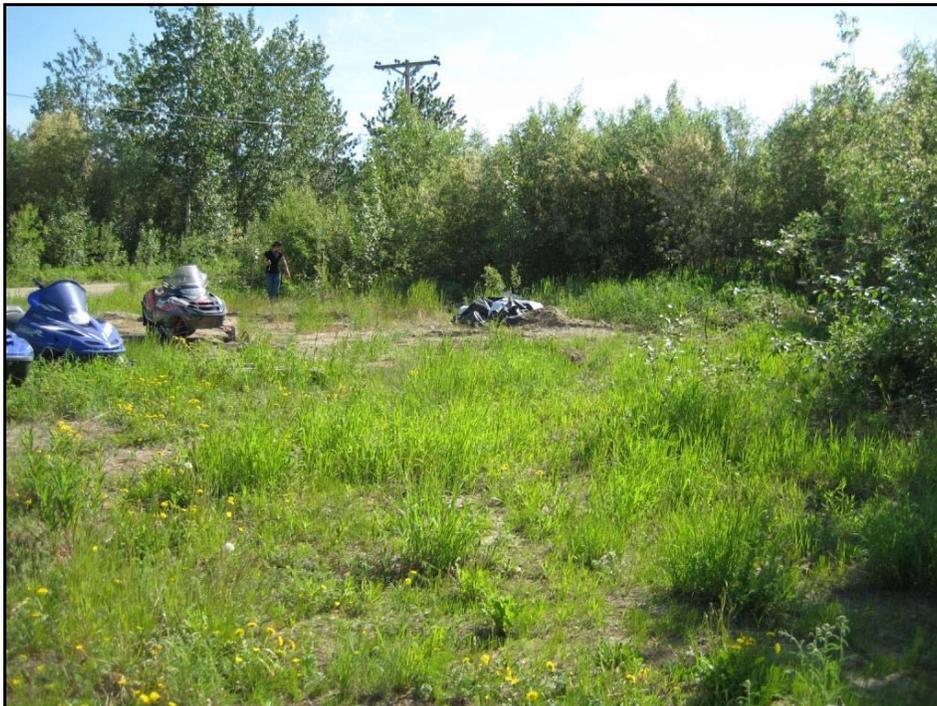
Photograph 6: Tanana Power Company known contaminated site.

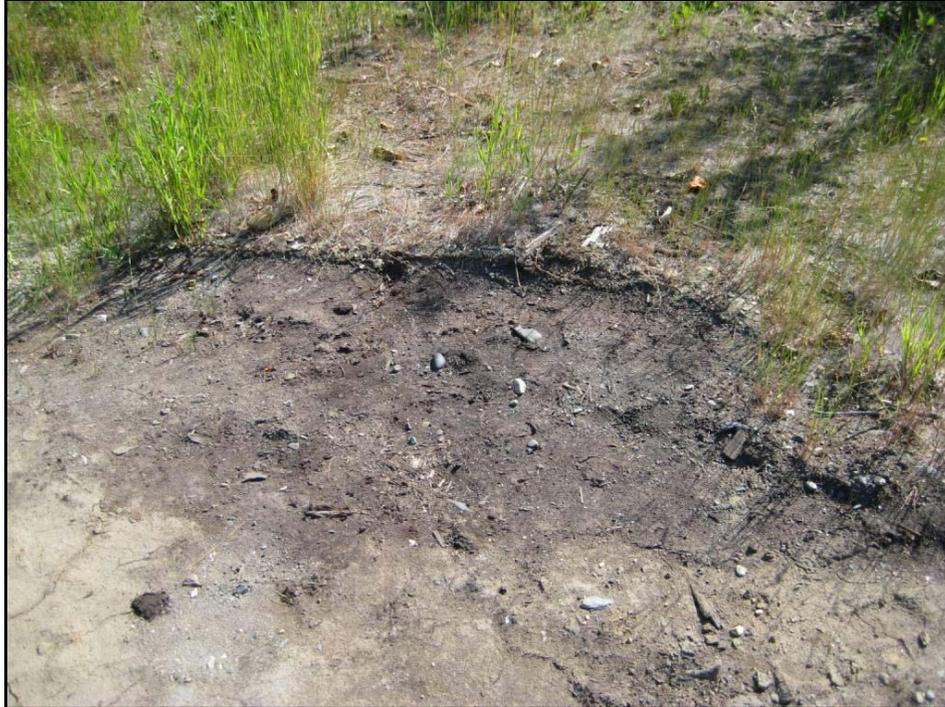
Photograph 7: Soil staining with odor at the *Tanana Power Company* known contaminated site.

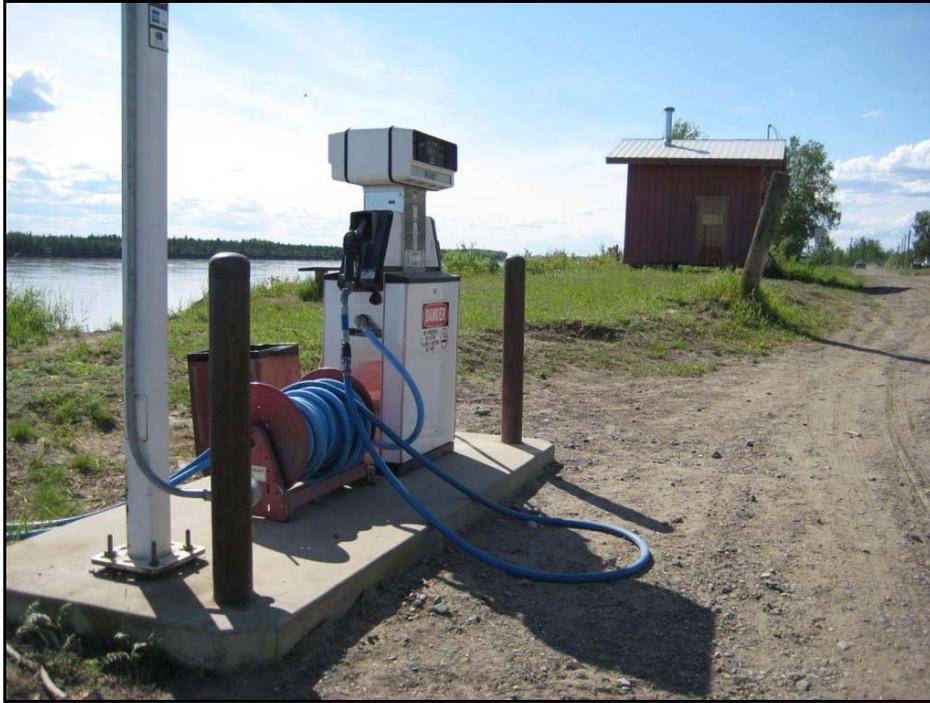
Photograph 9: The dispenser at Tanana Gas Company Fuel Station site of environmental concern.

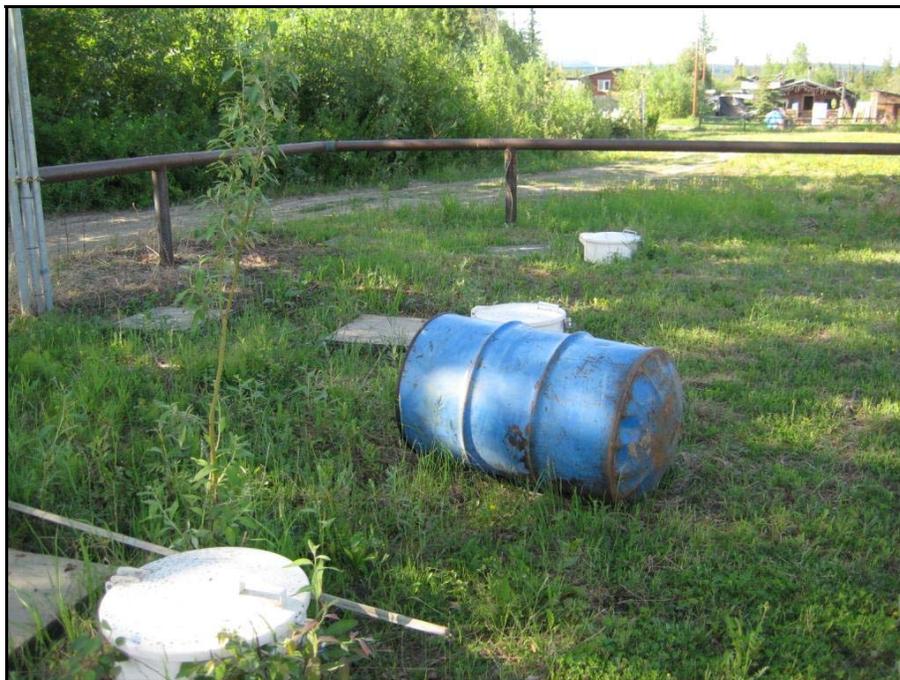
The Tanana Gas Company is identified as a closed LUST site in the DEC LUST database, therefore, the former underground storage tank is not included as a potential source of contamination. A bulging drum containing unknown liquids was observed on the property during the site visit. This drum has the potential for leaks and could be a possible contamination source. The Tanana Gas Company Fuel Station is shown in photographs 9 and 10 in Appendix B.

Photograph 10: Expanded drum above UST's at the Tanana Gas Company Fuel Station site of environmental concern.

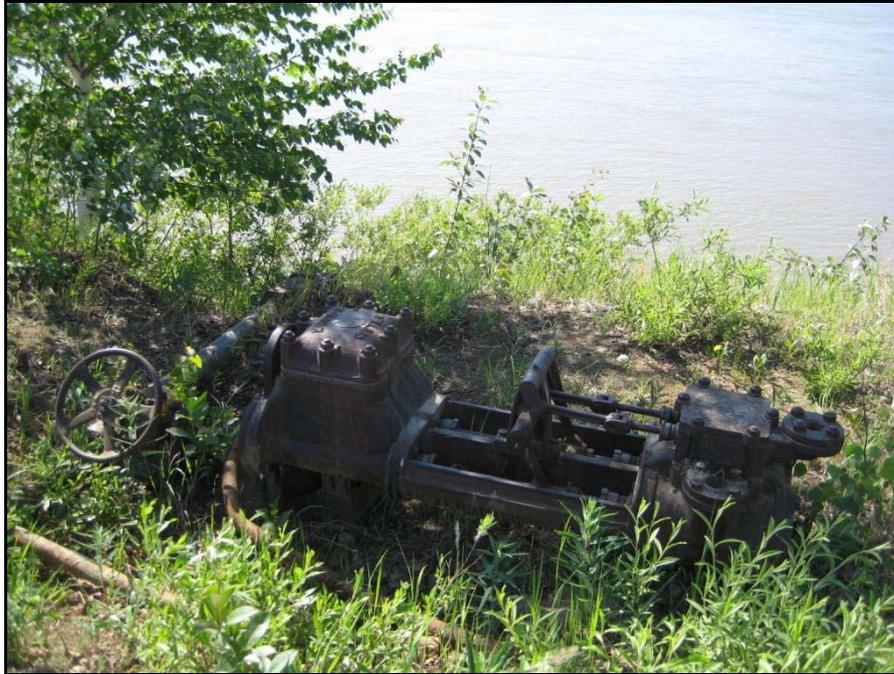
Wooden containers and wood stave tanks were reportedly used to store fuel for the Fort Gibbon facility. Wood alone is not sufficient containment for fuel, and it is likely that historical contamination is present in the areas of any former wooden fuel storage containers. Additionally, an old pump reportedly associated with the wood stave tank farm was observed during the site visit. The pump was in poor condition and any oil used to operate this pump likely has been released. It is not known when this system was decommissioned. Photograph 11 in Appendix B shows the pump at the site.

Photograph 11: Old pump which fueled the Former Fort Gibbon Wood Stave Tank Farm site of environmental concern.

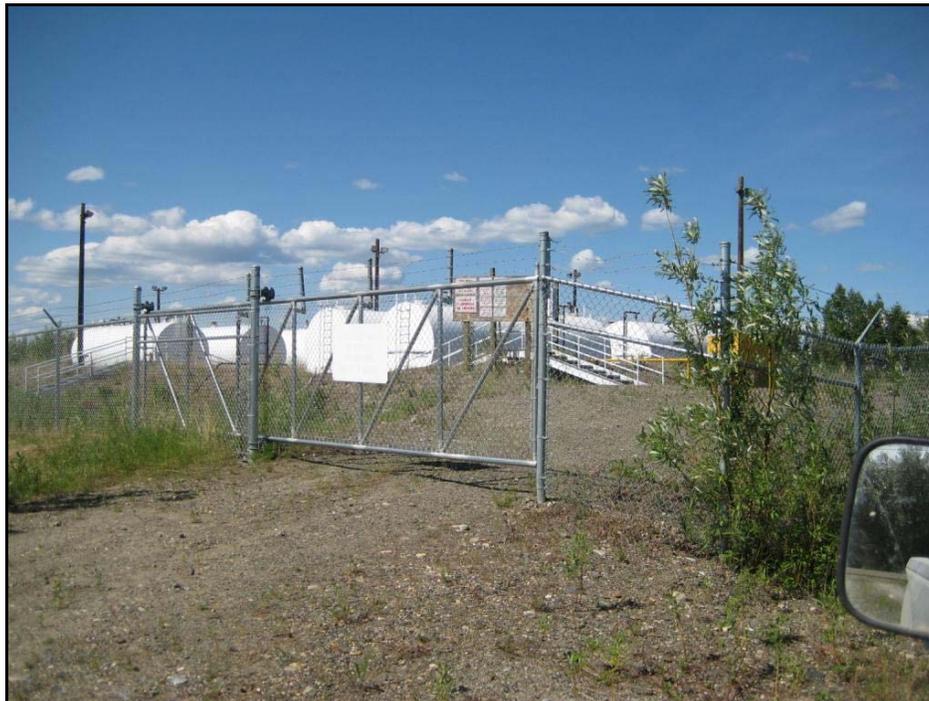
Tanks stored at the Tanana Power Company include eight 25,000-gallon capacity diesel storage tanks, two 25,000-gallon capacity compartment diesel tanks, one 4,000-gallon capacity city fuel dispenser tank, and one empty 25,000-gallon capacity contingency tank. While this is a bulk petroleum storage facility and could be a potential contaminated site, no staining, stressed vegetation, or other evidence of spills were observed during the site visit. The Tanana Power Company is shown in photograph 12 in Appendix B.

Photograph 12: Tank farm at the Tanana Power Company site of environmental concern.

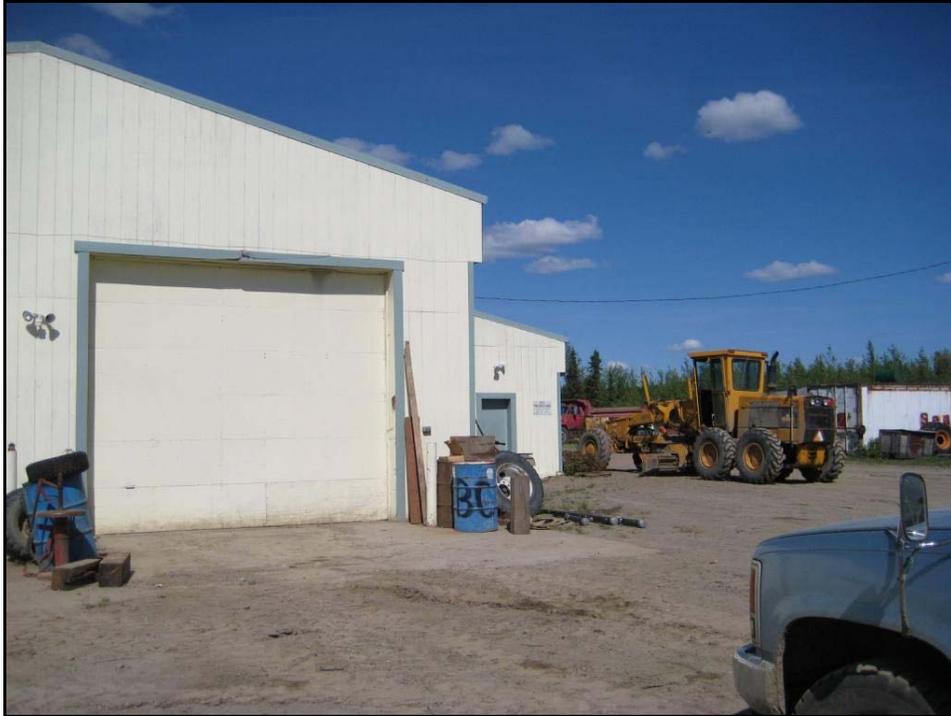
Multiple miscellaneous bulk fuel storage tanks under 1,000 gallons, as well as heavy machinery identified in Section 6.3, are stored at the city shop. There was some minor staining observed during the site visit indicating a possible release at this site. The City Shop / Garage are shown in photographs 13 and 14 in Appendix B.

Photograph 13: City Shop/Garage site of environmental concern.

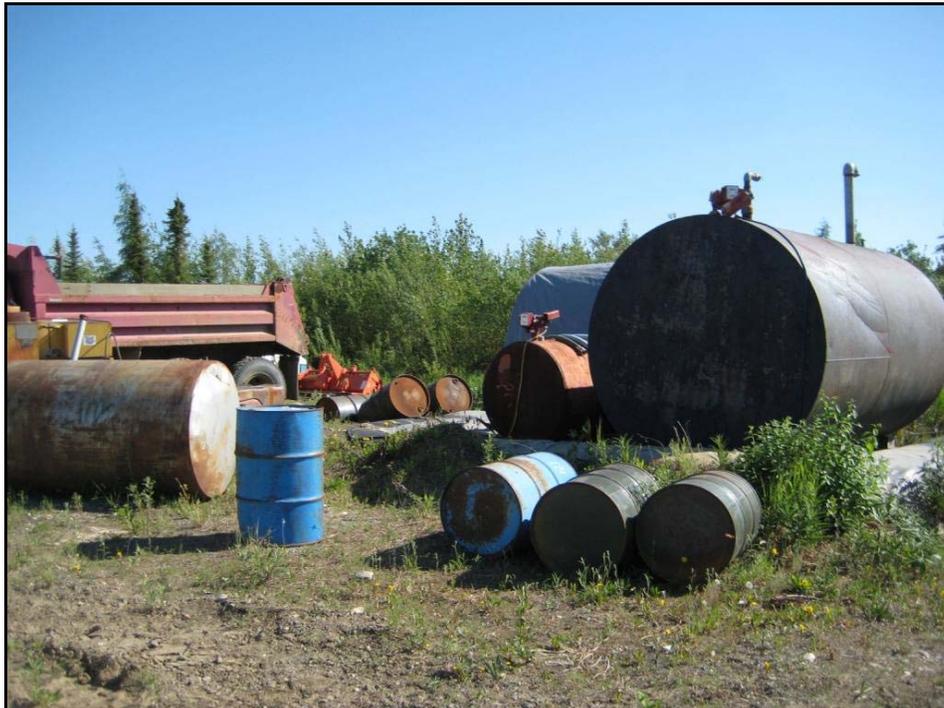
Photograph 14: Tanks and drums at the City Shop/Garage site of environmental concern..

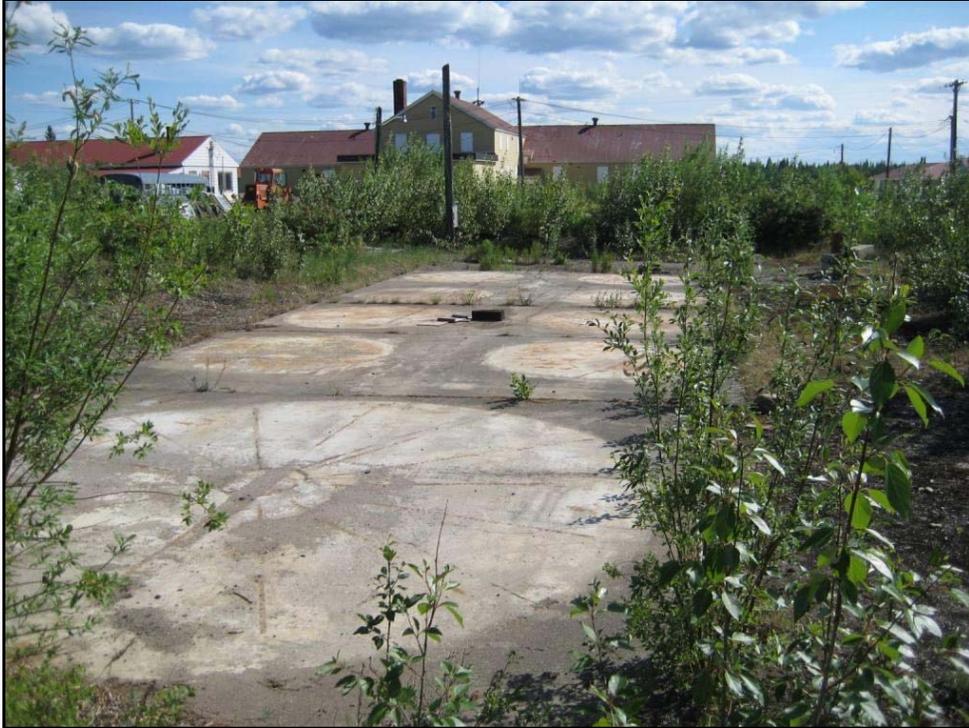
Photograph 15: IHS Tanana Health Center contaminated site former tank farm.

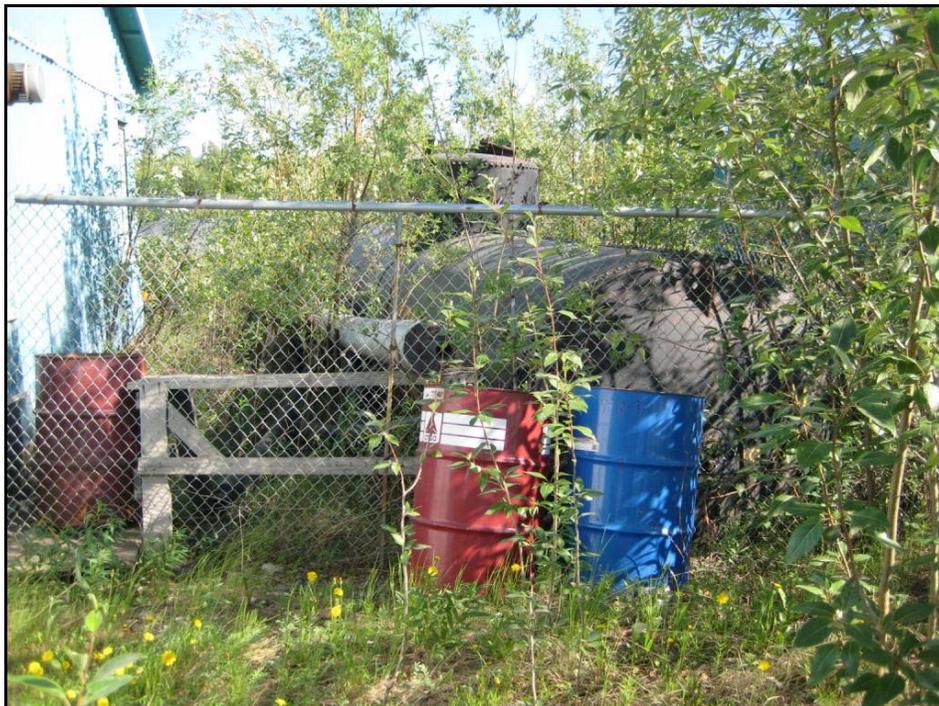
Two 55-gallon capacity drums and a 10,330-gallon train fuel tank were observed at the site of the former washeteria during SLR's site visit. No soil staining was observed at this facility; however, a fuel odor was noted indicating contamination is present in this area. The site is shown in photograph 20 in Appendix B.

Photograph 20: 10,000 gallon train-car fuel tank used for heating the Former Washeteria site of environmental concern.

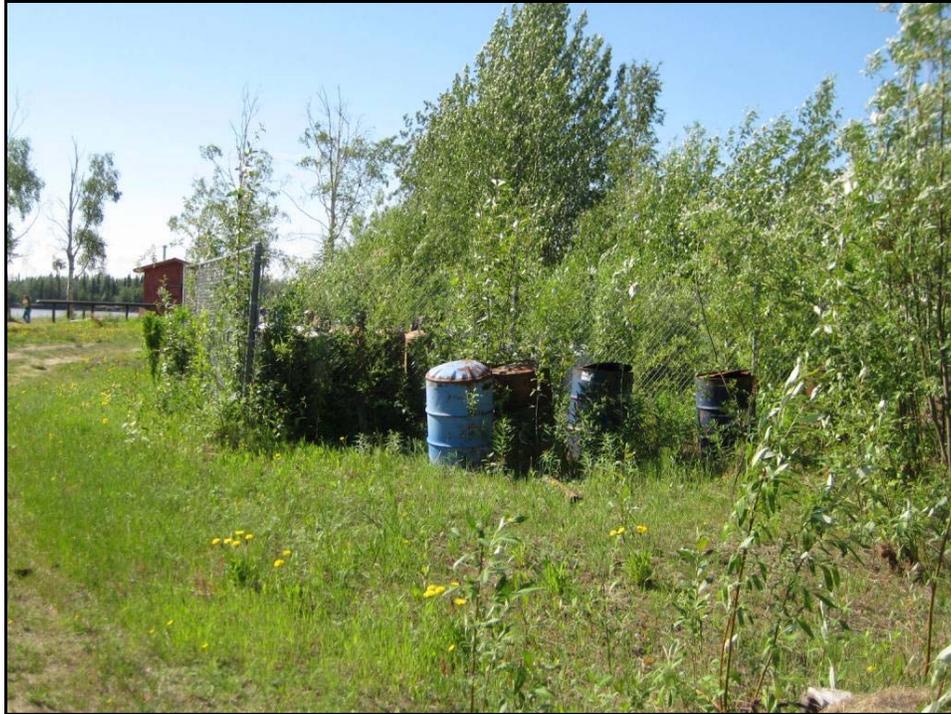
This drum storage area was observed during the site visit. Approximately eight drums and 30 gas cylinders were present at the time of observation. All of the drums appeared to be in poor condition and one of the drums was bulging. It is possible the weathered drums at this

location have previously caused a release and potential contamination. The site area is shown in photograph 21 in Appendix B.

Photograph 21: Second Avenue Drum Storage Area site of environmental concern.

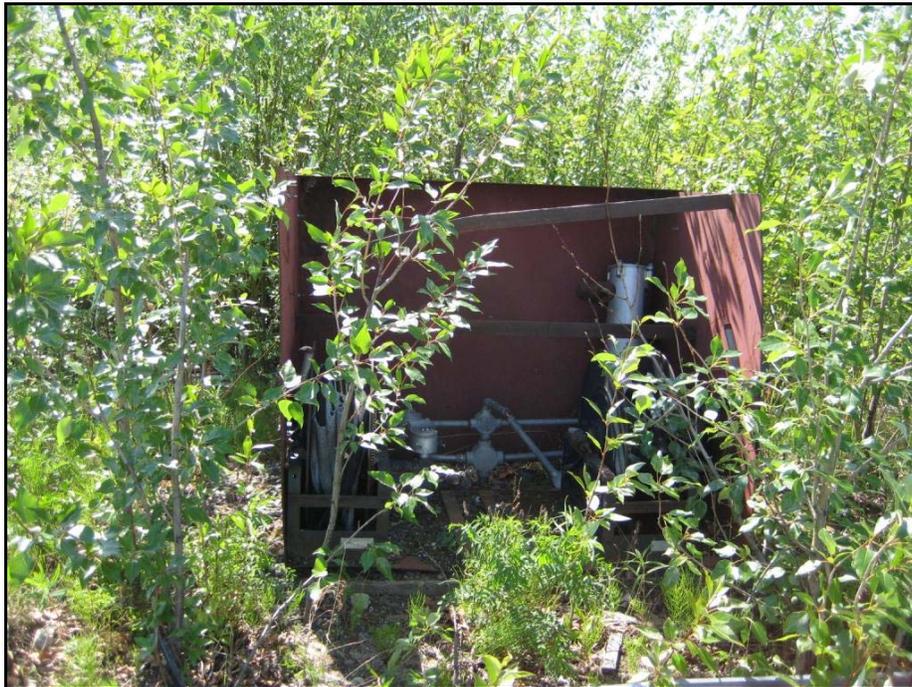
Three rail tank cars, each reportedly 15,000-gallons in size, are buried near the runway at the airport. The tanks have manholes visibly protruding upwards through the ground surface. A former fuel dispenser is located near the tanks. No evidence of fuel spills at this area was observed; however, as a bulk fuel storage location, this area is a potential contamination source. The tanks are reportedly abandoned and information on the owner and operational history of this fuel storage and dispensing system was not available. The site is shown in photographs 22 and 23 in Appendix B.

Photograph 22: This dispensing unit formerly drew fuel from the Buried Rail Cars site of environmental concern.

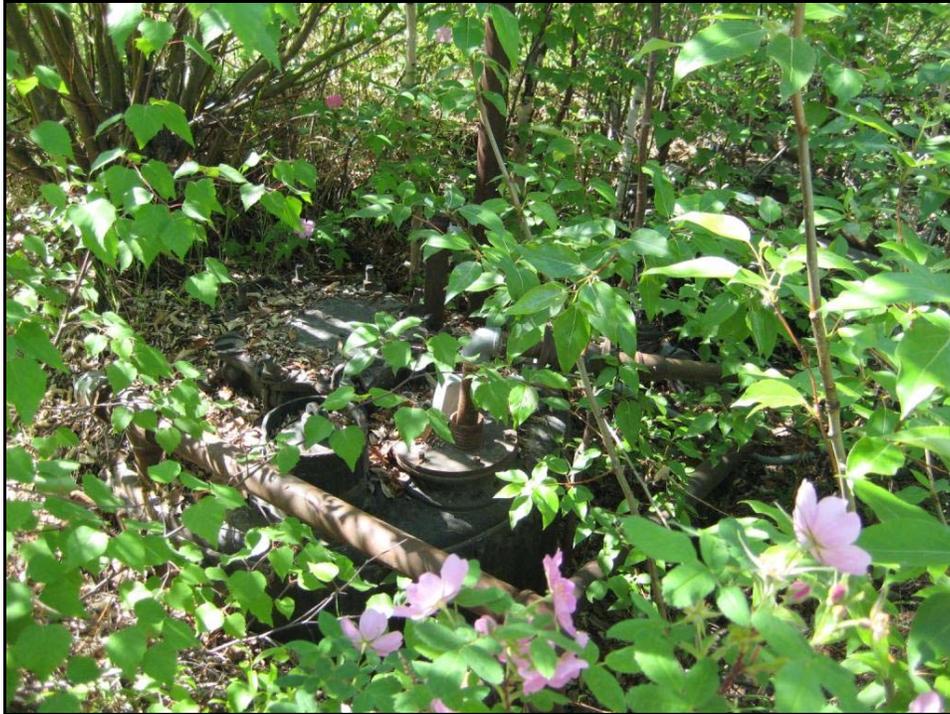
Photograph 23: Manhole to one of the Buried Rail Cars site of environmental concern.

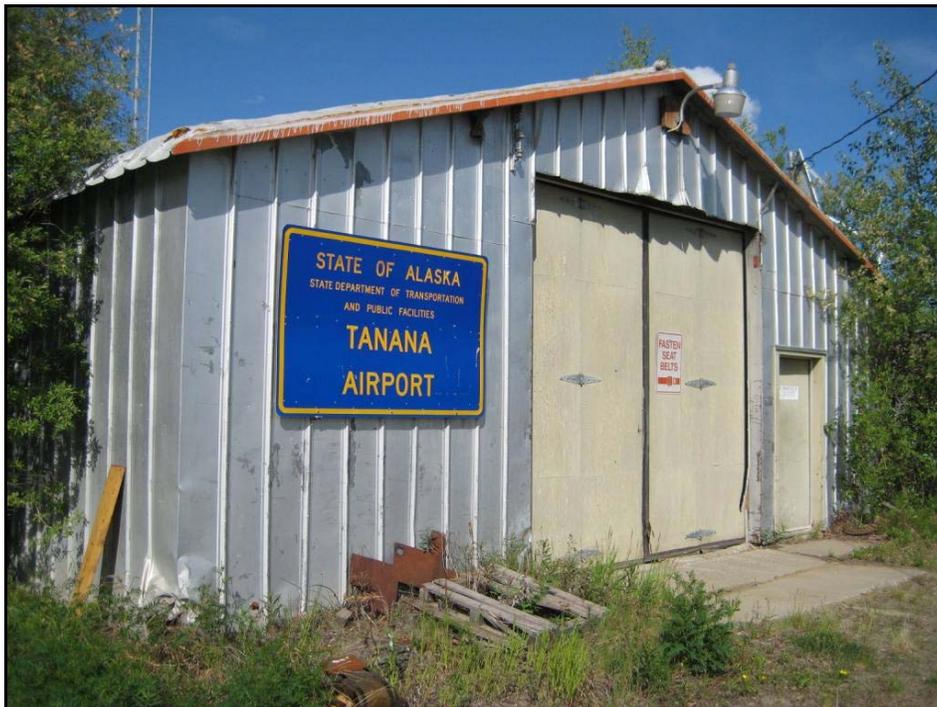
DEC File Number	Site Owner	Site Name	History	Recommendations	Reference
			investigations at the former AST location indicate DRO, benzene, and ethylbenzene above ADEC cleanup levels are present in soils around the former AST. The site is shown in photograph 24 of Appendix B.

Photograph 24: ADOT&PF Tanana Maintenance Shop
