Division of Spill Prevention and Response Contaminated Sites Program

ADOT&PF REGIONAL COMPLEX - JUNEAU

Summary updated: June 2005

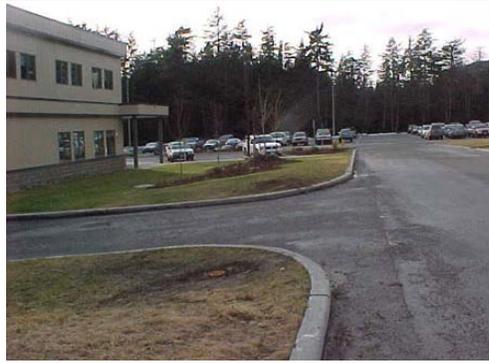
Just left and down from the center of the photo below is a monitoring well used to track migration of contamination in the ground water. Ground water flow is from right to left in this photo looking west; Marine Highway Safety Building is on the left.
