# Division of Spill Prevention and Response Contaminated Sites Program

## ANIAK WHITE ALICE SITE

**Database Name:** Aniak White Alice Site/Middle School

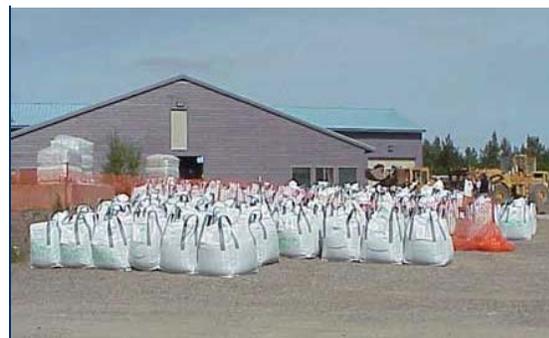
Super sacks filled with contaminated soil outside the Joe Parent School building await shipment to an off-site permitted disposal facility. (Shannon and Wilson photo)

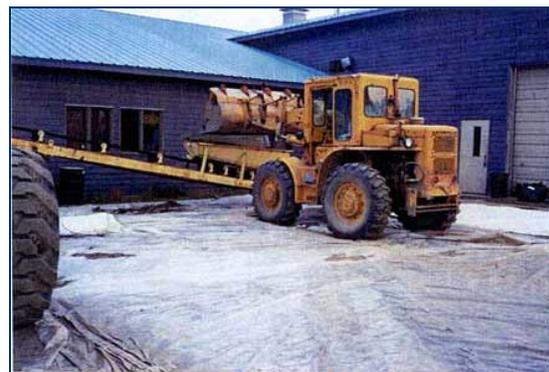
The excavation and removal of PCB-contaminated soil is shown outside the Joe Parent School building in 2001. (Shannon and Wilson photo)

Between 1998 and 2001, DEC hired contractors to better characterize the extent and location of remaining PCB contamination adjacent to the wood shop and to clean up a portion of the site. Roughly 870 tons of PCB-contaminated soil were excavated and shipped off-site for disposal. The PCB-contaminated soil that remained in the area was under the temporary cap (a liner and clean soil); therefore, there was no current exposure to it. ([See report below](#), "PCB Cleanup, Aniak Middle School," Shannon and Wilson, December 2001.)

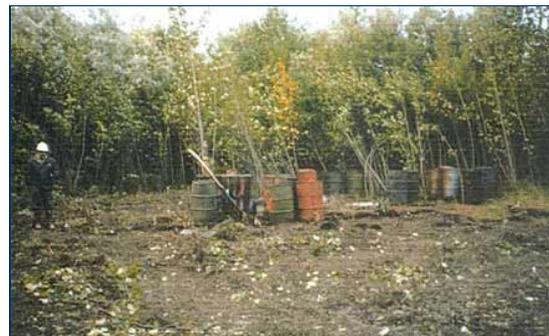
Drums on the site as they appeared before the U.S. Army Corps of Engineers removed them in August 1998.

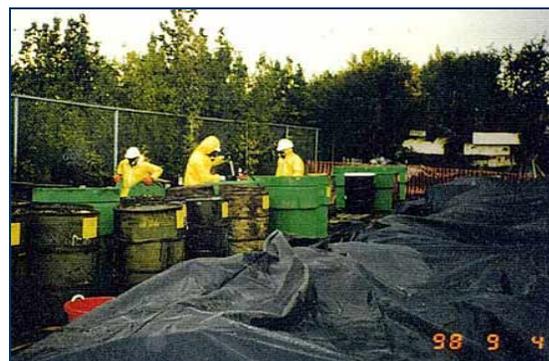
Workers prepare drums during a U.S. Army Corps of Engineers' removal in August 1998.

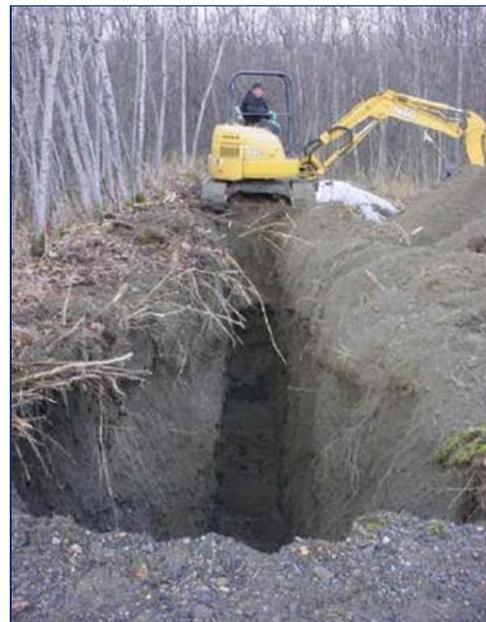
In October 2006, DEC's contractor sampled the contents of the former WACS septic system, soil around the septic system and soil near a former drum storage area. The results showed concentrations of PCBs, arsenic, chromium and trichloroethylene (TCE) above cleanup levels in the septic system and in soil, thus expanding the area of concern and contaminants that warrant cleanup. ([See report below](#), "Septic System and Area F Characterization," May 2007.)

A septic trench is dug in Aniak in October 2006 to allow for sampling. The trench was backfilled after sampling.
