BENTLEY MALL EAST SATELLITE BUILDING

Database Name: Bentley Mall East Satellite

Summary updated: June 2008

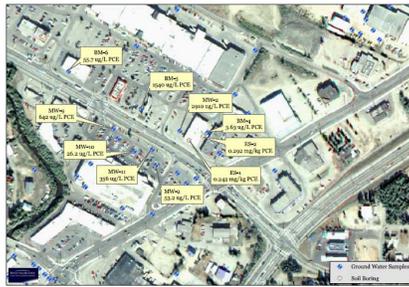
Figure 2: Bentley Mall East Satellite Building

1. PCE was detected above DEC clean up levels in two soil borings (ES-1 and ES-2) that were located in close proximity to the East Satellite

- Building (see Figure 2). The concentrations were 0.242 milligrams per kilograms (mg/kg) and 0.292 mg/kg respectively for ES-1 and ES-2 respectively. The cleanup level is 0.03 mg/kg.

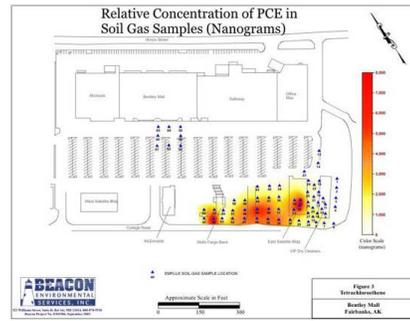
Figure 3: Bentley Mall East Satellite Building

4. Monitoring wells located hydraulically up gradient from VIP Cleaners did not detect PCE.
 5. Elevated levels of PCE were detected in the soil gas samples in close proximity to the East Satellite Building and in several areas along the private sewer line that runs to the west from the building (see Figure 3). The elevated soil gas levels can be caused by PCE in the vadose zone soil (soil between the ground surface and the water table), PCE in the groundwater, or a combination of both.

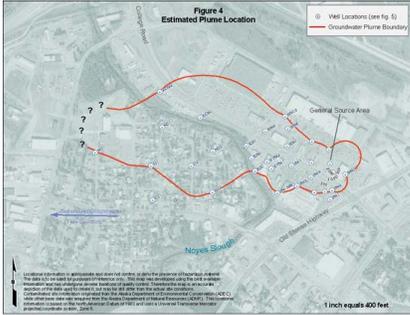
Figure 4

The estimated horizontal extent of the PCE groundwater plume is shown in [Figure 4](#). The figure was generated by the DEC using a mathematical interpolation algorithm. It estimates the location of the groundwater plume. The actual location of the plume may differ somewhat from what is shown.

The red contour line in [Figure 4](#) represents the 5 micrograms per liter ($\mu\text{g/L}$) concentration which is the public safe drinking water standard. The area enclosed by the 5 $\mu\text{g/L}$ contour represents the estimated area where the groundwater is above the public safe drinking water standard. ADEC wants any private wells within this area identified and possibly sampled in the future.

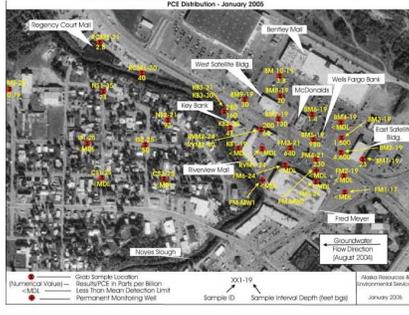
Figure 5

Additional detailed information is provided in [Figure 5](#). PCE concentrations are shown for the individual sampling locations. At some sampling locations, PCE was detected at two different depths at the same location. Please see Figure 5's legend for additional explanation.

The possibility of vapors from either PCE contaminated soil or groundwater migrating into nearby buildings is under investigation. Indoor air was recently sampled at the East Satellite and Wells Fargo buildings (see [Figure 5](#) for locations). The preliminary sampling results are being evaluated.
