PHOTOGRAPHS

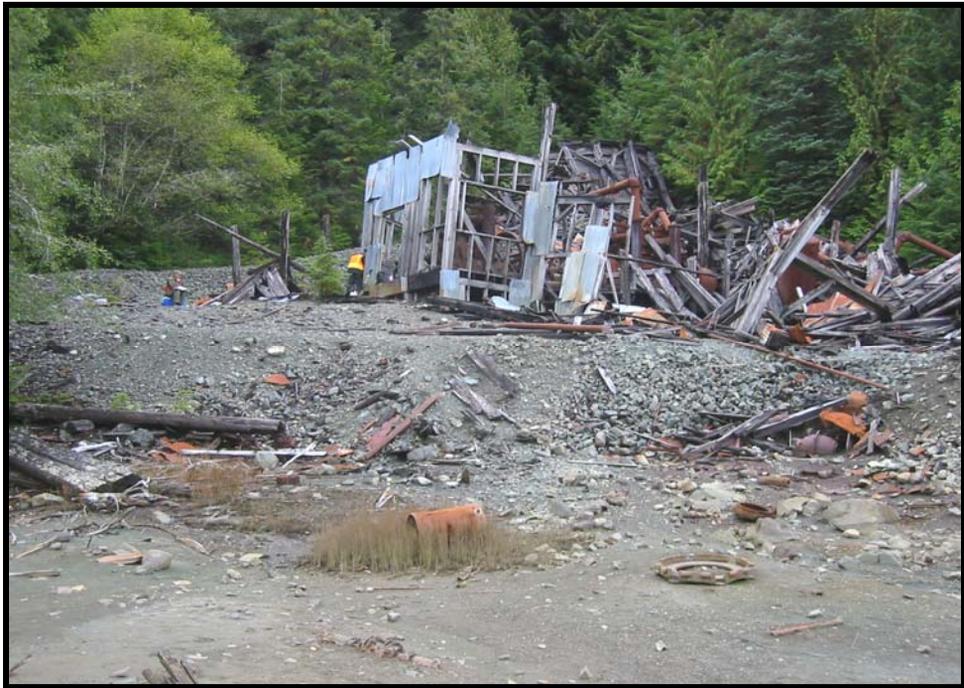
Photograph 1. Mill site and associated waste rock and tailings.

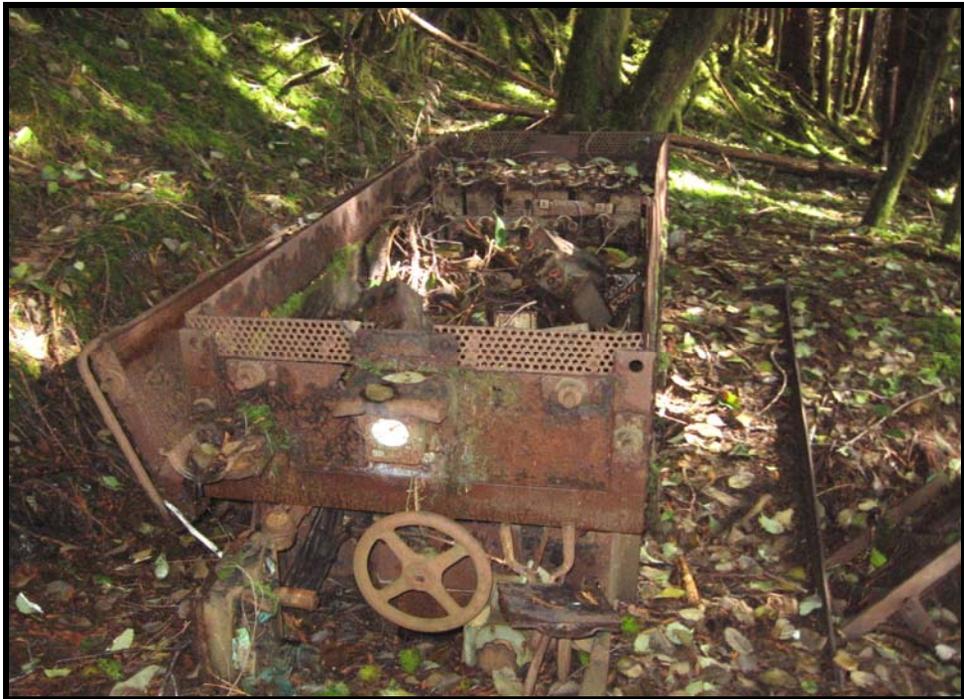
Photograph 2. Electric locomotive.

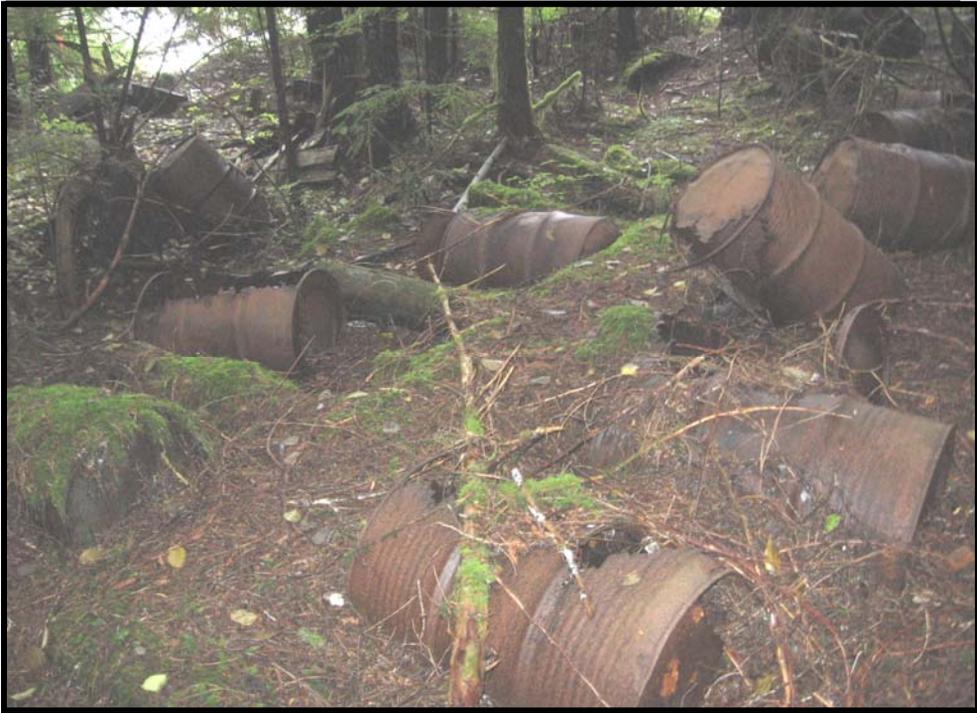
Photograph 3. One of several drum caches.

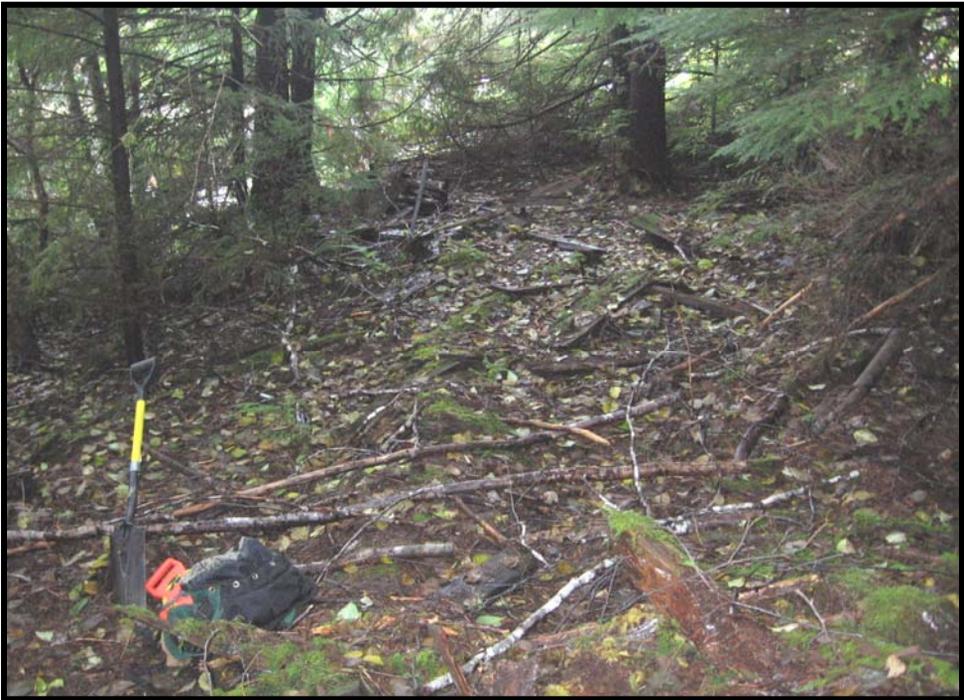
Photograph 4. Former location of building C4.

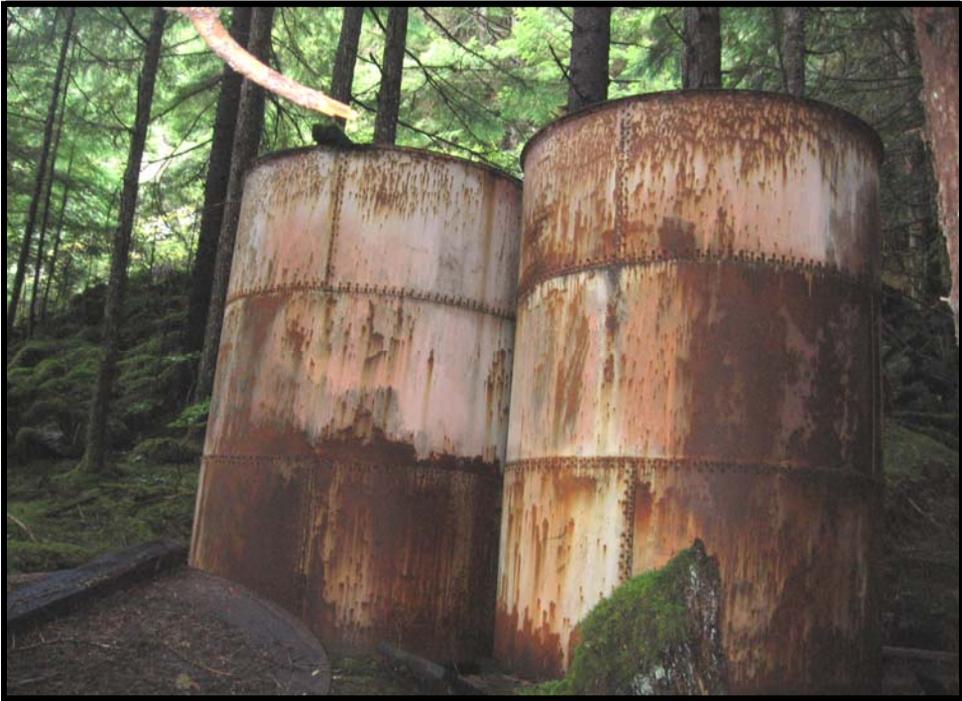
Photograph 5. AST area near mill site.

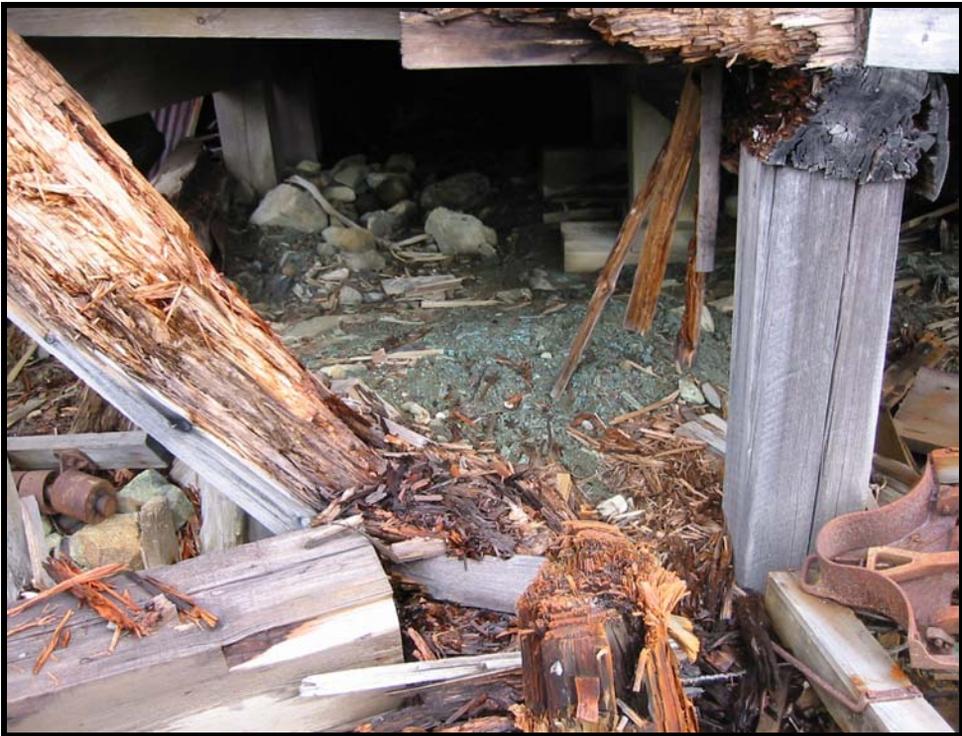
Photograph 6. Unsaturated tailings beneath mill.

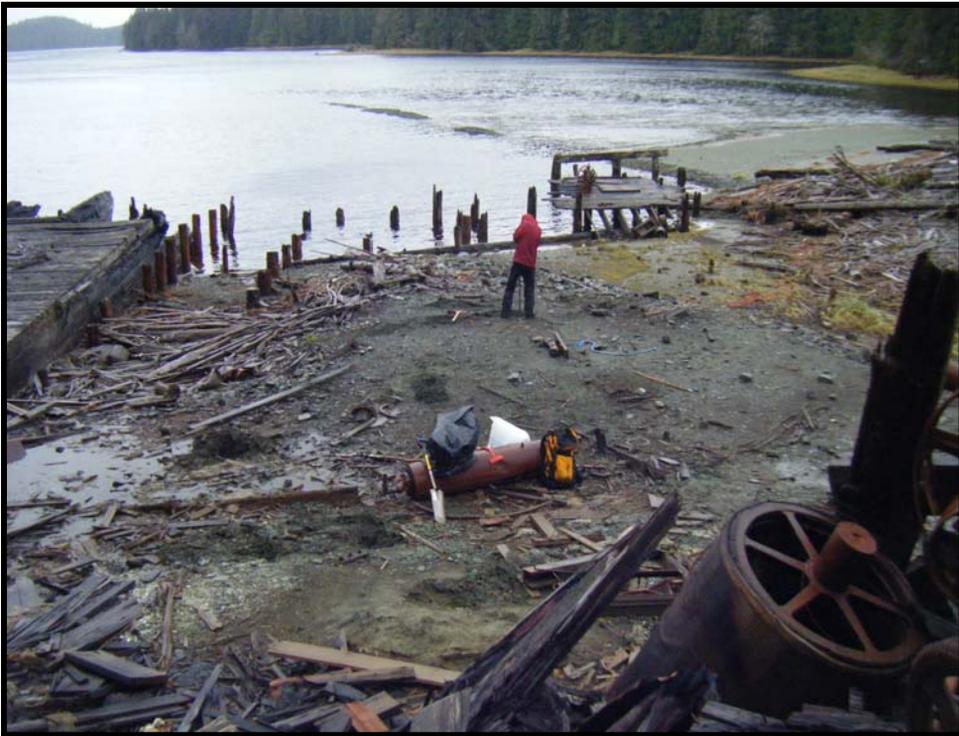
Photograph 7. Test holes advanced near barge, November 2009.

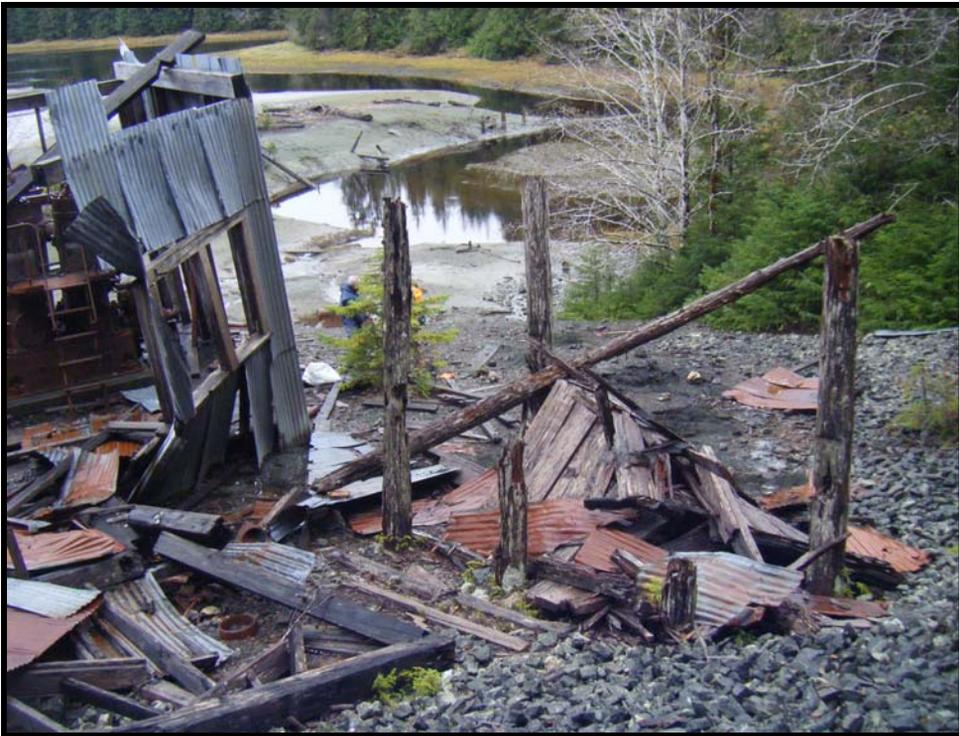
Photograph 8. Location of waste rock sample collected from D1 and rock mixed in with mine tailings.

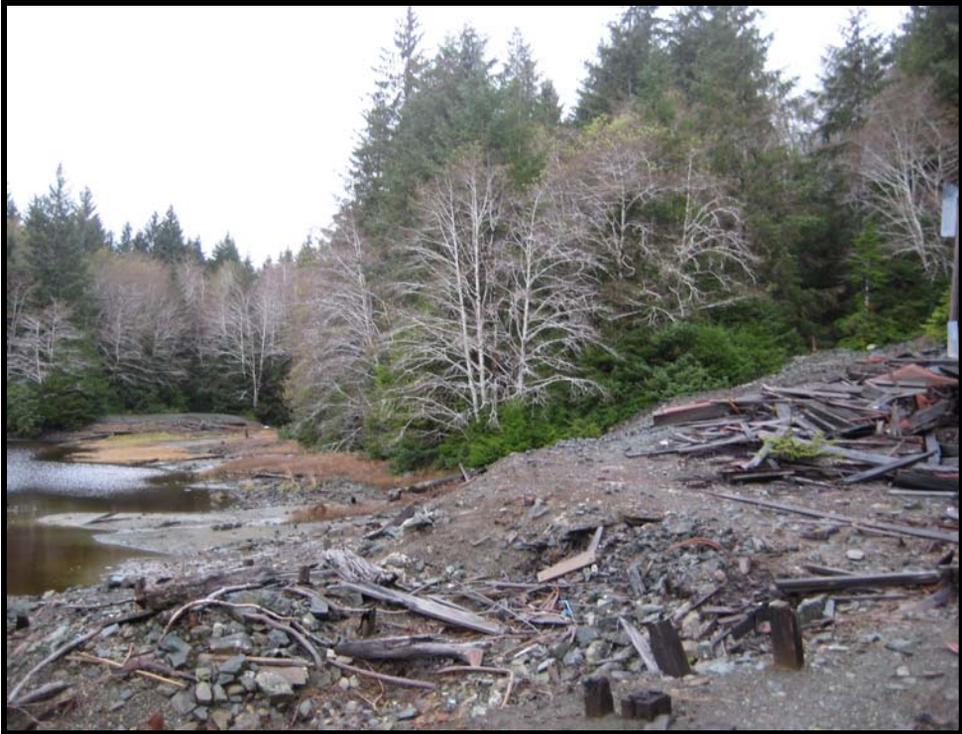
Photograph 9. Location of mill site repository between Unnamed Stream and mill site.

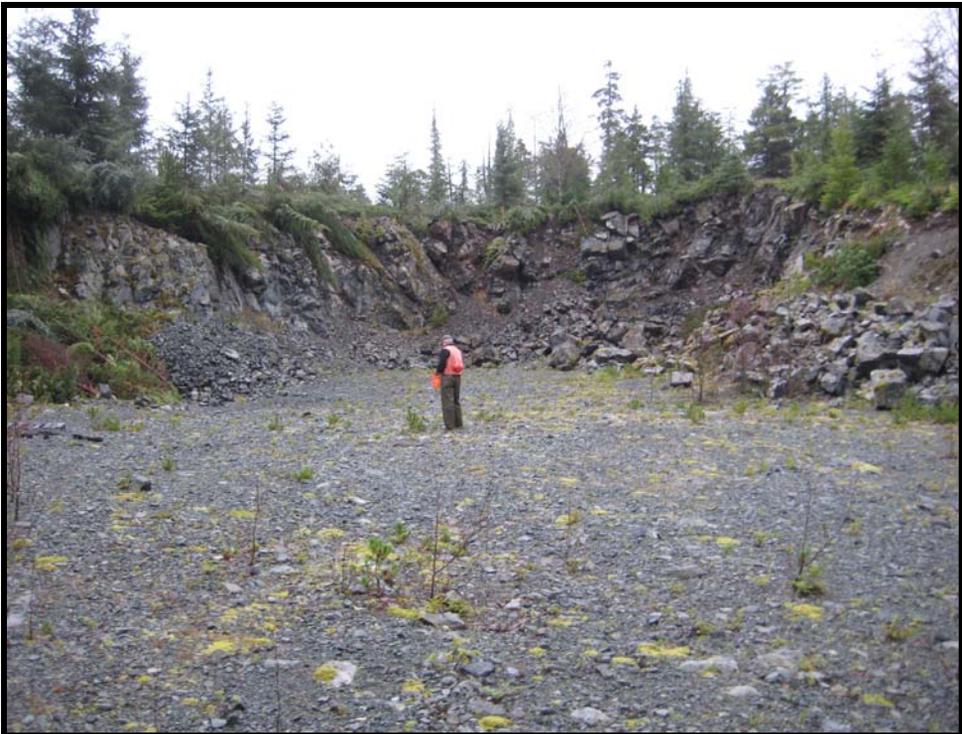
Photograph 10. Borrow Pit West (Alternative 2 Primary) repository.

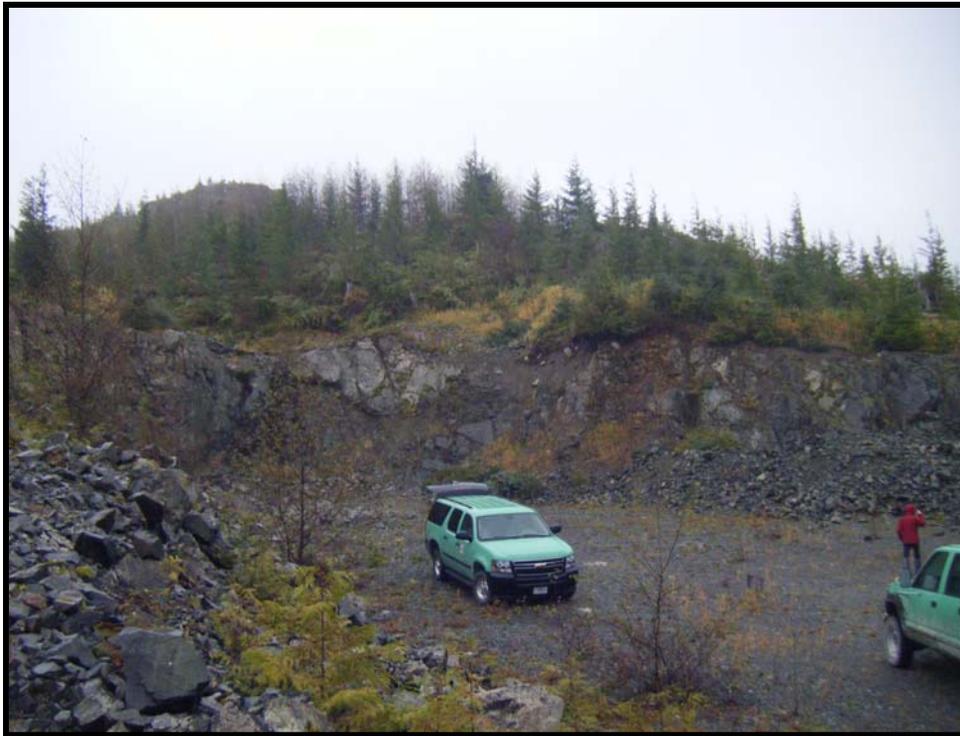
Photograph 11. Borrow Pit East (Alternative 2 Secondary) repository.
