**Greater Kuparuk Area (GKA)  
Alpine Field  
Corrosion Programs Overview**

**April 7, 2003**

***Commitment to Corrosion Monitoring***  
***3<sup>rd</sup> Annual Report to the Alaska Department of Environmental Conservation***

**Prepared by  
ConocoPhillips Corrosion Team**

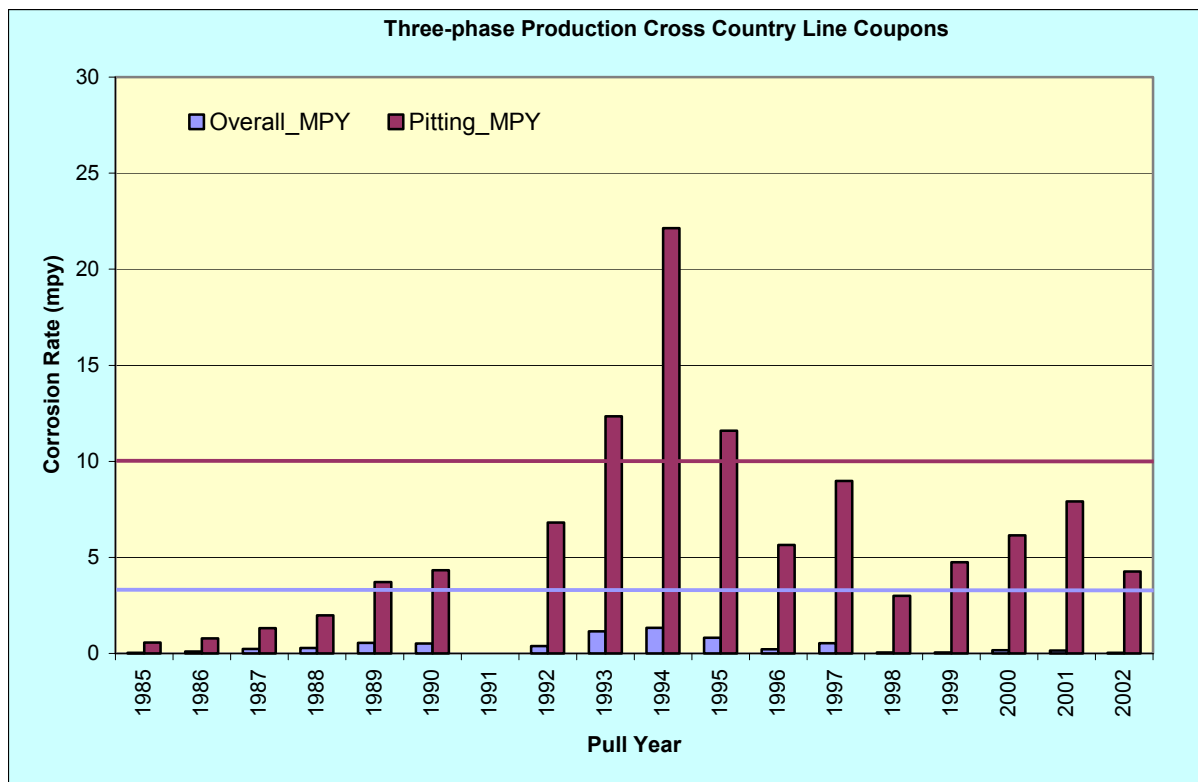
**Figure 1. Three-phase Production Cross-Country Line Coupons – general and pitting corrosion rates as a function of time.**

*Three-phase Production Cross-Country Lines:* The monitoring data summarized in Kuparuk Tables 1 and 2 and presented in Figure 1 suggest that general corrosion is under control. The data presented in the Tables 1 and 2 and in Figure 1 include corrosion coupon data from the wet oil lines.

Recurring CRM inspections also support the conclusion that corrosion is under control in the three-phase production cross-country lines. In 2002, 517 corrosion-rate monitoring (CRM) inspections were conducted, with 11 minor increases found (i.e. less than 3% of total CRM inspections resulted in an increase). Other internal inspection data also support the CRM data conclusions and are discussed in section 3.1.c, below.

In 2002, of the three wet oil lines only the 12" CPF2 Wet Oil Line showed any significant coupon corrosion rate; the corrosion inhibitor concentration was increased on this line.

Where corrosion rates exceeded targets, corrosion inhibitor concentrations were increased and/or the amount of inspection was increased. In 2002, coupon or probe corrosion rates exceeded targets on 10 lines and corrosion inhibitor concentrations were increased on all 10 of these lines. In 2002, inspection results indicated minor corrosion had occurred on 7 lines that did not have coupons or probes that exceeded the target corrosion rates; corrosion inhibitor concentrations were increased in all 7 of these lines. A complete listing of the 20 lines with corrosion rates that exceeded targets or where inspection indicated increase damage, is given Table A1 of Appendix A.

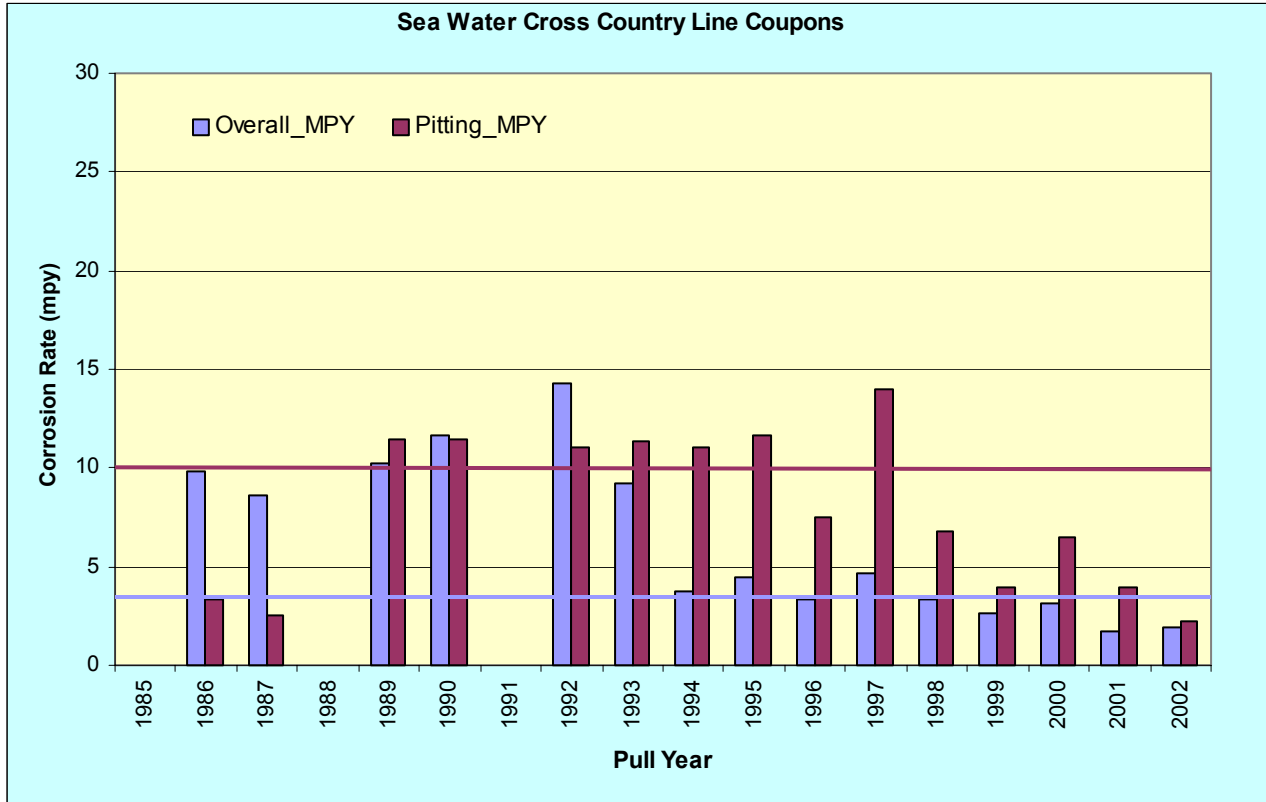
**Figure 2. Seawater Cross-Country Line Coupons – general and pitting corrosion rates as a function of time.**

*Sea Water Cross-Country Lines:* The monitoring data summarized in Kuparuk Tables 1 and 2 and presented in Figure 2 above, shows the average corrosion rates for the sea water cross-country line coupons remained under thresholds in 2002. UT inspections were conducted in the area of the coupons with the high general corrosion rates and no increases to existing minor damage were found. An ER probe has been installed in the same area with no appreciable corrosion rate noted.

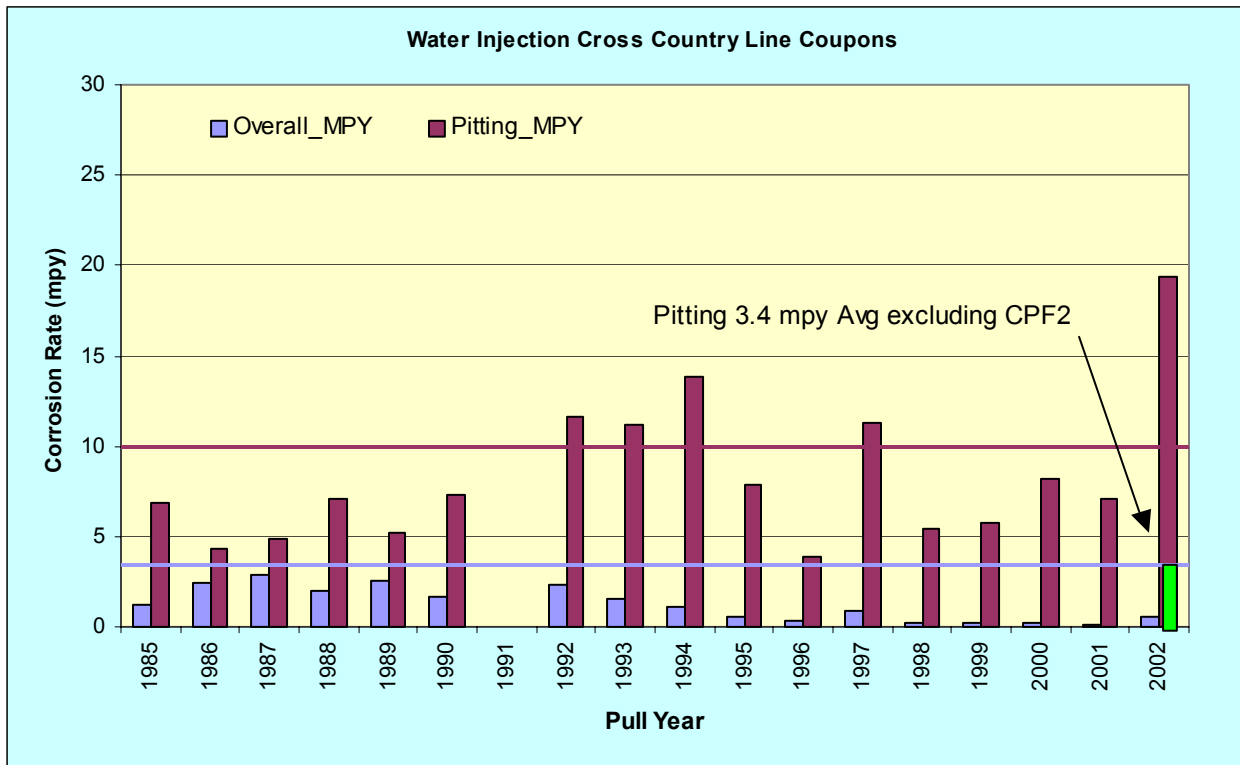
**Figure 3. Water Injection Cross-Country Line Coupons – general and pitting corrosion rates as a function of time.**

*Mixed Water Injection Cross-Country Lines:* The monitoring data summarized in Kuparuk Tables 1 and 2 and presented in Figure 3 show that average general corrosion rates are below the threshold, but that pitting rates for the field are above the threshold. Closer analysis of the data shows that the average pitting rate excluding CPF2 locations is well under the threshold. Recent inspection data from the CPF2 lines show some damage on three lines. This information, along with coupon results, was used to prioritize 2003 inspection efforts. RTR inspection work for 2003 will target 15,000 feet of cross-country water injection lines.

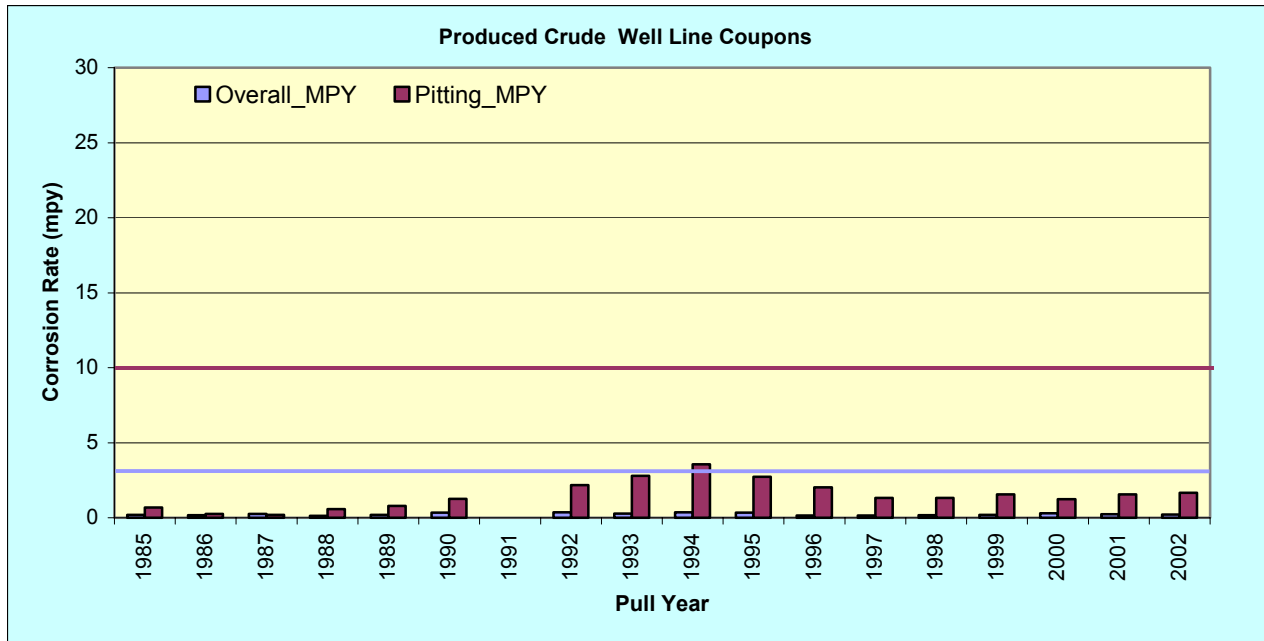
**Figure 4. Three-phase Production Well Line Coupons – general and pitting corrosion rates as a function of time.**

*Three-phase Production and Mixed Water Injection Well Flow Lines:* While the monitoring data summarized in Kuparuk Tables 1 and 2 and presented in Figures 4 and 5 suggest that corrosion rates are below targets, inspection data indicates that higher rates are actually being experienced. The well line inspection data are discussed in section 3.1.b below, and are a good example of why monitoring data alone cannot be relied upon to characterize corrosion in a given system.

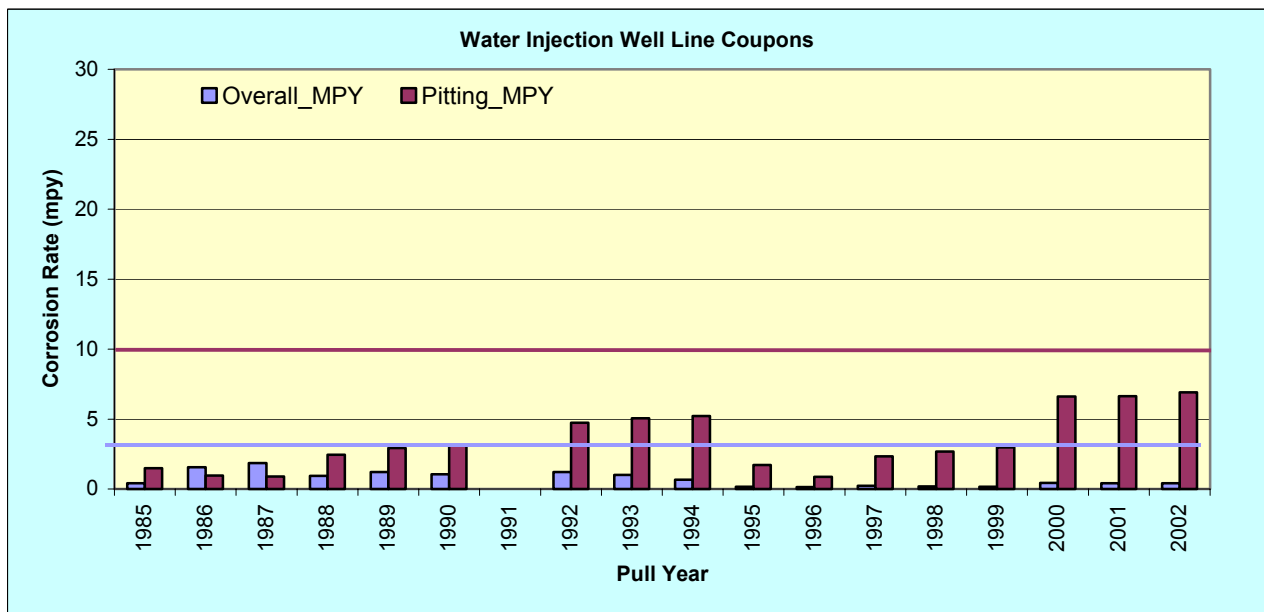
**Figure 5. Water Injection Well Line Coupons – general and pitting corrosion rates as a function of time.**

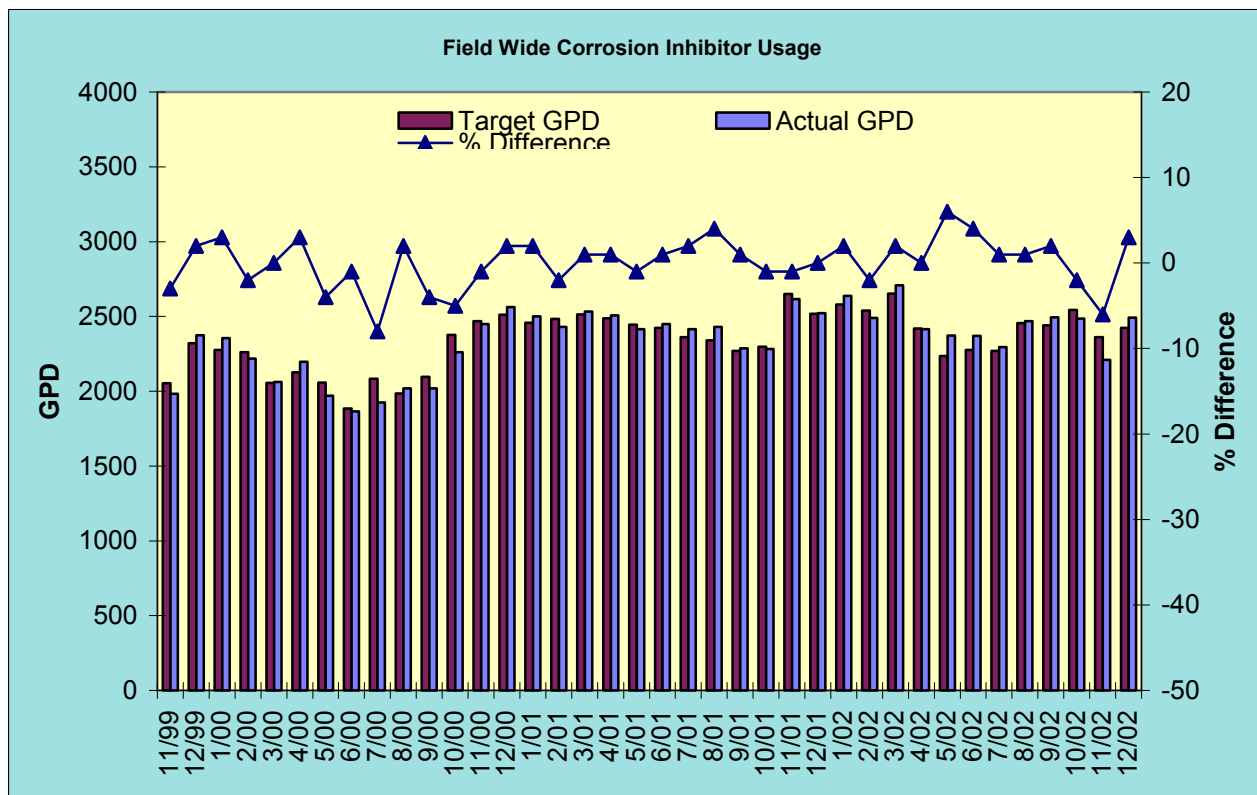
**Figure 6. Field-wide Corrosion Inhibitor Use – actual amount of corrosion inhibitor used per day, recommended amount of corrosion inhibitor used per day, and the percent difference between the actual and the recommended amounts.**

For the Kuparuk field, Figure 6 shows the actual number of gallons of corrosion inhibitor pumped per day, the recommended number of gallons of corrosion inhibitor per day, and the percent difference between the two. The difference fluctuated around zero percent deviation from the recommended amount of corrosion inhibitor; the average deviation for the year was 0.9%. The extreme variation seen in the November data was caused by the production upsets associated with the earthquake prorations.

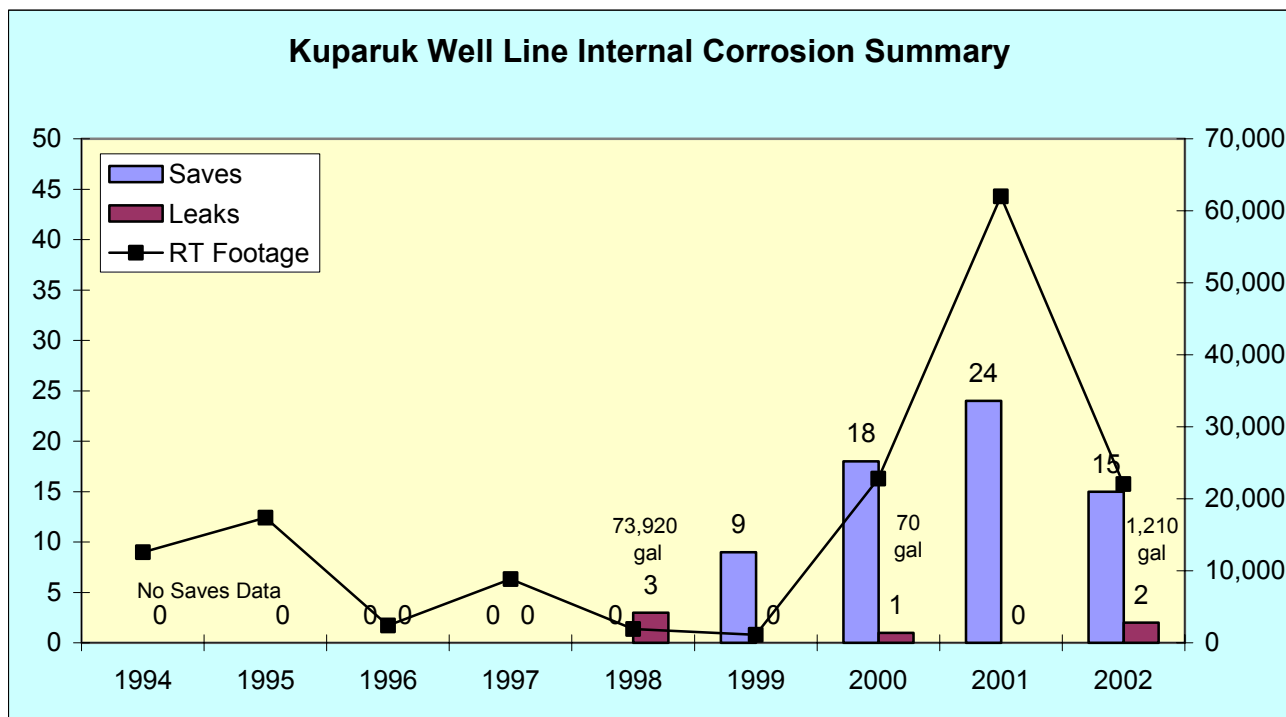
As indicated in Figure 8 below, repair recommendations were initiated on 17 lines (8 injection, 9 production) in 2002 because of internal corrosion damage. The two leaks were on production lines. Repairs typically consist of either sleeving or replacing the de-rated section of line. The graph indicates a decrease in inspection footage from 2001 to 2002. This was the first year we encountered well lines with obstructions that did not allow efficient use of the RTR crawler. As a result, these lines required manual RT as the primary inspection method. We met our primary 2002 goal of inspecting all well lines with a 0.312" nominal pipe wall thickness.

**Figure 8. Summary of Well Line Internal Corrosion Inspections – RT footage, leaks, and saves as a function of time.**

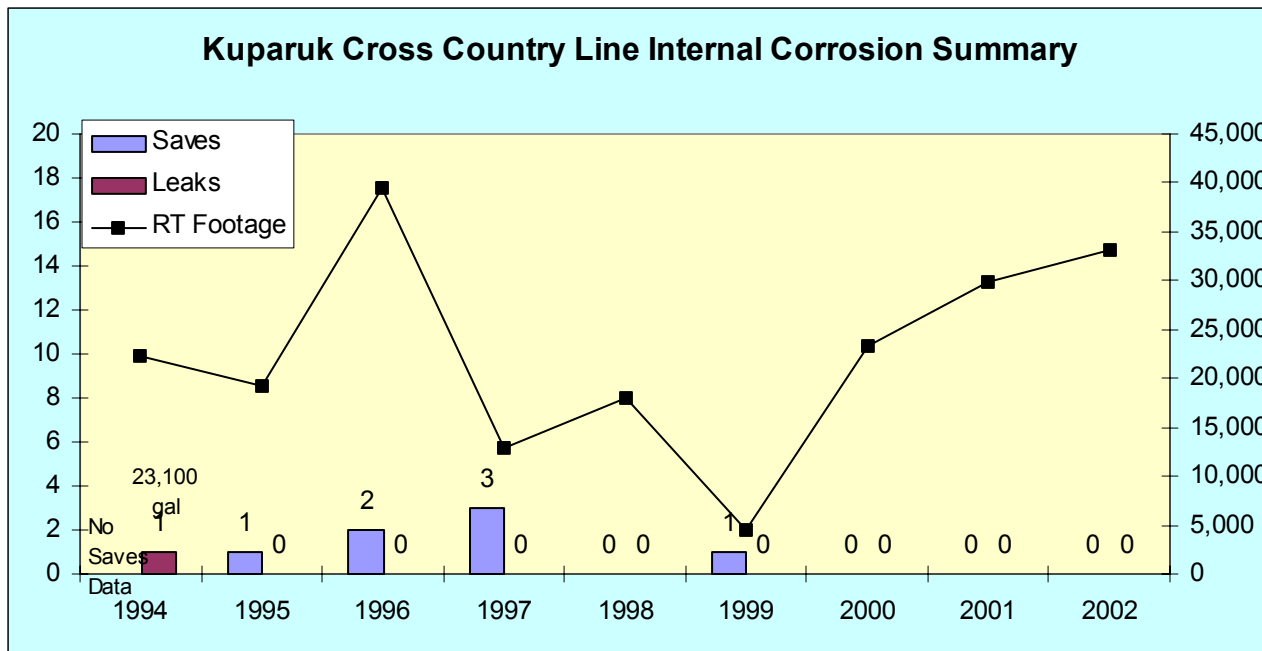
As indicated in Figure 9, no (0) repair recommendations were initiated on cross-country lines because of internal corrosion damage in 2002. Inspection results in Figure 9 indicate that the corrosion mitigation programs are adequately protecting the three-phase lines and the water injection lines.

**Figure 9. Summary of Cross-Country Line Internal Corrosion Inspections – RT footage, leaks, and saves as a function of time.**

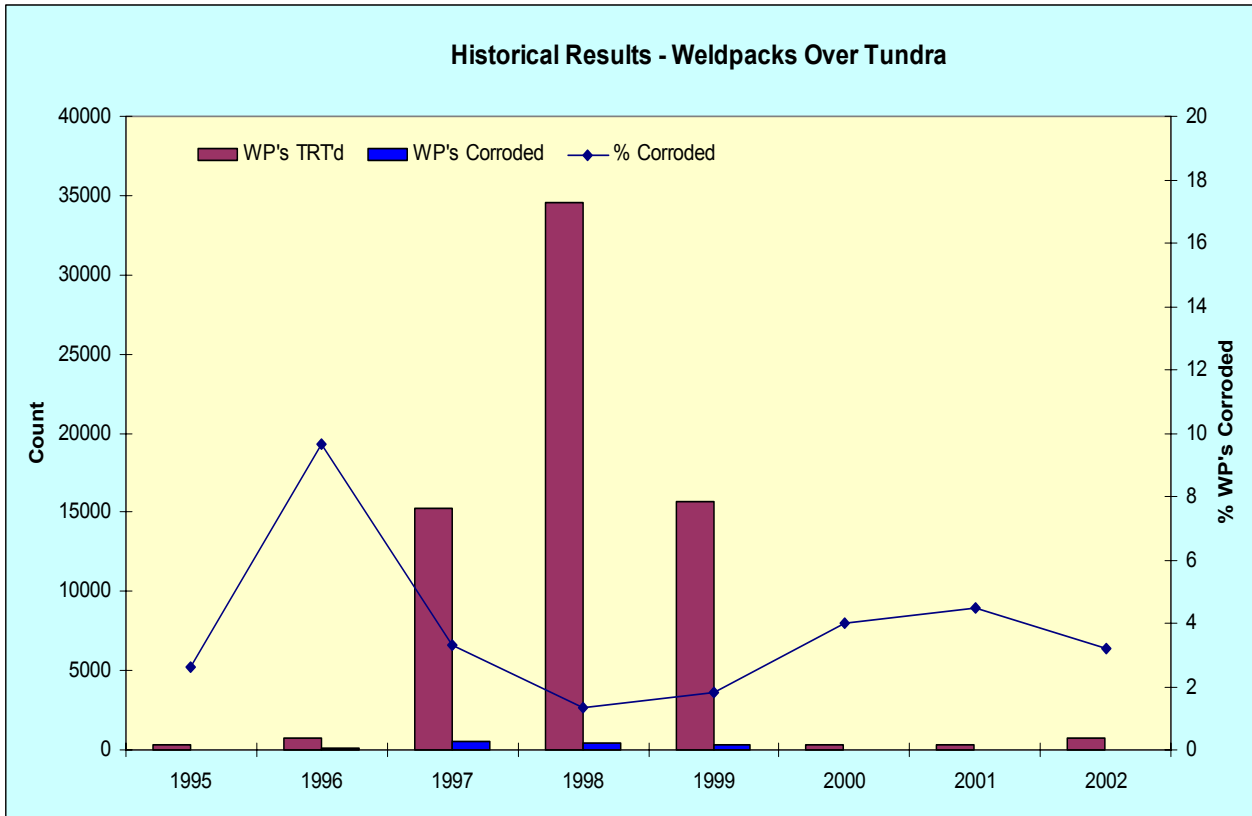
**Figure 10. Summary of Weld Packs on Cross-Country Lines over Tundra (off-pad) – number of weld packs inspected, number of weld packs corroded, and percent of weld packs corroded.**

Figure 10 illustrates the most-mature external corrosion inspection program of the three external corrosion programs. A review of results, obtained early in this program was initiated in 2002. A larger recur inspection program for these weld packs is scheduled to begin in 2003.

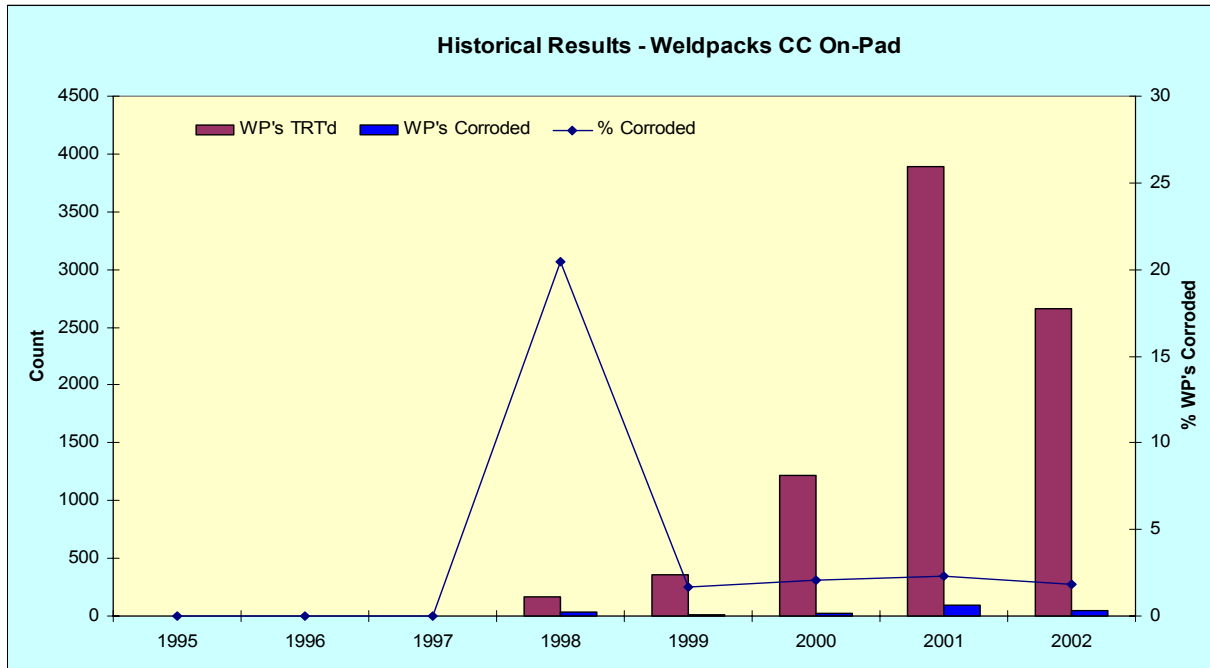
**Figure 11. Summary of Weld Packs on Cross-Country Lines on Pads – number of weld packs inspected, number of weld packs corroded, and percent of weld packs corroded.**

Figures 11 and 12 depict the results of the major focus of the external weld pack inspection program in 2002. The cross-country on-pad weld packs were inspected using a prioritization scheme based on the historical corroded-to-wet ratios of the over-tundra portions of the cross-country lines. The well line weld-packs were inspected using a prioritization scheme that examined the oldest, the hottest, and thinnest-walled lines first. As of year-end 2002, 92% of the cross-country on-pad weld-packs and 60% of the well line weld-packs have received their baseline TRT inspection.

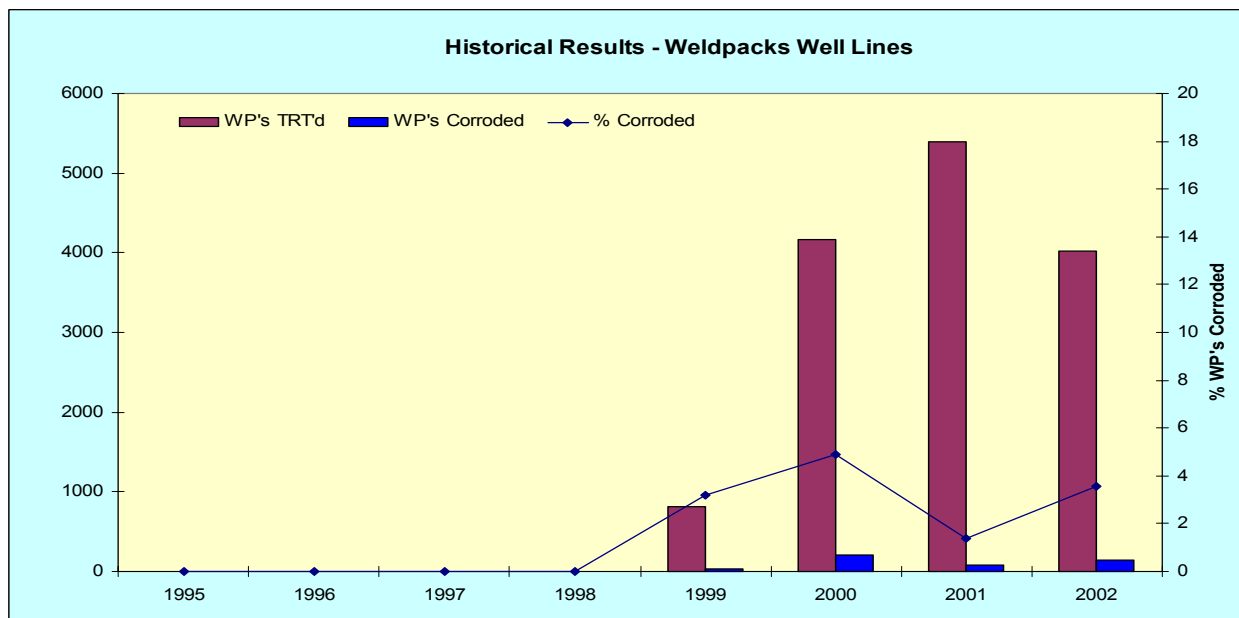
**Figure 12. Summary of Weld Packs on Well Lines – number of weld packs inspected, number of weld packs corroded, and percent of weld packs corroded.**

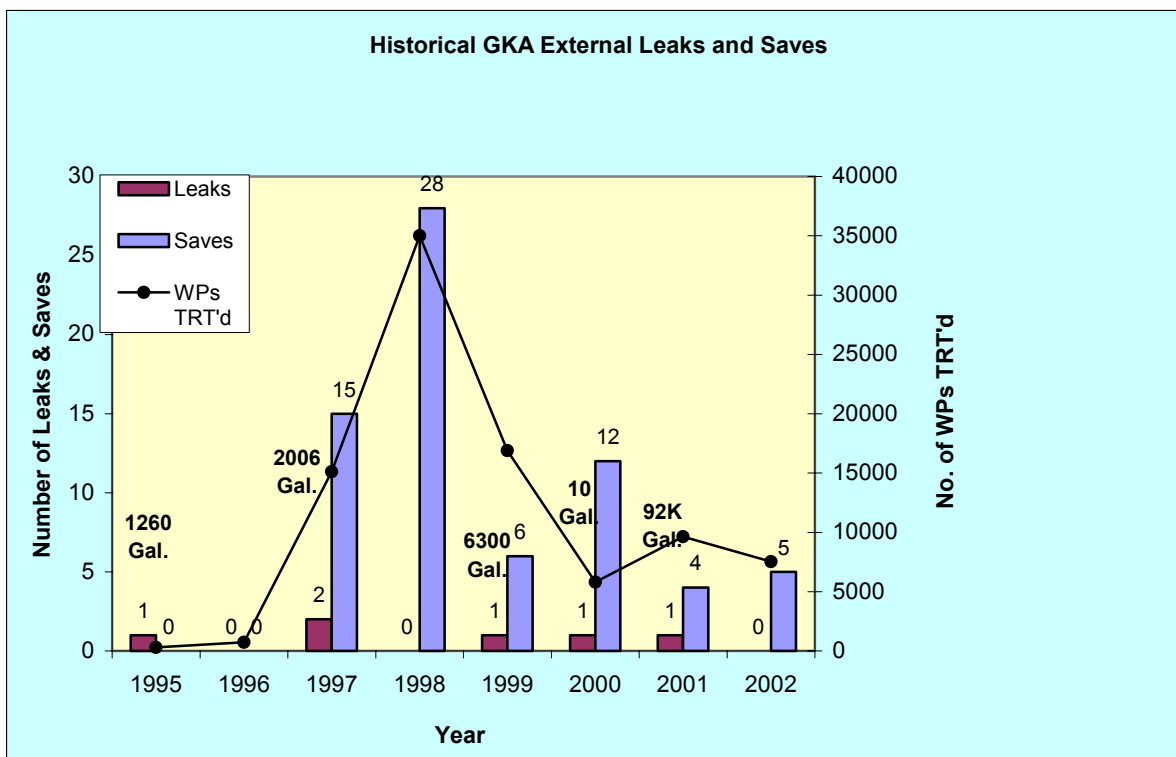
**Figure A1. Leaks, saves, number of weld packs inspected with TRT, and volumes of leaks as a function of time.**

Note: The leak in 2001 due to external corrosion was located in a weld pack in a below-grade piping segment, and as such, would not have been detected by the TRT inspection program. The location had not yet received PTI/TWI inspection.
