**Greater Kuparuk Area (GKA)
Western North Slope (WNS)
Corrosion Programs Overview**

March 30, 2007

Commitment to Corrosion Monitoring
7th Annual Report to the Alaska Department of Environmental Conservation

Prepared by
ConocoPhillips Corrosion Team

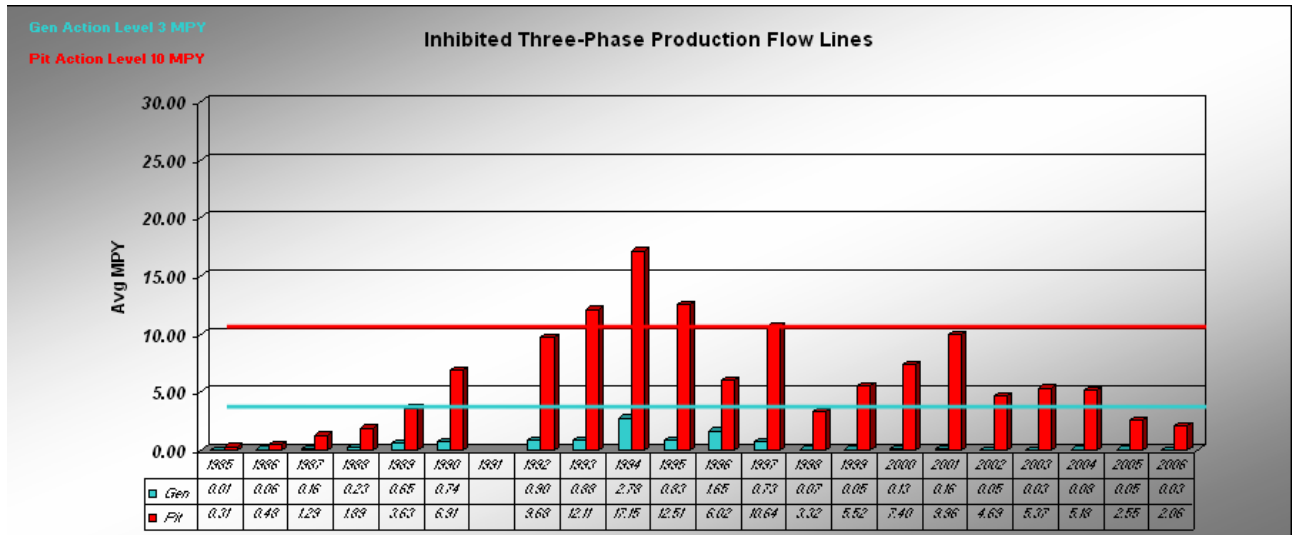
Figure 1. Inhibited Three-Phase Production Flow Line Coupons – general and pitting corrosion rates by year.

Three-phase Production Flow Lines: The monitoring data summarized in Kuparuk Tables 1 and 2 and presented in Figure 1 suggest that general corrosion is under control. The data presented in Tables 1 and 2 and in Figure 1 include corrosion coupon data from the wet oil lines starting at CPF3 and going to CPF1 and CPF2.

Where corrosion rates exceeded targets, corrosion inhibitor concentrations were increased and/or the amount of inspection was increased. In 2006, coupon, probe or inspection-based corrosion rates exceeded targets or revealed increased damage on 15 lines. In 2006, inspection results indicated minor corrosion had occurred in eight of these fifteen lines. A complete listing of the lines with coupon/probe corrosion rates that exceeded targets and/or where inspection indicated increased damage is given in Table 3.

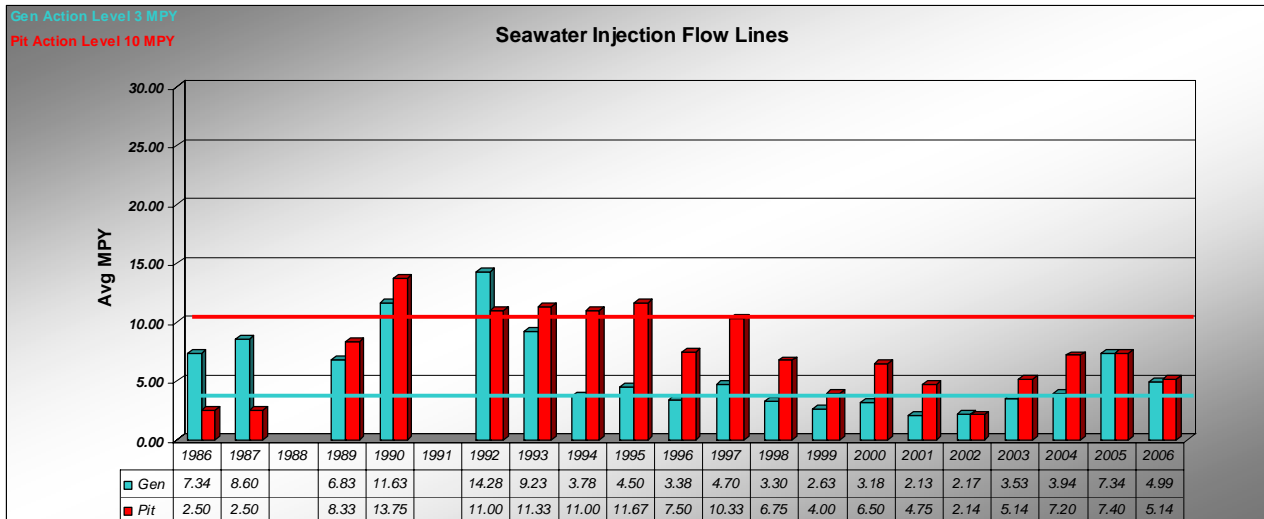
Figure 2. Seawater Injection Flow Line Coupons – general and pitting corrosion rates by year.

Sea Water Flow Lines: The monitoring data summarized in Kuparuk Tables 1 and 2 and presented in Figure 2 above, show the average corrosion rates for the sea water flow line coupons. Average general corrosion rates are above the threshold and pitting rates for the field are below the threshold. Biocide concentration was doubled and pigging frequency increased in early 2006.

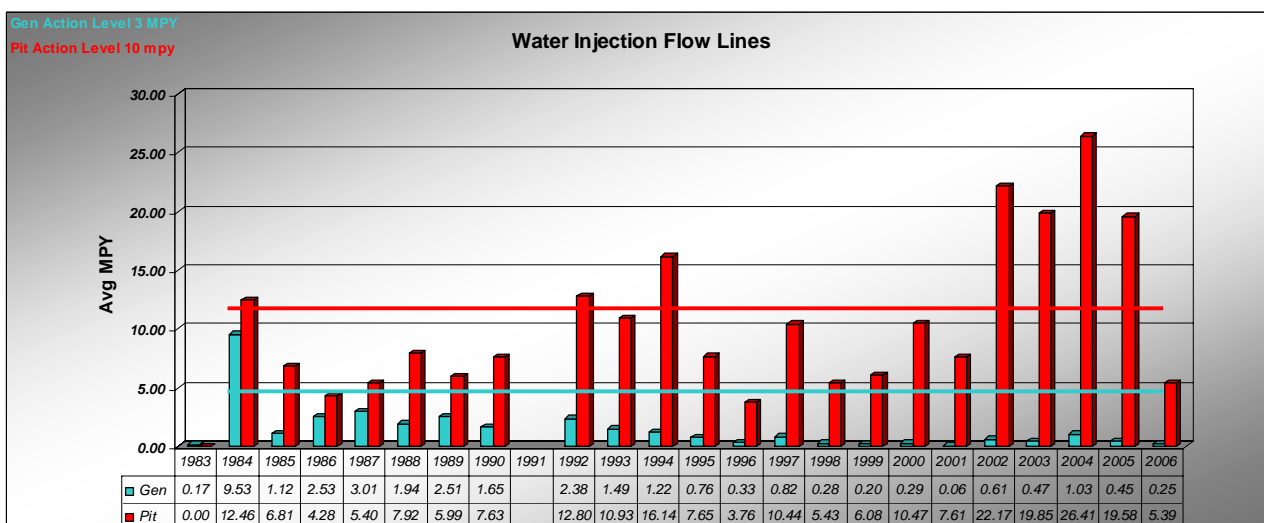
Figure 3. Water Injection Flow Line Coupons – general and pitting corrosion rates as by year.

Water Injection Flow lines: The monitoring data summarized in Kuparuk Tables 1 and 2 is presented in Figure 3. Increased pigging and biocide have brought the WI flow lines pitting rates under control. Since seawater and produced water commingling were suspended at CPF2 in 2005, pitting rates have been reduced markedly. Coupon results are used to prioritize inspection efforts. During 2005 additional equipment was installed and procedures were implemented to provide enhanced biocide treatments at CPF2. Cleaning pigs were upgraded to include brushes in addition to the disks and the pigging procedures changed to include multiple (three) pig runs per monthly cleaning cycle.

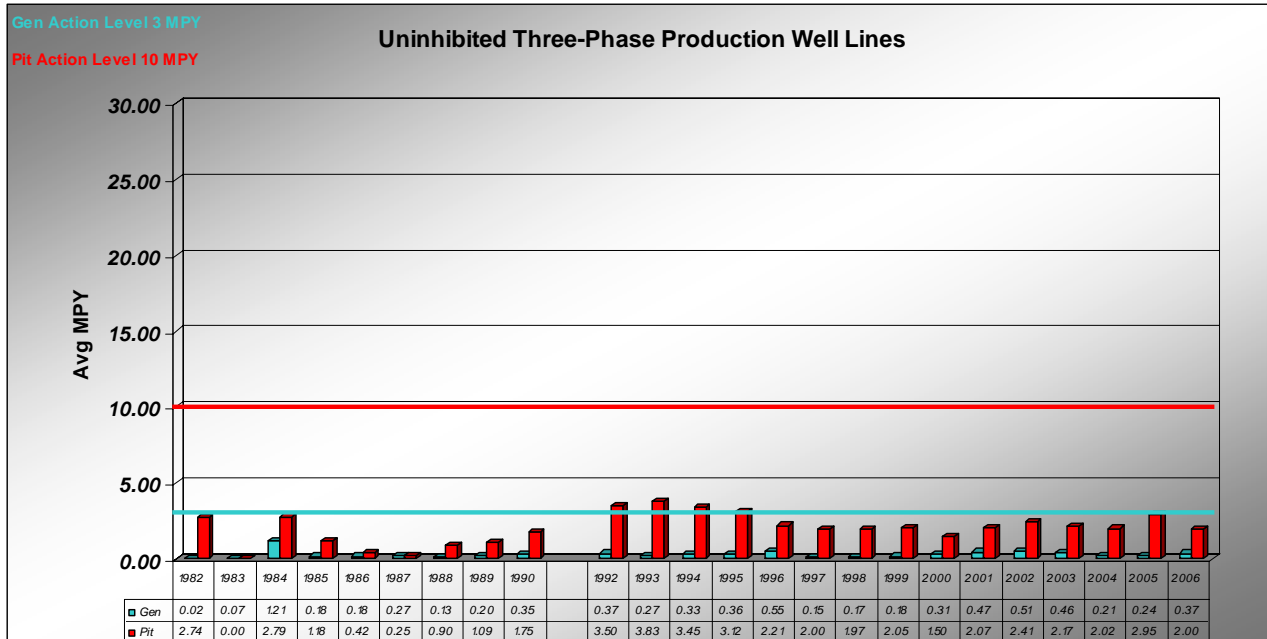
Figure 4. Uninhibited Three-Phase Production Well Line Coupons – general and pitting corrosion rates by year.

Three-phase Production Well Flow Lines: While the monitoring data summarized in Kuparuk Tables 1 and 2 and presented in Figures 4 and 5 suggest that corrosion rates are below targets, inspection data indicate that higher corrosion rates have been experienced historically. The well line inspection data are discussed in section 3.1.b below, and are a good example of why monitoring data alone cannot be relied upon to characterize corrosion in a given system. For three-phase production, coupons monitor free flowing fluid and have not shown the predominant, under-deposit corrosion mechanism.

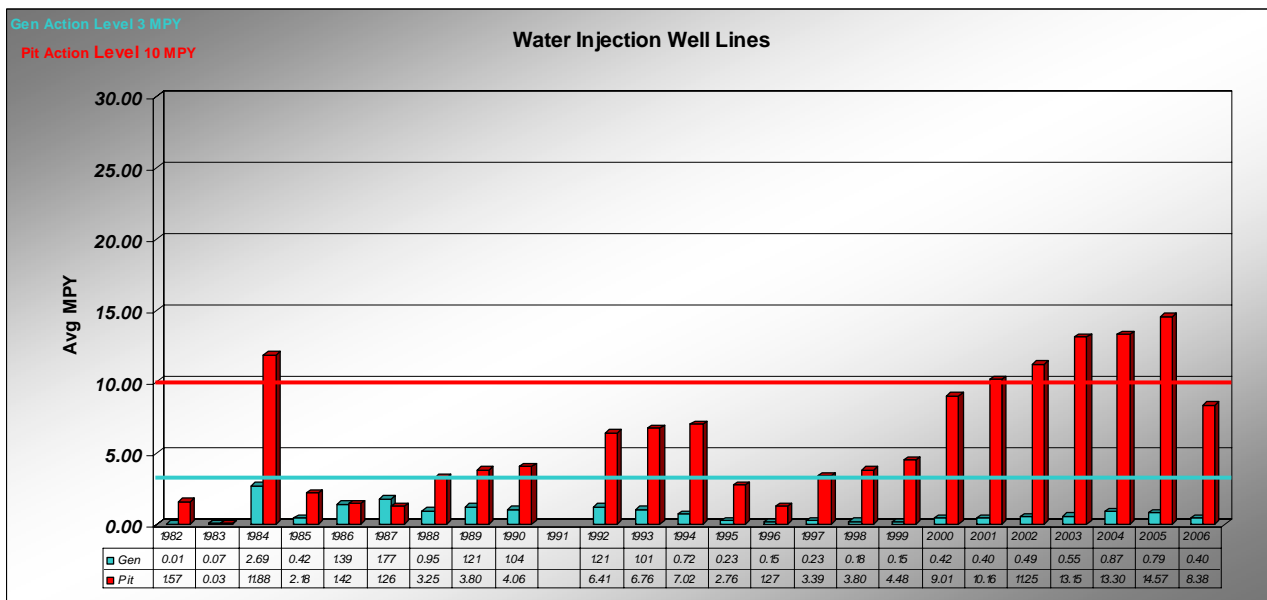
Figure 5. Water Injection Well Line Coupons – general and pitting corrosion rates by year.

Water Injection Well Flow Lines: As discussed in section 3.1.b below, the well line inspection data on water injectors show that there are a significant number of corrosion related repairs. The water feeding this system is treated at the facilities with biocide and is discussed under Figure 3 - Water Injection Flow Line Coupons. We believe that corrosion in the water injection well lines is exacerbated by additional solids accumulating in the well lines because of low flow rates and improved pigging upstream of the well lines.

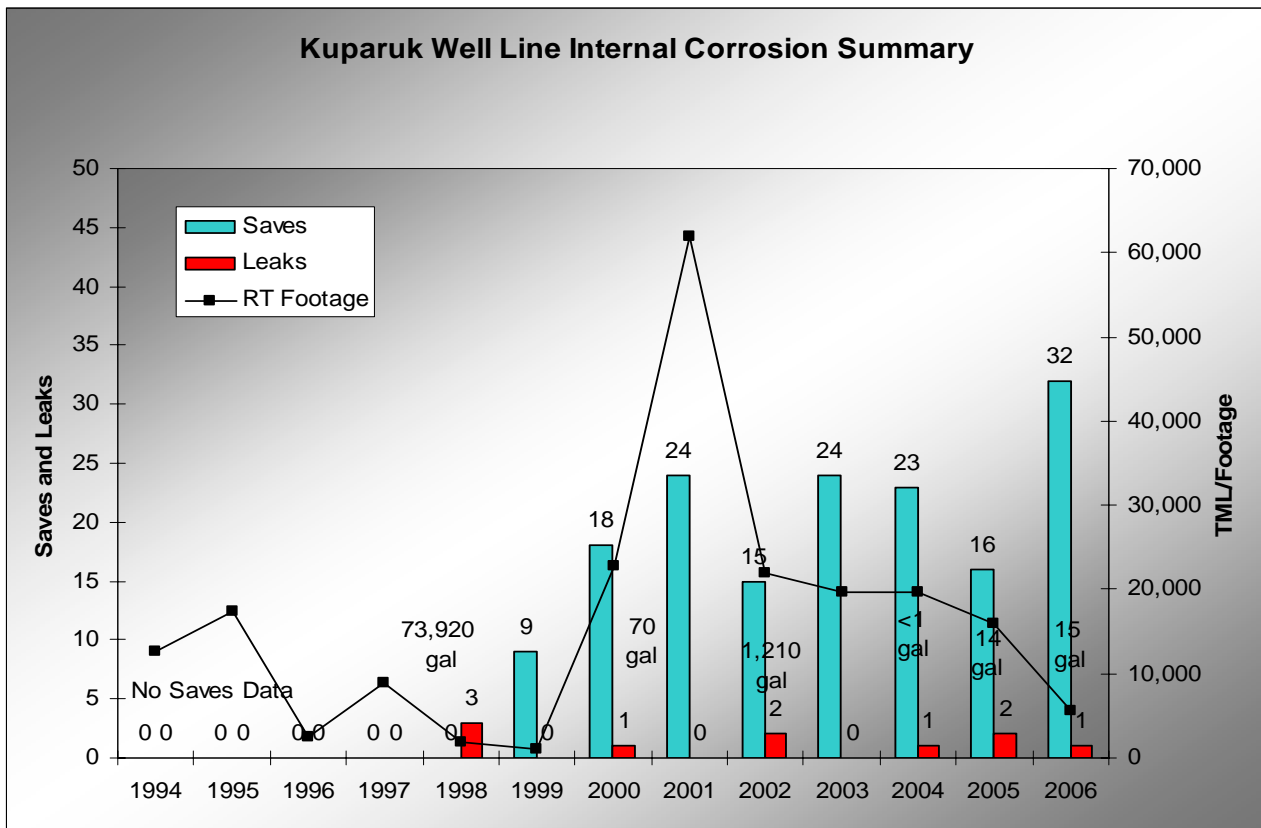
As indicated in Figure 8 below, repair recommendations were initiated on 33 well lines in 2006 because of internal corrosion or a combination of internal and external corrosion damage (19 water injection lines and 14 production lines). The 32 saves resulted primarily from the Known Damage Recur (KDR) program that was unaffected by other inspection program priorities. The predominant corrosion mechanism was associated with solids (under-deposit corrosion or erosion). More information on the leak can be found in section 3.1.g.

Figure 8. Summary of WI and Three-Phase Production Well Line Internal Corrosion Inspections – RT footage, leaks, and saves by year.

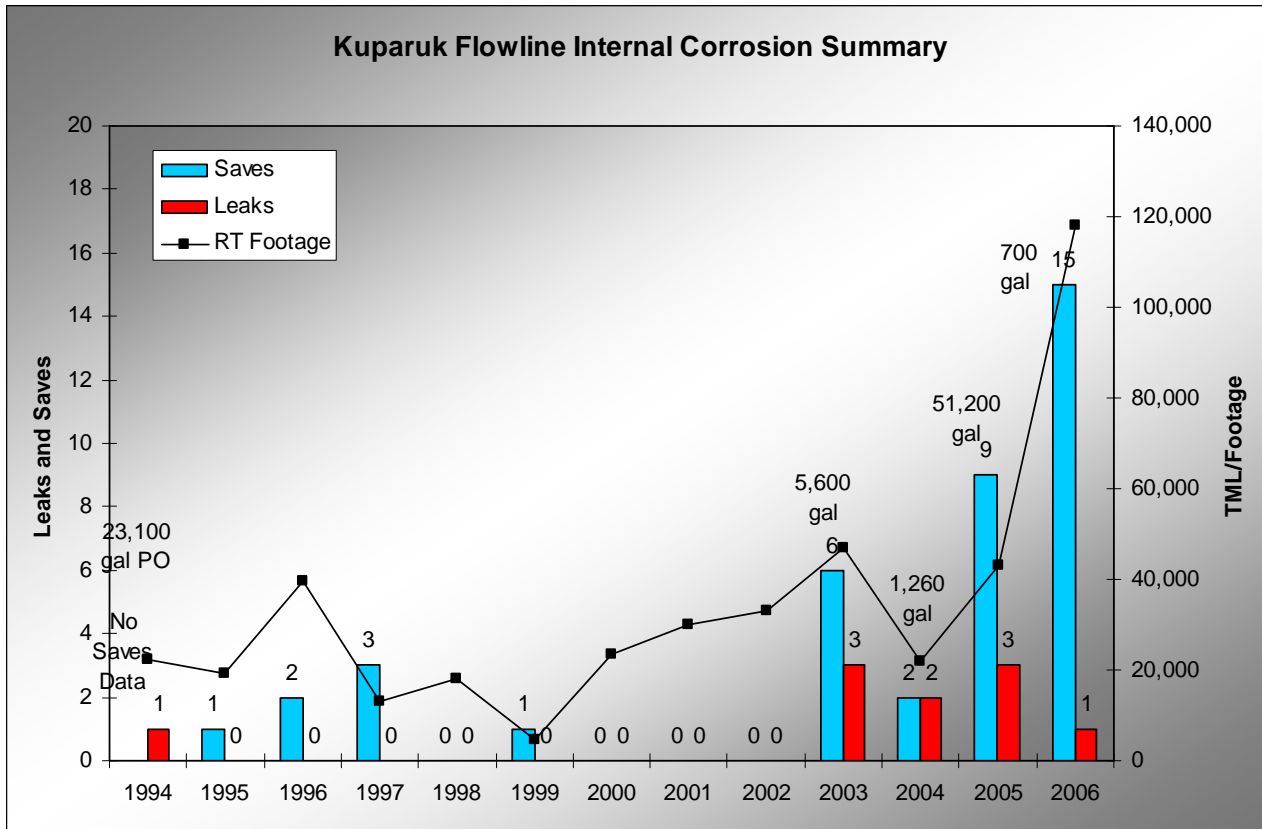
As indicated in Figure 9 below, 16 repair recommendations were initiated on flow lines (7 water injection and 9 production) in 2006 because of internal corrosion damage. The corrosion mechanism for all repair recommendations was deadleg or solids-related corrosion. The leak was in the production system. More information on the leak can be found in section 3.1.g.

Figure 9. Summary of WI and Three-Phase Production Flow Line Internal Corrosion Inspections – RT footage, leaks, and saves by year.

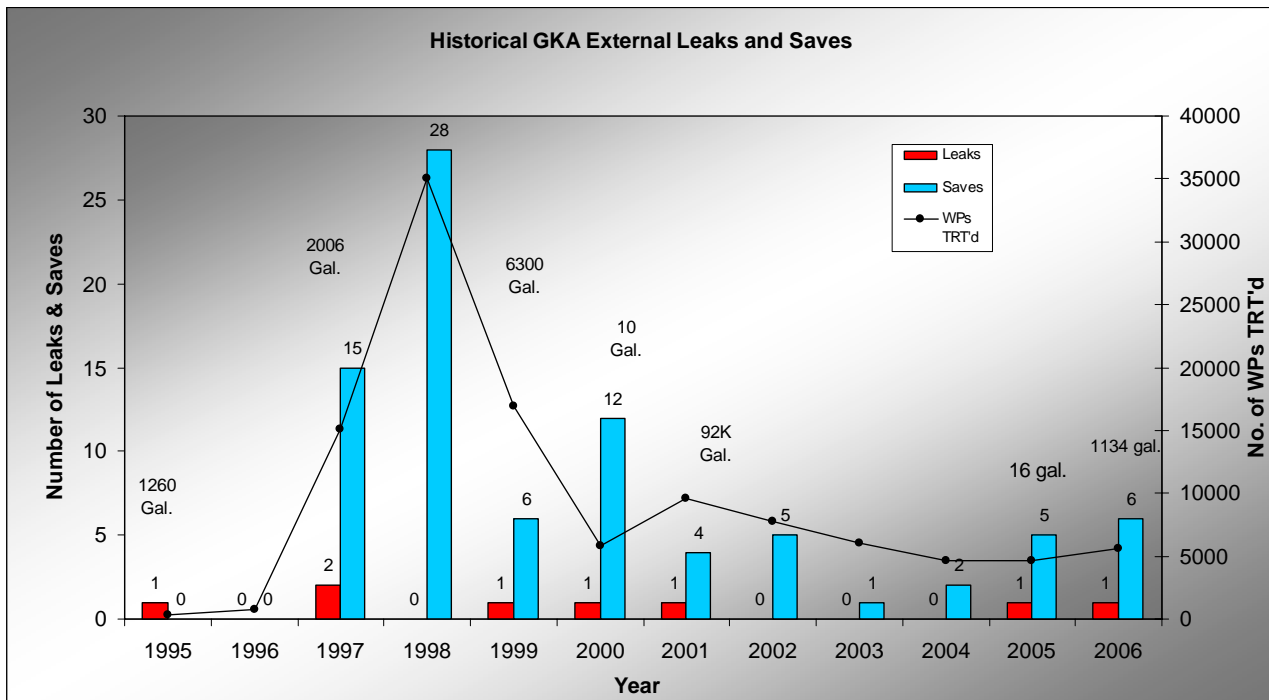
Figure 10. Leaks, saves, number of weld packs inspected with TRT, and volumes of leaks by year.

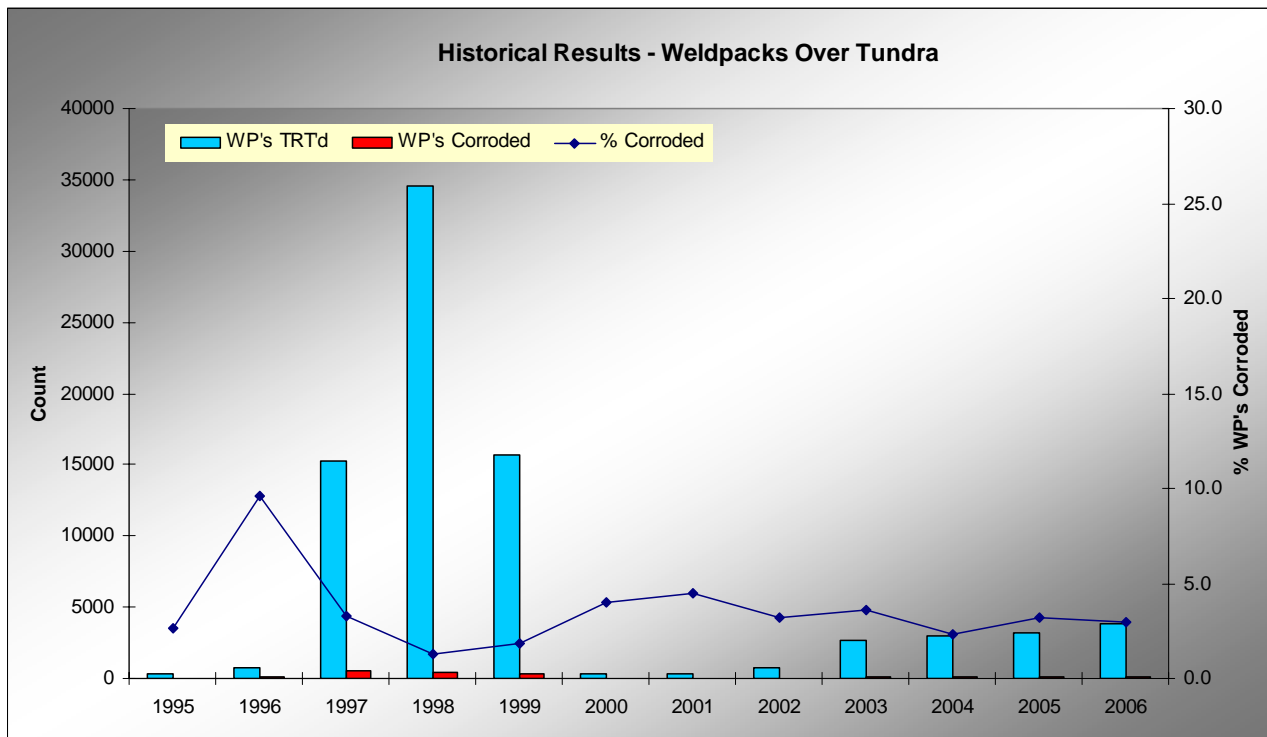
Figure 11. Summary of Flow Line Over-Tundra (off-pad) Weld Packs.

Figure 11 illustrates the latest results from the external corrosion inspection program. 2002 through 2006 values include re-inspections and clean-up of locations missed or not properly documented during the original base line effort.

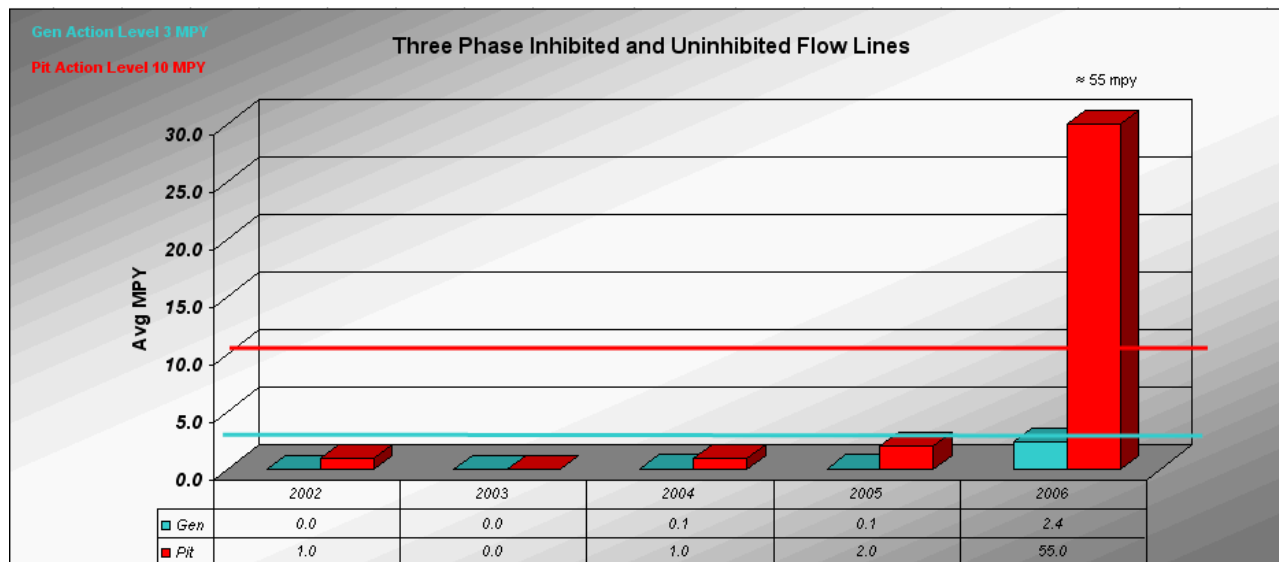
Figure 13. WNS Three-phase Production Flow Line Coupons – general and pitting corrosion rates by year.

Three-phase Production Flow Lines: The monitoring data summarized in WNS Tables 7 and 8 and presented in Figures 13 show that pitting corrosion rates exceeded the action level.

The pitting corrosion rate in one coupon in the CD2 line was also high. This line did not receive corrosion inhibition treatment in 2006. Corrosion inhibitor injection facilities had been planned to coincide with water breakthrough at this drillsite. The actual water production rate outpaced the forecasted water rate significantly. To respond to the unexpected water rate, the installation of the injection facilities has been accelerated.

In response to the coupon and probe corrosion rates, corrosion inhibitor concentrations in the CD1 line were increased several times. In addition, a new corrosion inhibition formulation was tested in December 2006.

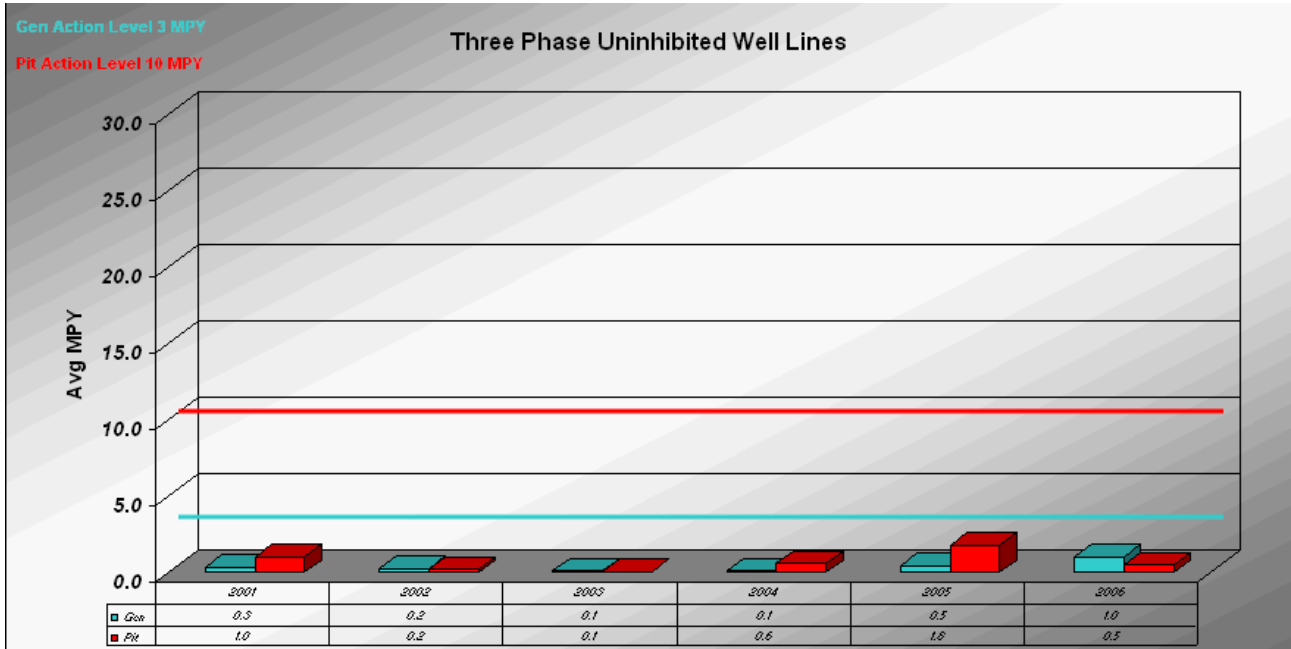
Figure 14. WNS Three-phase Production Well Line Coupons – general and pitting corrosion rates by year.

Three-phase Production Well Lines: The monitoring data summarized in WNS Tables 7 and 8 and presented in Figures 14 show that corrosion rates have not approached action levels in the well lines. Inspection data, discussed in section 4.1.b, indicates that significant corrosion damage has not taken place in these lines.

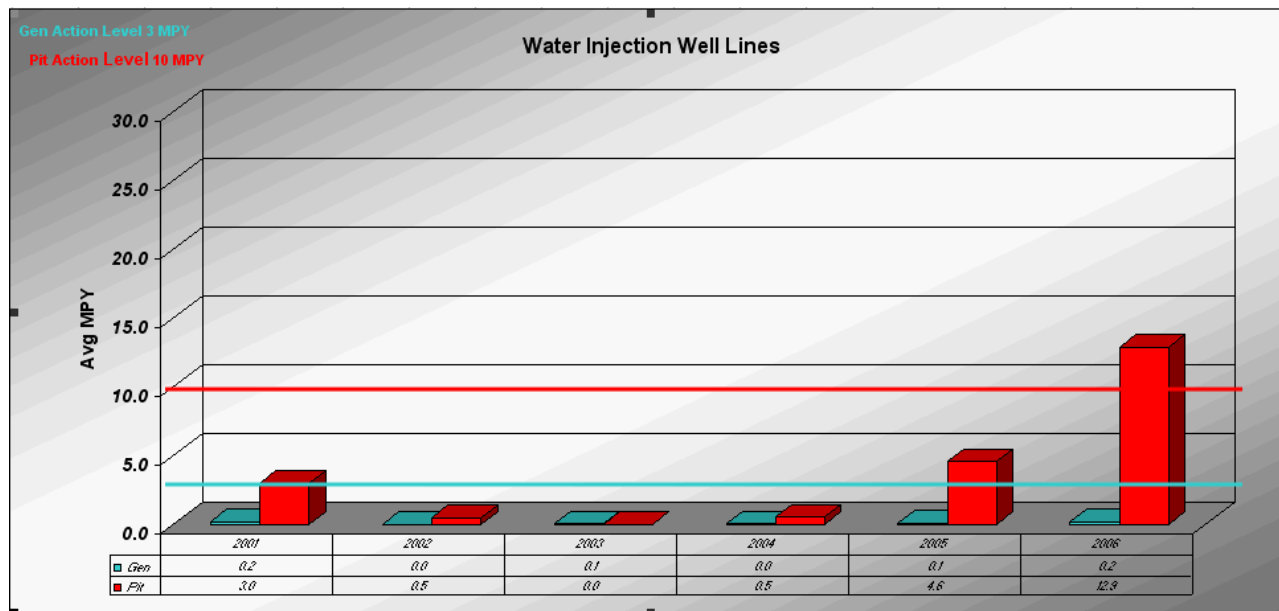
Figure 15. WNS Water Injection Well Line Coupons – general and pitting corrosion rates by year.

Water Injection Well Lines: The monitoring data in Figure 15 show that corrosion may be beginning in the injection wells in the WNS. Inspection data presented in section 4.1.b do not indicate damage in these lines, but given Kuparuk’s experience with corrosion-related repairs, WNS inspection programs will continue to look for damage in the injectors.
