ALASKA DEPARTMENT OF ENVIRONMENTAL CONSERVATION
Division of Spill Prevention and Response
Prevention and Emergency Response Program

SITUATION REPORT

INCIDENT NAME: FV Orcrist

SITREP #: 1

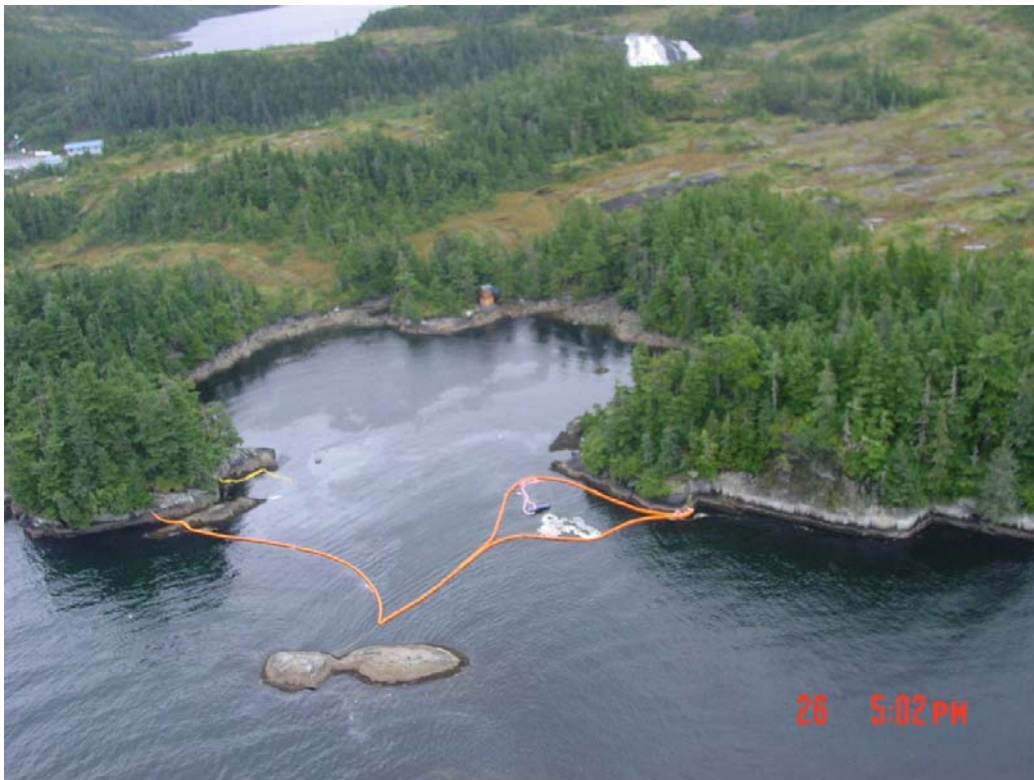
F/V Orcrest stern visible inside loop of orange boom. Lake Bay Hatchery is in the upper left of the photo. (ADEC photo)

RESPONSE ACTION: The vessel operator reported to the Coast Guard that he was able to dive on the vessel and plug the fuel vents. Hard boom and absorbent sausage boom have been deployed to help contain any fuel or engine oil coming from the vessel.

FUTURE PLANS AND RECOMMENDATIONS: Continue to maintain boom and source control. ADEC staff will continue to work with the U.S. Coast Guard to monitor efforts to remove or re-float the vessel.
