**ALASKA DEPARTMENT OF ENVIRONMENTAL CONSERVATION**  
**Division of Spill Prevention and Response**  
**Prevention and Emergency Response Program**

**SITUATION REPORT**

**INCIDENT NAME:** EAFB Product Recovery Tank Spill     **SITREP #:** 3 and Final

**LOCATION:** West Ramp Pumphouse Building 13196, EAFB.

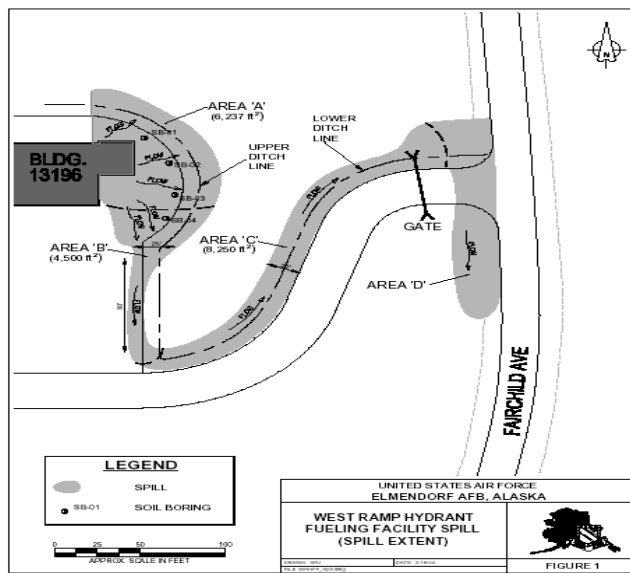
PERP Project Manager met with EAFB Civil Engineering's Project Manager and their consultant February 17. EAFB's consultant, Weston Solutions, is performing site characterization work to further define the extent of the spill impact area (reference the spill extent drawing). Four borings, drilled up to 24 feet below grade, were used to delineate the subsurface and lateral extent of the spill impact area.

Spill extent drawing near the pumphouse.

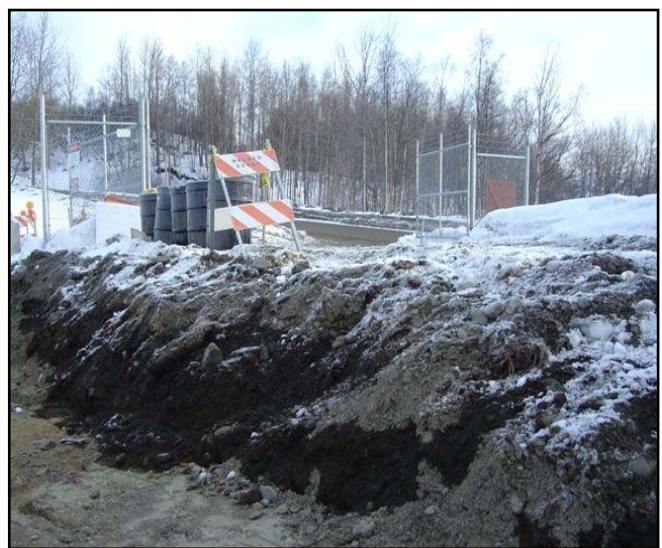
Spilled fuel concentrating in the ditch down gradient from the pumphouse has permeated the soil. Fuel observed seeping into excavated areas of the ditch is being removed and highly concentrated areas are being identified for additional removal. An additional excavator is being employed to achieve maximum soil removal efficiency along with constant monitoring of site conditions to direct soil removal activities.

Fuel seeping into recently excavated ditchline near gated entrance to powerplant.
