SITUATION REPORT

INCIDENT NAME: DeHarts Marina/Fuel Dock, Juneau

SITREP #: 5 and final

SPILL NUMBER: 04119926501

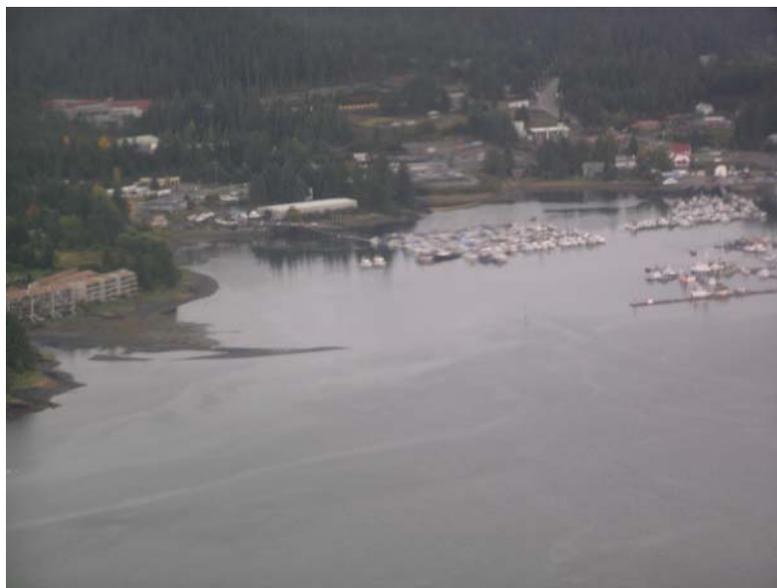
Scattered residual transparent sheens visible from the air. Saturday, September 24th.
