ALASKA DEPARTMENT OF ENVIRONMENTAL CONSERVATION
Division of Spill Prevention and Response
Prevention and Emergency Response Program
SITUATION REPORT

Sand Point Abandoned Drum Site

SITREP: # 4 and Final

SPILL #: 07259904601

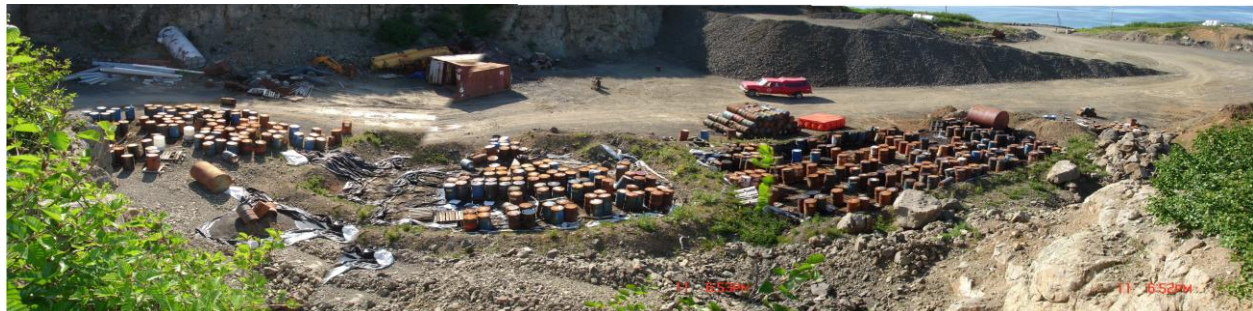
Spill cleanup and drum consolidation effort after July 11, 2007

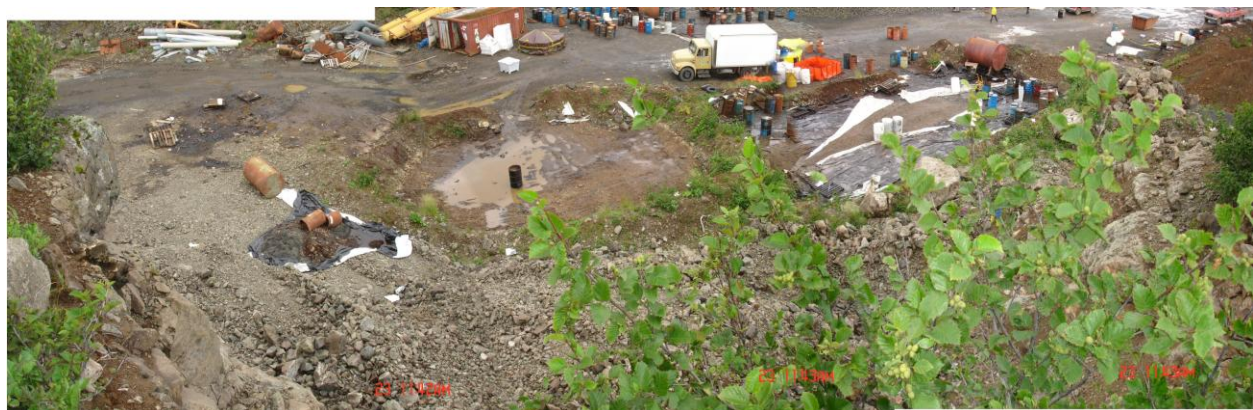
Spill cleanup and drum consolidation after August 23, 2007

SOURCE CONTROL: On August 23, 2007, all the drums that were leaking were characterized and the contents of the drums were consolidated into larger tanks or other sound drums until the contents were recycled or properly disposed of at local facilities. Or they were retained until addition characterization of the drum contents could be completed.
