**ALASKA DEPARTMENT OF ENVIRONMENTAL CONSERVATION**  
**Division of Spill Prevention and Response**  
**Prevention and Emergency Response Program**

**SITUATION REPORT**  
**As of 11:00 AM on March 17, 2010**

**INCIDENT NAME:** Princess Kathleen

**SITREP #:** 5

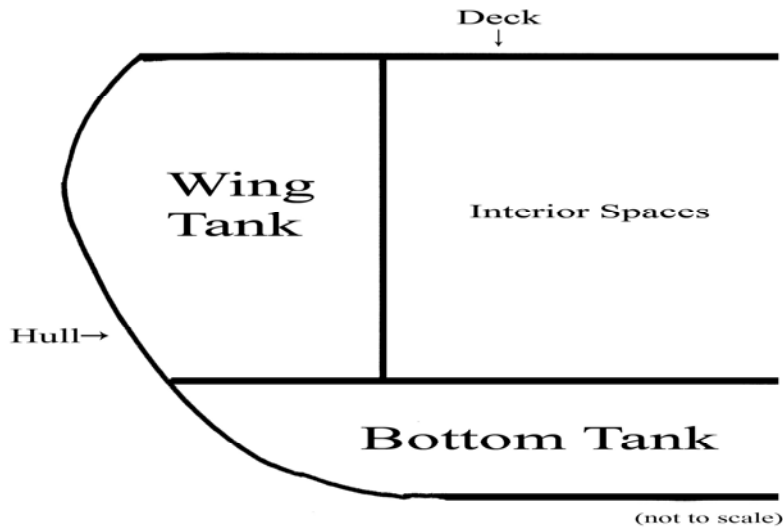
**RESPONSE ACTION:** The *Princess Kathleen* has two types of fuel tanks, wing tanks and bottom tanks. Wing tanks are tanks that sit along the side of the hull. A bottom fuel tank is fuel storage between the hull of the ship and a second inner barrier placed somewhat higher in the vessel. (See the graphic on page 3 depicting the two types of fuel tanks.)

Diagram of the two types of tanks present onboard the *Princess Kathleen*. Graphic by ADEC.
