ALASKA DEPARTMENT OF ENVIRONMENTAL CONSERVATION
Division of Spill Prevention and Response
Prevention and Emergency Response Program
SITUATION REPORT

Repsol Q2 Pad Gas and Mud Release

SITREP # 23

SPILL NUMBER: 12399904601

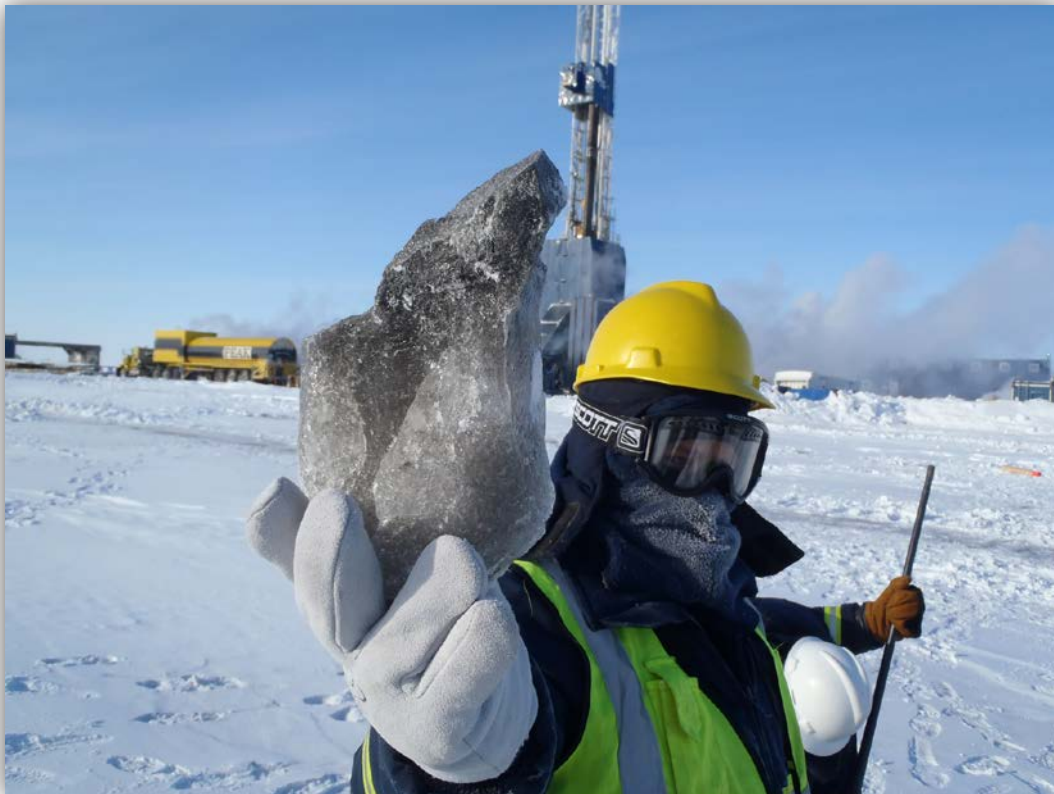
A piece of frozen downhole material ejected out off the pad during the gas kick. ADEC Photo.
