ALASKA DEPARTMENT OF ENVIRONMENTAL CONSERVATION  
Division of Spill Prevention and Response  
Prevention and Emergency Response Program  
**SITUATION REPORT**

## Fuel Barge *Leo*

SITREP # 2 and Final

SPILL #: 12119925601

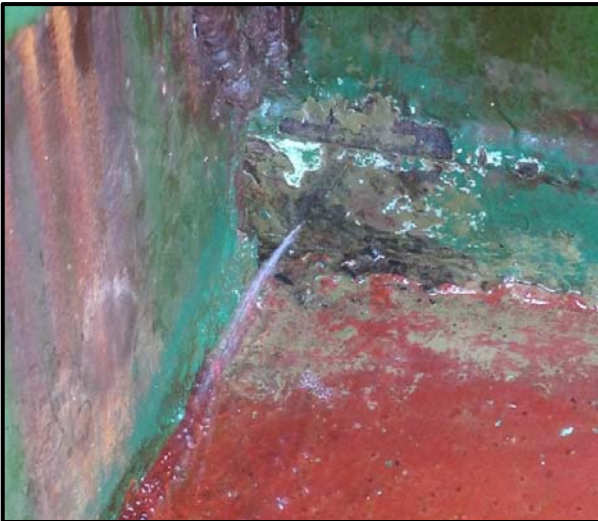
**BEFORE**

HOW AND WHEN THE SPILL WAS DISCOVERED: The crew onboard the Tug *Altair*, the tug transporting the fuel barge *Leo*, noticed sheen in the water and traced it back to a 2-inch fracture between the raised cargo tank bulkhead and deck of the barge.

CAUSE OF SPILL: Kirby Offshore Marine (Kirby) fuel barge *Leo* discovered a fracture between the raised cargo tank bulkhead and the deck of the barge near the bow of the vessel. The fracture is impacting one of the cargo tanks onboard resulting in a gasoline leak. The cause of the fracture is unknown at this time and is being investigated.

*Fuel leaking through the fracture and onto the deck of the barge, September 12, 2012. (Photo/Kirby Offshore Marine)*

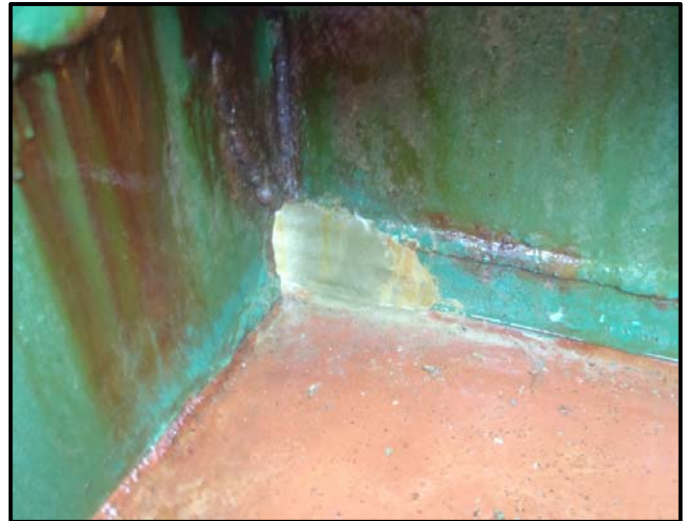
**AFTER**

*Temporary seal over the fractured area stopping the leak, September 13, 2012. (Photo/ADEC)*

SOURCE CONTROL: A temporary seal was placed on the fracture and an internal transfer of fuel was completed the night of September 12. These actions stopped the fuel leak.
