ALASKA DEPARTMENT OF ENVIRONMENTAL CONSERVATION
Division of Spill Prevention and Response
Prevention and Emergency Response Program
SITUATION REPORT

Kulluk Tow Incident

SITREP #: 12

TIME/DATE OF DISTRIBUTION: 6:00 p.m., January 10, 2013

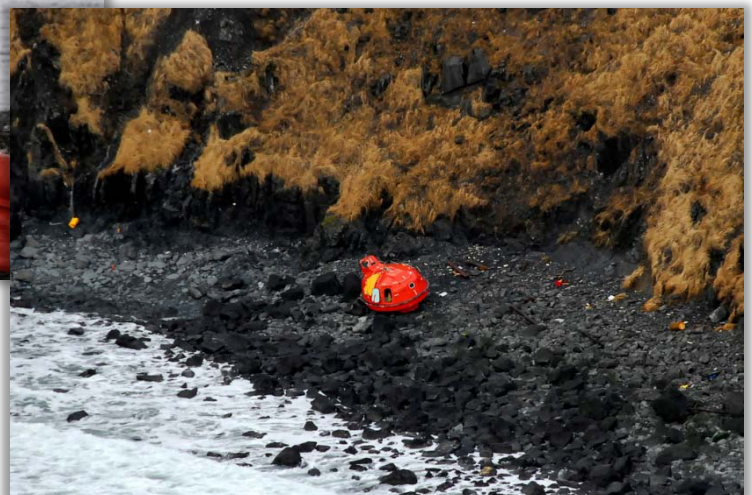
HOW/WHEN SPILL WAS DISCOVERED: **No spill has occurred directly from the CDU *Kulluk*. Four lifeboats and one rescue boat were swept from the CDU *Kulluk*, either while it was towed or when it grounded on Sitkalidak Island.**

A life raft belonging to the CDU Kulluk sits on the beach near the CDU Kulluk grounding site (Photo/ Petty Officer 2nd Class Zachary Painter, U.S. Coast Guard).

SOURCE CONTROL: **The potential exists for the release of approximately 316 gallons of ultra low sulfur diesel fuel. To date there has been no confirmation of any release. The Unified Command is developing and implementing plans to access the grounded lifeboats for their removal and to determine the quantity of fuel that remains onboard them.**
