ALASKA DEPARTMENT OF ENVIRONMENTAL CONSERVATION
Division of Spill Prevention and Response
Prevention and Emergency Response Program
SITUATION REPORT

Kulluk Tow Incident

SITREP #: 13 and Final

SPILL #: 12249936201

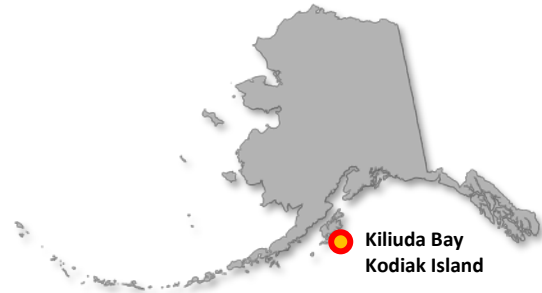
Response Action: The CDU *Kulluk* remains safely anchored in Kiliuda Bay at its assessment position. In addition to being anchored, the CDU *Kulluk* is also tethered to the M/V *Lauren Foss* and the M/V *Ocean Wave*. The vessel has been inspected by Det Norske Veritas and the Coast Guard for damage. It has been determined by these inspections that in its current condition the *Kulluk* does not pose a threat to the environment and can be safely relocated to Dutch Harbor, Alaska.
