ALASKA DEPARTMENT OF ENVIRONMENTAL CONSERVATION
Division of Spill Prevention and Response
Prevention and Emergency Response Program
SITUATION REPORT

F/V Eyak Grounding

SITREP #2

SPILL #: 15-11-99-019-01

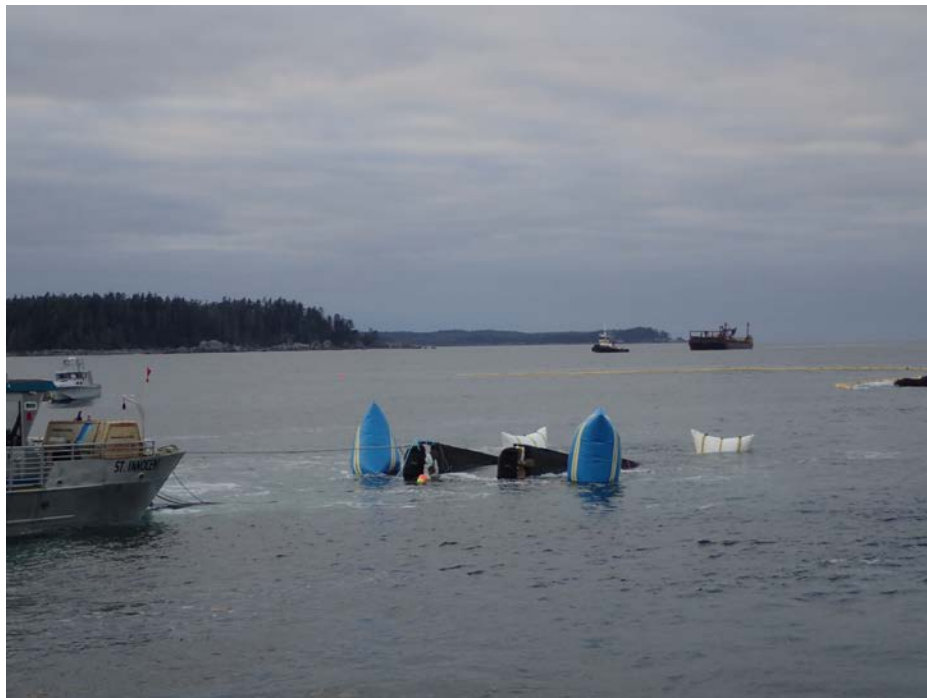
The salvage team begins towing the F/V Eyak to protected waters in Sitka Sound, January 27, 2015. (Photo/ADEC)
