ALASKA DEPARTMENT OF ENVIRONMENTAL CONSERVATION
Division of Spill Prevention and Response
Prevention and Emergency Response Program
SITUATION REPORT

F/V Eyak Grounding

SITREP #3 and final

SPILL #: 15-11-99-019-01

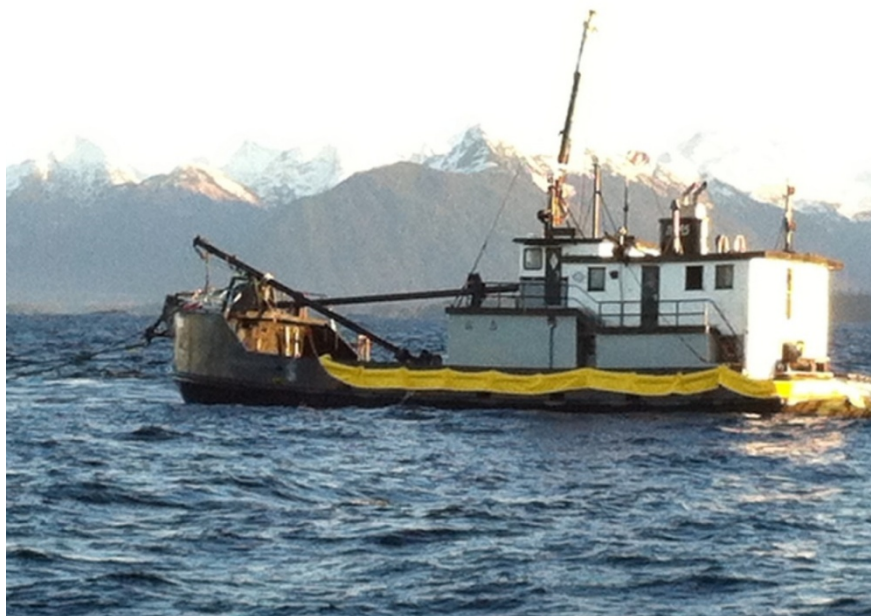
F/V *Eyak*, with temporary repairs, undertow back to Sitka on January 30. (Photo/ADEC)

The salvage crew completed temporary repairs to the hull on January 28. On January 29 the vessel was righted, floated and dewatered. SEAPRO maintained boom in a U-configuration down current from the F/V *Eyak* as a precautionary measure. Once the F/V *Eyak* was floating fuel was pumped from the tanks. 1,110 gallons of a

FUTURE PLANS AND RECOMMENDATIONS: The F/V *Eyak* will remain in Sitka until arrangements are made for permanent repairs to be conducted in Wrangell.
