ALASKA DEPARTMENT OF ENVIRONMENTAL CONSERVATION
Division of Spill Prevention and Response
Prevention and Emergency Response Program
SITUATION REPORT

Milne Point Tract 14 Production Line Release

SITREP #: 3

SPILL #: 15399905901

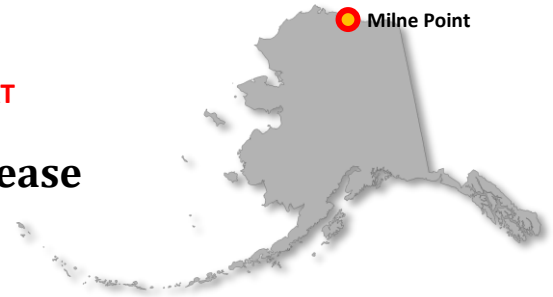
RESPONSE ACTION: HCA had 15 responders on site for Monday night operations overnight and anticipate 15-20 responders on site throughout today's daylight activities. A post-storm delineation of the impacted area has been completed with no significant change in the original delineated area. Crews were able to install a bypass line to re-establish normal levels of flow from Tract 14 wells. This eliminates the risk of freeze up within the pipeline and further protects the environment from additional spills. Responders are using mechanical equipment and hand tools to clear snow and ice. The ice cap that was created to protect the site from the weekend storm event proved to be effective. An ice pit has been constructed on site to stage affected snow and ice from the impacted area. A 70-foot by 70-foot ice pad has also been constructed adjacent to the impacted area to provide access to the affected tundra areas. This will facilitate access to and the removal of product from tundra. All collected materials will be removed from the ice pit, hauled away by dump truck, and

disposed in accordance with the law. An estimated 3,906 gallons (93 bbls) of liquids have been recovered by vacuum truck to date. Approximately 96 cubic yards of impacted snow have been removed and staged in containers for final removal and disposal. The spilled product volume estimates include impacted snow, ice, and released product from the pipeline. Due to this mixture, an actual volume estimate of fluids released from the pipeline remains unknown at this time. A Unified Command including representatives from HCA, ADEC, Environmental Protection Agency (EPA) and the North Slope Borough (NSB) will stand down as of 6 PM tonight. Operations will continue as this event enters the project phase. ADEC has mobilized three responders to the site to monitor clean-up operations.
