ALASKA DEPARTMENT OF ENVIRONMENTAL CONSERVATION
Division of Spill Prevention and Response
Prevention and Emergency Response Program
SITUATION REPORT

Milne Point Tract 14 Production Line Release

SITREP #: 4 REVISED

SPILL #: 15399905901

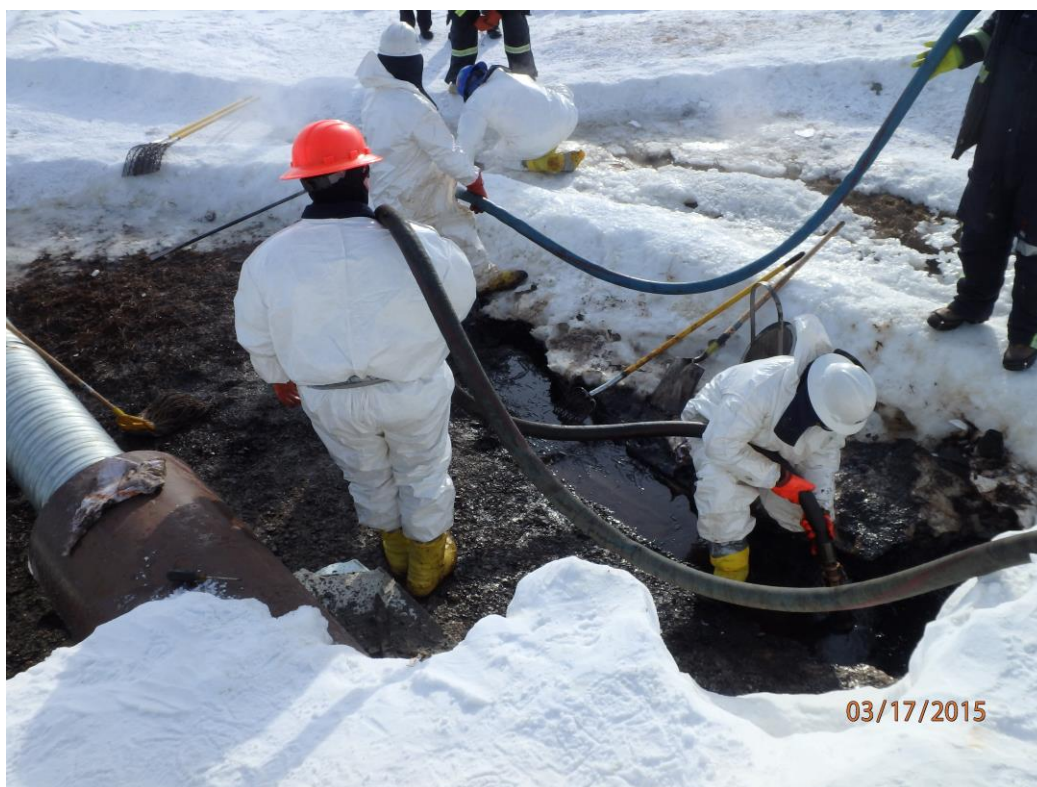
Figure 1. Tundra flood/flush and recovery operations to recover released fluids.

FUTURE PLANS AND RECOMMENDATIONS: Field operations will continue using the flood/flush and recovery tactic removing produced fluids north and south of the pipeline road crossing at the Tract 14 intersection. Field screening and analytical confirmation sampling is ongoing. Impacted snow melting is scheduled after the tundra tactics are completed.
