**SITUATION REPORT**

**TAPS PS-10 Electrical Isolation Joint Weep**

**SITREP # 2 & Final**

**SPILL #:** 15309914902

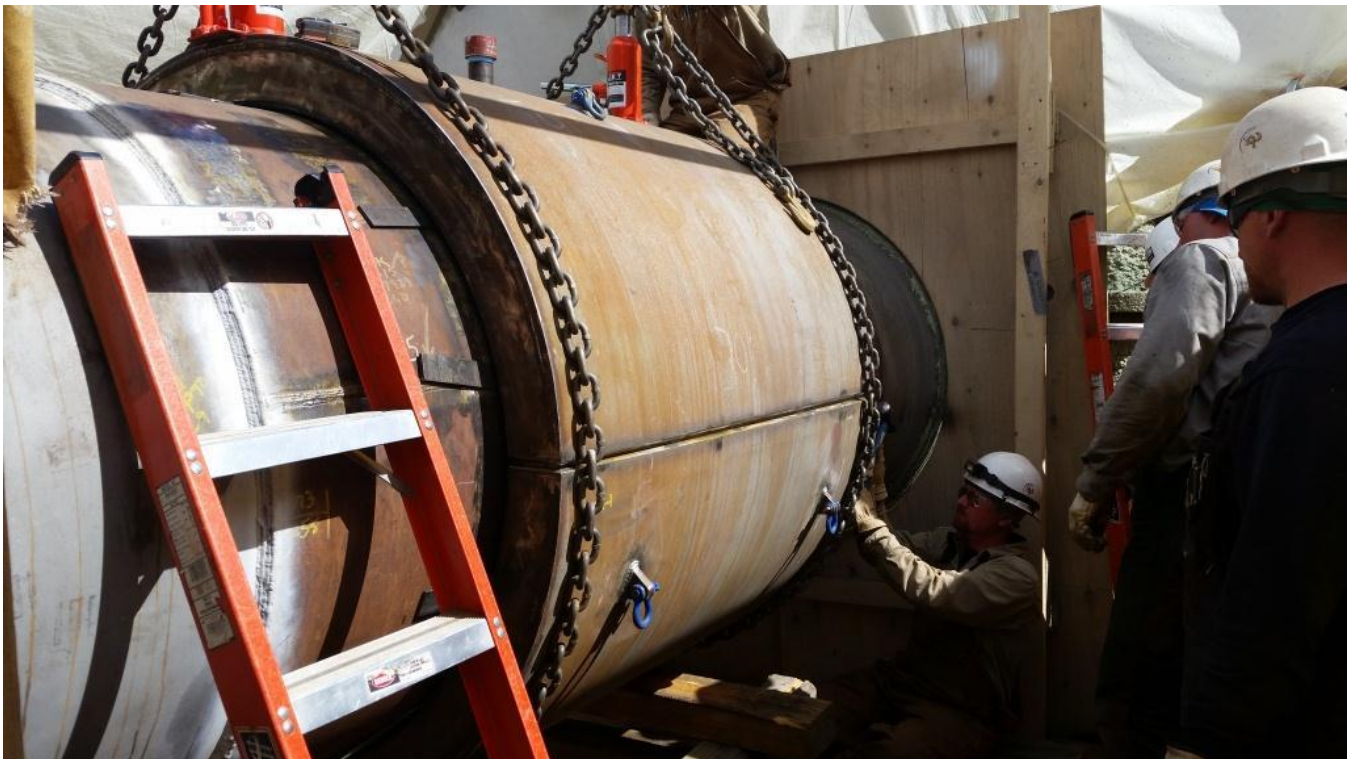
**SOURCE CONTROL:** The source of the spill was determined as an isolation fitting installed on the TAPS 48-inch mainline. The purpose of the isolation fitting was to electrically isolate the mainline and facility piping cathodic protection systems to provide optimal corrosion protection. This fitting was installed during the initial pipeline construction. **A 60-inch sleeve was fabricated for installation over the isolation fitting. The sleeve was welded in place and is now providing full pressure containment of the isolation fitting. Full source control has been achieved due to installation of the sleeve.**

60-inch repair sleeve fit-up complete over line.  
(Photo: Alyeska Pipeline Service Company)

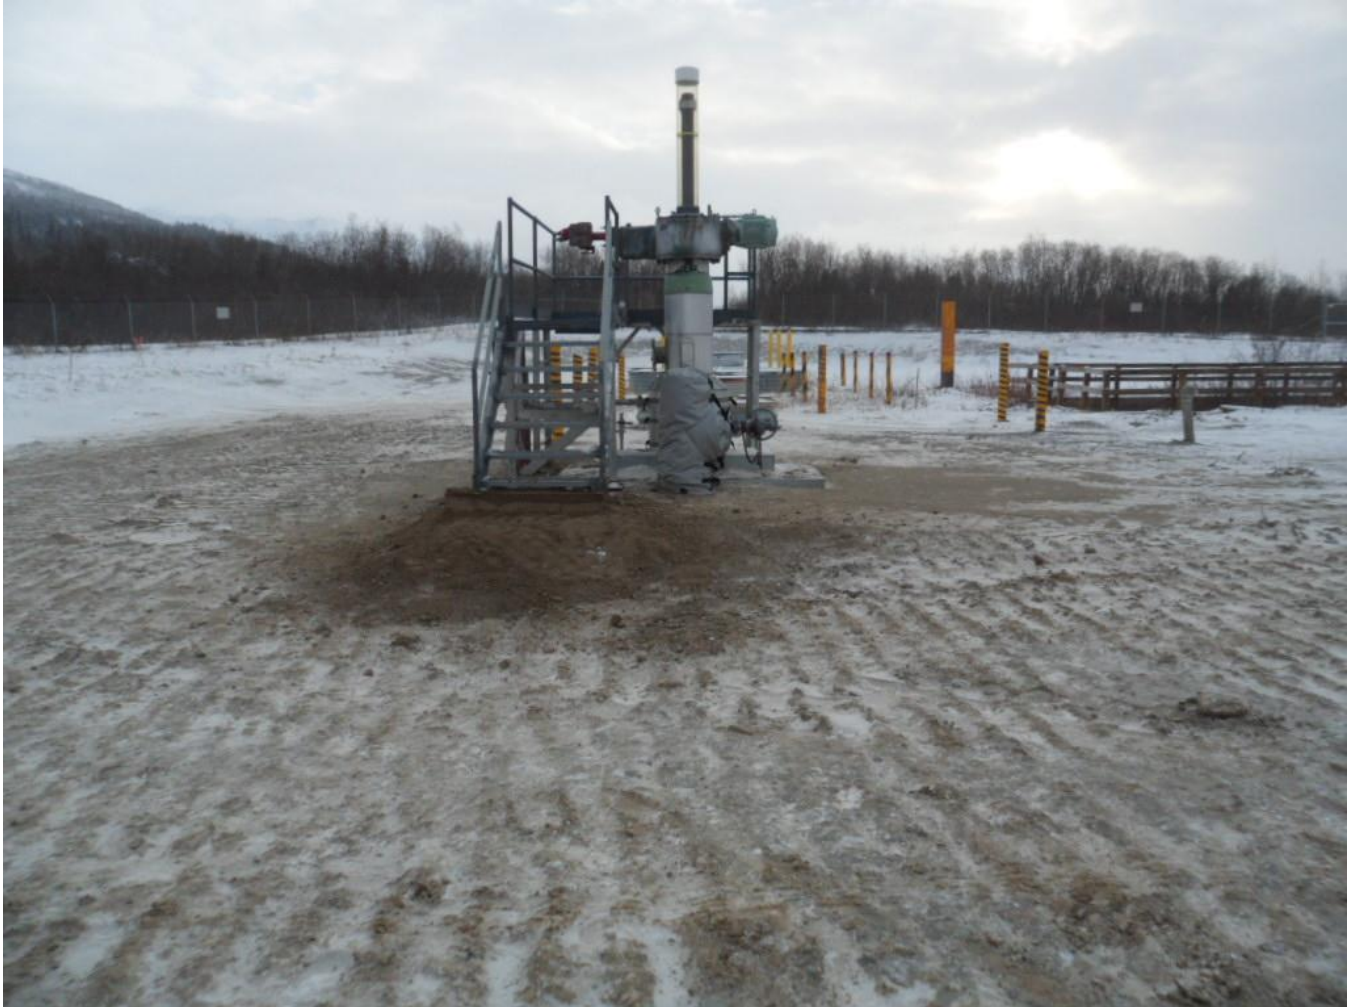
Creek to be incinerated. ADEC approved backfill of the excavation on October 28, 2015. At this time initial site cleanup has been completed.

Backfilled excavation at Pump Station 10 Block Valve 2.  
(Photo: Alyeska Pipeline Service Company)
