ALASKA DEPARTMENT OF ENVIRONMENTAL CONSERVATION
Division of Spill Prevention and Response
Prevention and Emergency Response Program
SITUATION REPORT

F/V Pacific Venture Sinking

SITREP #: 3

SPILL #: 15119924402

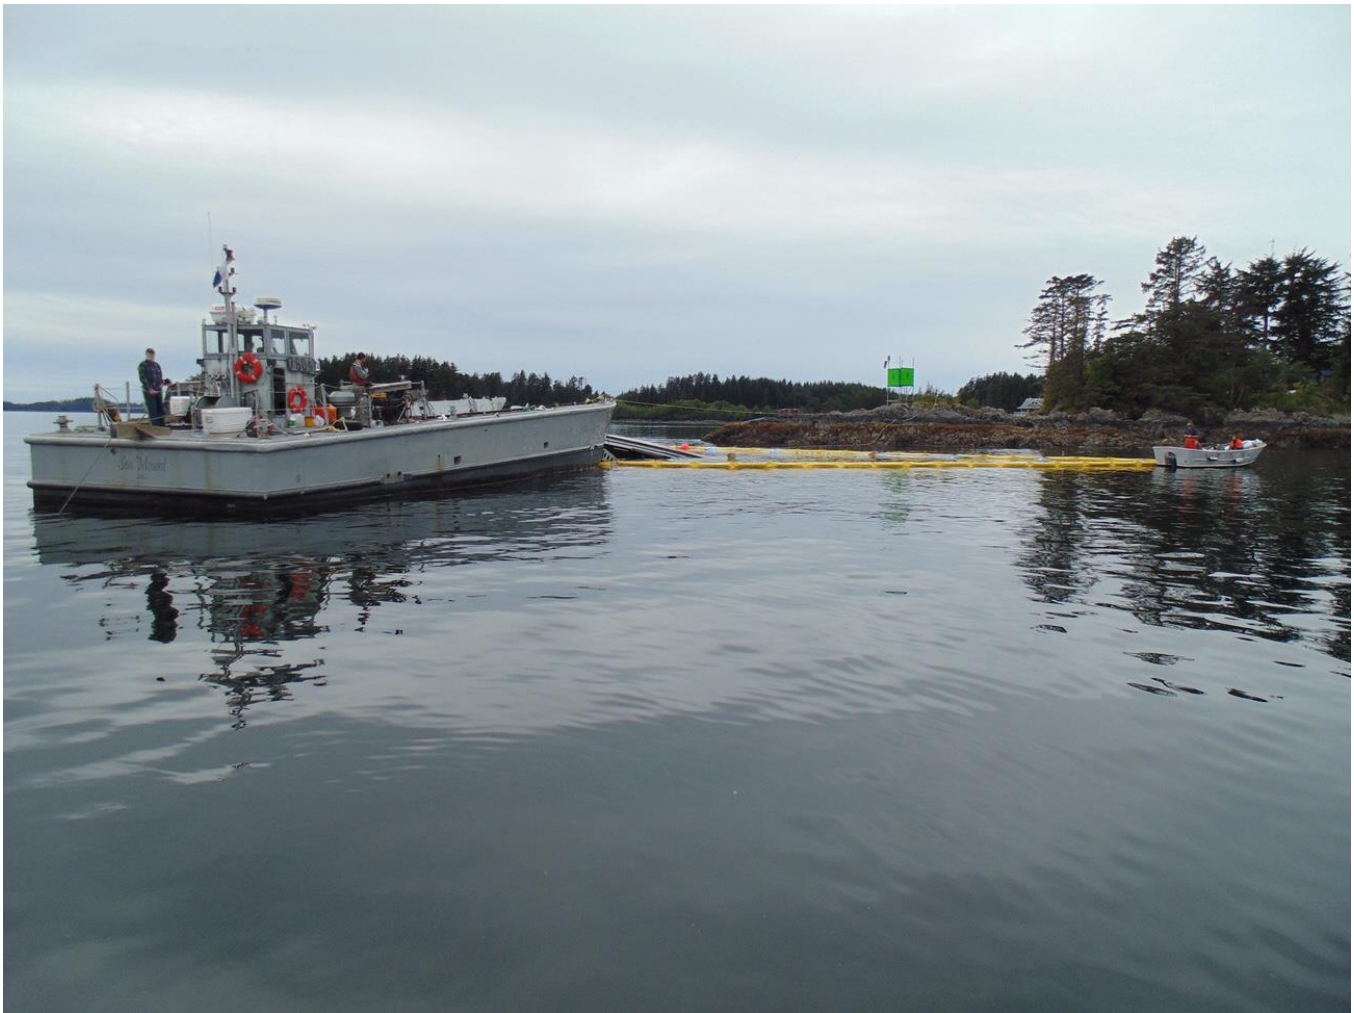
M/V Seamount prepares to lighter fuel from F/V Pacific Venture, September 4, 2015. (Photo/USCG)

RESPONSE ACTION: Fuel vents on the port side of the vessel have been plugged and other product remains in closed systems. The starboard vent is resting on the sea floor and will be assessed during lightering operations. Global Diving has mobilized and is expected to begin lightering operations this afternoon. The 60-foot landing craft, *Seamount* will be used for staging of divers, lightering operations and temporary storage of recovered oil.
