ALASKA DEPARTMENT OF ENVIRONMENTAL CONSERVATION
Division of Spill Prevention and Response
Prevention and Emergency Response Program
SITUATION REPORT

F/V Pacific Venture Sinking

SITREP #: 4 and Final

SPILL #: 15119924402

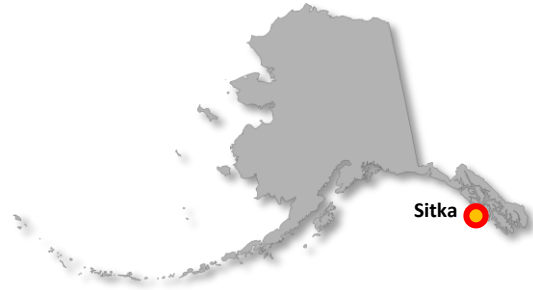
On September 5, 2015, Global Diving completed removal/recovery of 700 gallons of petroleum products and oily water. The accumulated waste was temporarily stored at the Sitka Petro Marine facility, with disposal of the recovered waste to be completed via shipment to Full Cycle LLC in Ketchikan. On September 6, the salvage team, Southeast Underwater Services began salvage operations. Southeast Alaska Petroleum Response Organization (SEAPRO) remained in service to maintain sorbent boom until the vessel was raised. On September 17, the salvors partially refloated the vessel and towed it to Eliason Harbor in preparation to remove the vessel

from the water. The vessel was successfully refloated on September 21 with the assistance of a W&S Construction crane barge, towed to Halibut Point Marine Services and removed from the water.
