**ALASKA DEPARTMENT OF ENVIRONMENTAL CONSERVATION**  
**Division of Spill Prevention and Response**  
**Prevention and Emergency Response Program**  
***SITUATION REPORT***

## Tug Challenger Sinking

**SITREP #:** 2 and Final

**SPILL #:** 15119925501

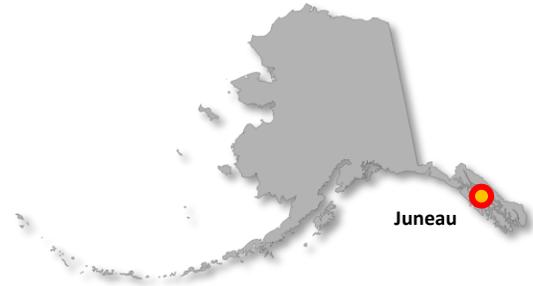
**TIME/DATE OF SPILL:** The vessel sank on September 12, 2015 at 2 p.m. in approximately 20 feet of water.

**CAUSE OF SPILL:** The vessel sank in approximately 20 feet of water. The cause of the sinking is under investigation by the USCG.

**RESPONSE ACTION:** After arriving on scene on Saturday, minimal sheening was observed by members of the USCG. The sheen was determined to be unrecoverable. The USCG deployed 500 feet of containment boom at the site of the vessel on Sunday. Southeast Lighterage (SEAL) and Global Diving & Salvage, Inc. were contracted to evaluate and remove pollution sources aboard the tug. Diving and lightering operations were completed on September 15, 2015. SEAL changed out the USCG containment boom this morning and replaced it with their own containment boom. SEAL will maintain and inspect the boom daily. Any recoverable oil that surfaces will be recovered to fullest the extent possible. The USCG and ADEC continue to monitor the vessel and surrounding areas for any signs of pollution.

**SOURCE CONTROL:** Containment boom was placed around the vessel by USCG responders on Sunday, September 13, 2015. Global Diving & Salvage and Southeast Alaska Lighterage (SEAL) have removed all accessible pollution sources and hazards from the vessel.

**FUTURE PLANS AND RECOMMENDATIONS:** The Coast Guard and ADEC will continue monitoring for any further oil seepage and environmental impacts.
