ALASKA DEPARTMENT OF ENVIRONMENTAL CONSERVATION
Division of Spill Prevention and Response
Prevention, Preparedness, and Response Program
SITUATION REPORT

Frosty Fuels Cold Bay Diesel Spill

SITREP #: 2 and Final

SPILL #: 15259930701

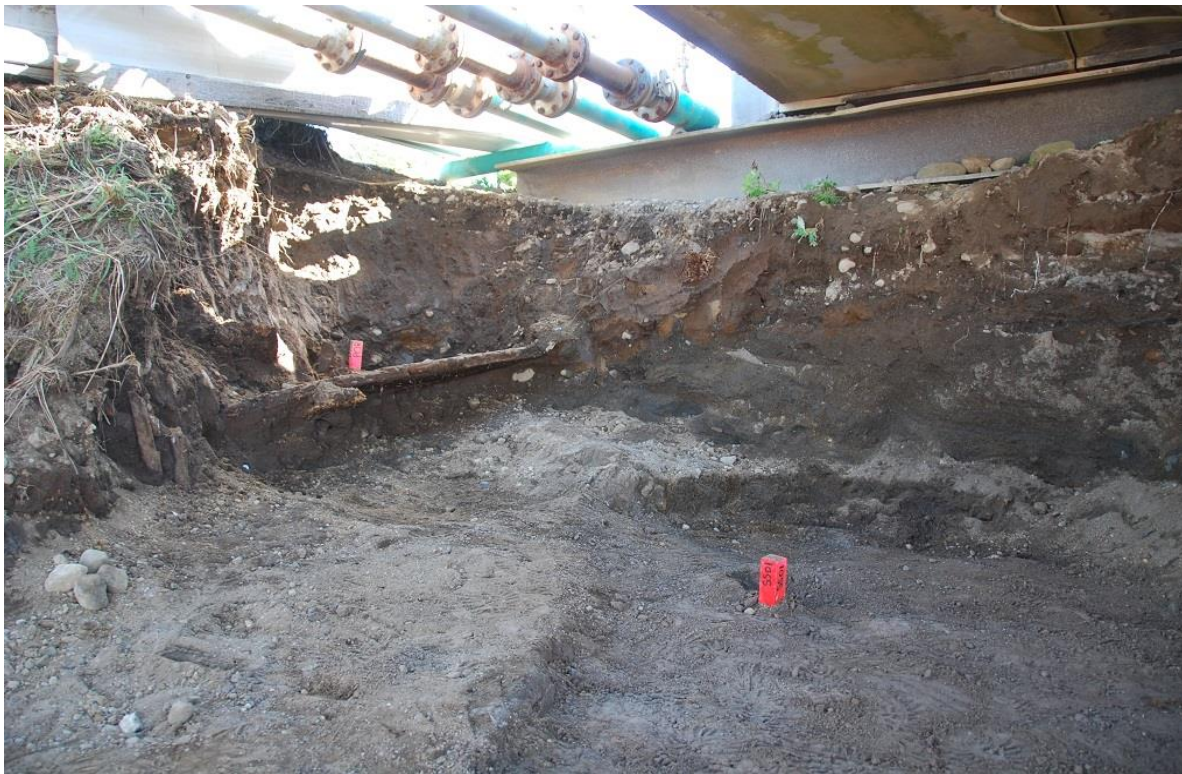
Close up of excavation under Cold Bay Dock, June 21, 2016. (Photo/ Kanaga Environmental Consulting LLC)

RESPONSE ACTION: On June 20, 2016, clean up contractors hired by the PRP mobilized to Cold Bay to conduct final cleanup. The excavation activity at the Cold Bay city dock began on June 21 and completed on June 27. Approximately 22 cubic yards of contaminated soil and 10 cubic yards of contaminated cobble were removed from the spill site. Heavily contaminated soil has been sent to an approved facility for treatment and disposal.
