ALASKA DEPARTMENT OF ENVIRONMENTAL CONSERVATION
Division of Spill Prevention and Response
Prevention Preparedness and Response Program
SITUATION REPORT

Qinaq River Submerged Caterpillar EL180

SITREP #: 2

SPILL #: 16279908401

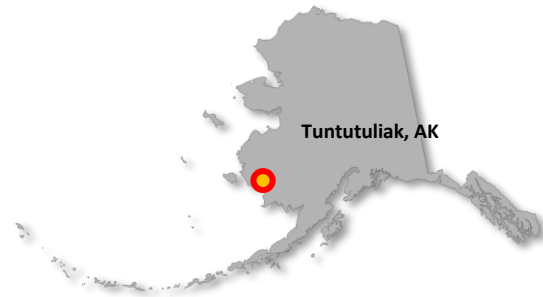
SOURCE CONTROL: The excavator is submerged in the river and currently surrounded by ice except for an exposed part of the excavator's boom. The excavator's compartments containing fuel and oil are submerged and are not accessible.
