ALASKA DEPARTMENT OF ENVIRONMENTAL CONSERVATION  
Division of Spill Prevention and Response  
Prevention Preparedness and Response Program  
**SITUATION REPORT (SITREP)**

**BPXA Flow Station 1 Drill Site 2 Well 3 Release**

**SITREP #: 2**

**SPILL #: 17399910401**

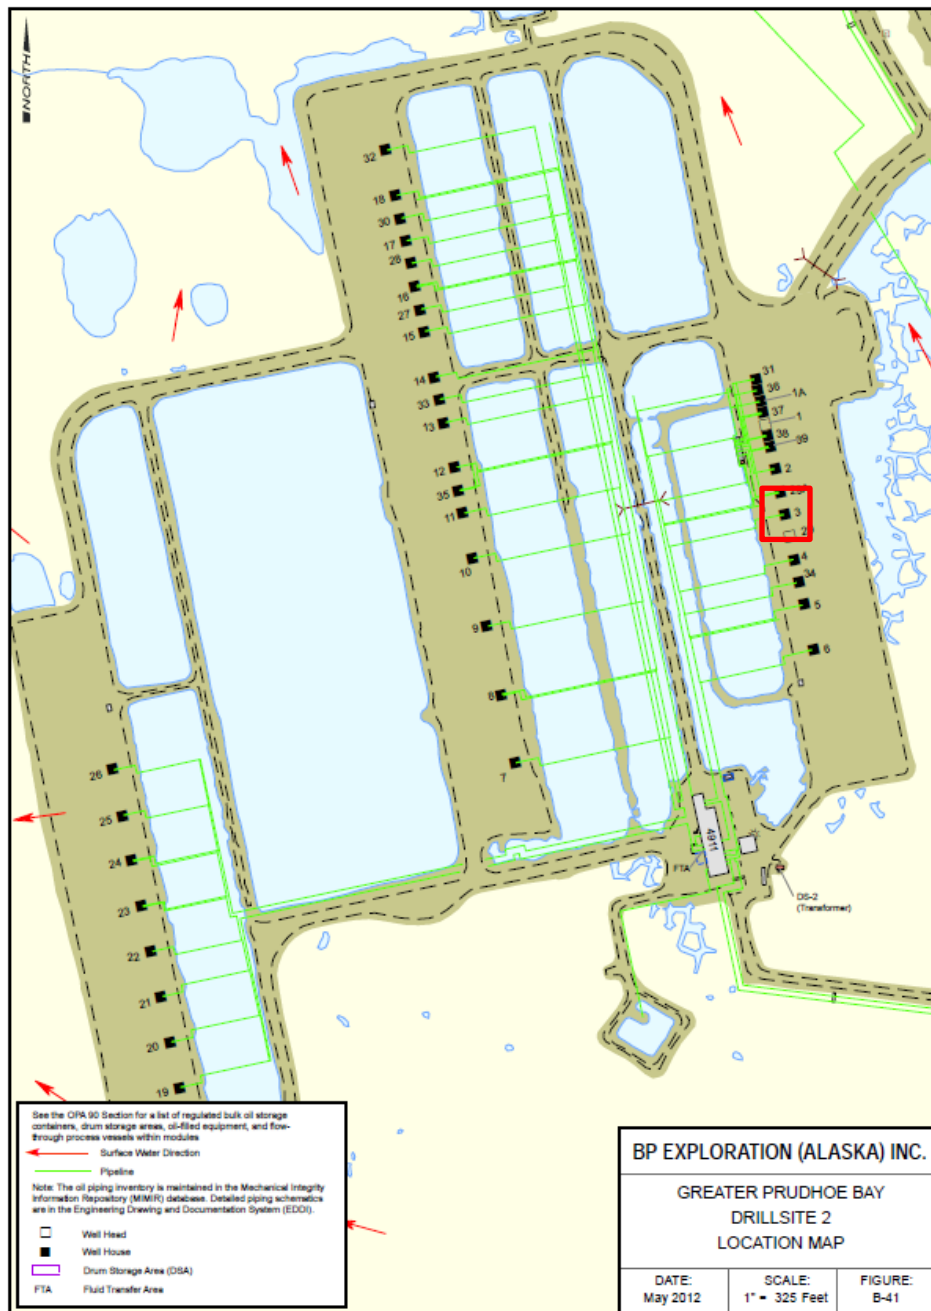
Diagram of Drill Site 2 from BPXA’s Oil Discharge Prevention and Contingency Plan. Well 3 (incident location) marked with red box.
