ALASKA DEPARTMENT OF ENVIRONMENTAL CONSERVATION  
Division of Spill Prevention and Response  
Prevention Preparedness and Response Program  
**SITUATION REPORT (SITREP)**

## **BPXA Flow Station 1 Drill Site 2 Well 3 Release**

**SITREP #:** 4

**SPILL #:** 17399910401

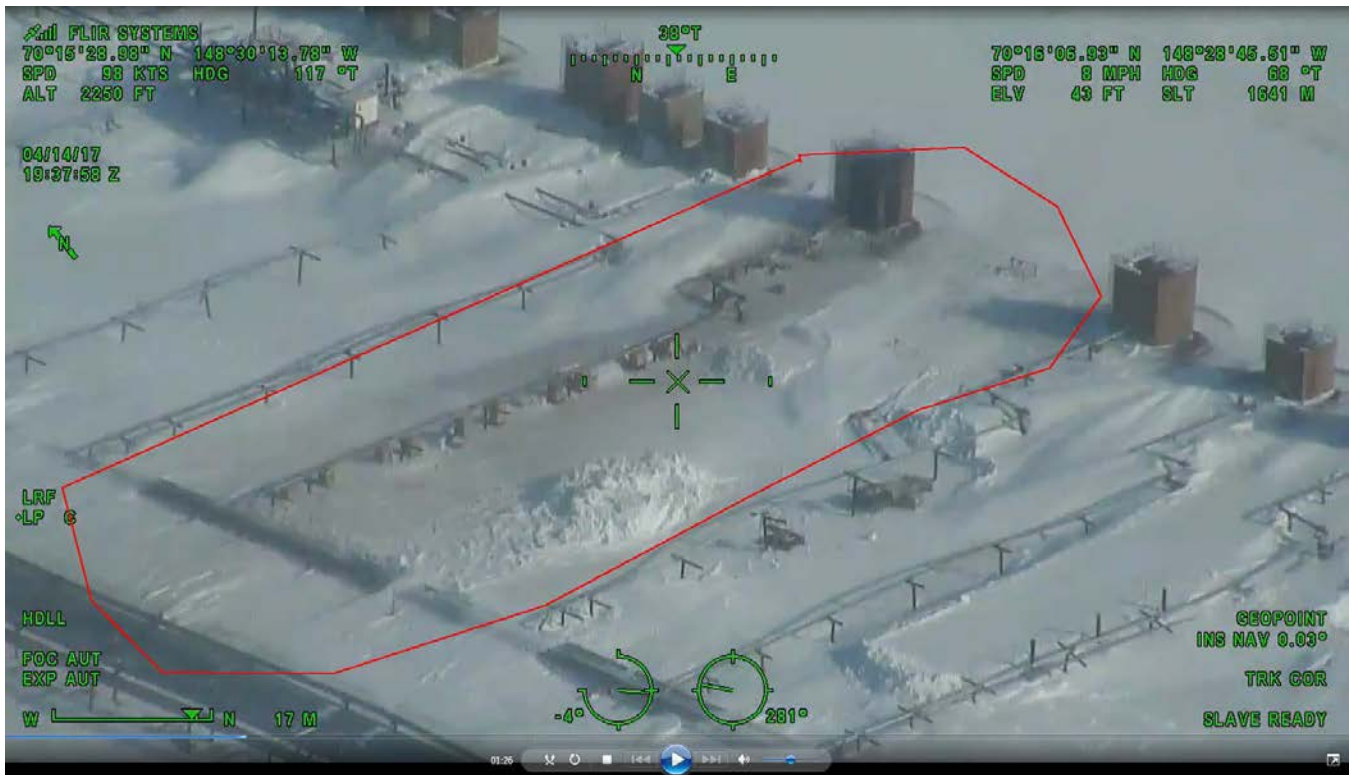
**TYPE/AMOUNT OF PRODUCT SPILLED:** The well is no longer venting gas, which caused an initial spray of crude oil that impacted the well pad. A Forward Looking Infrared (FLIR) overflight on April 14, 2017, showed that the crude spray plume did not leave the pad. The impacted area is limited to the reserve pit of the gravel pad, however cleanup responders have not yet confirmed there are no impacts to adjacent tundra. No volume estimate for the crude spray released is available at this time.

FLIR image from the incident location, taken during an overflight on April 14, 2017. Well 3 and the extent of crude misting is visible on the snow within the red-lined area. [Photo: BPXA]
